IS THERE REALLY AN ACTIVE FAULT (CIBYRA FAULT?) CUTTING THE STADION OF THE ANCIENT CITY OF CIBYRA? (BURDUR-FETHIYE FAULT ZONE, TURKEY)

irem $ELITEZ^{1}$ and Cenk YALTIRAK^{1}

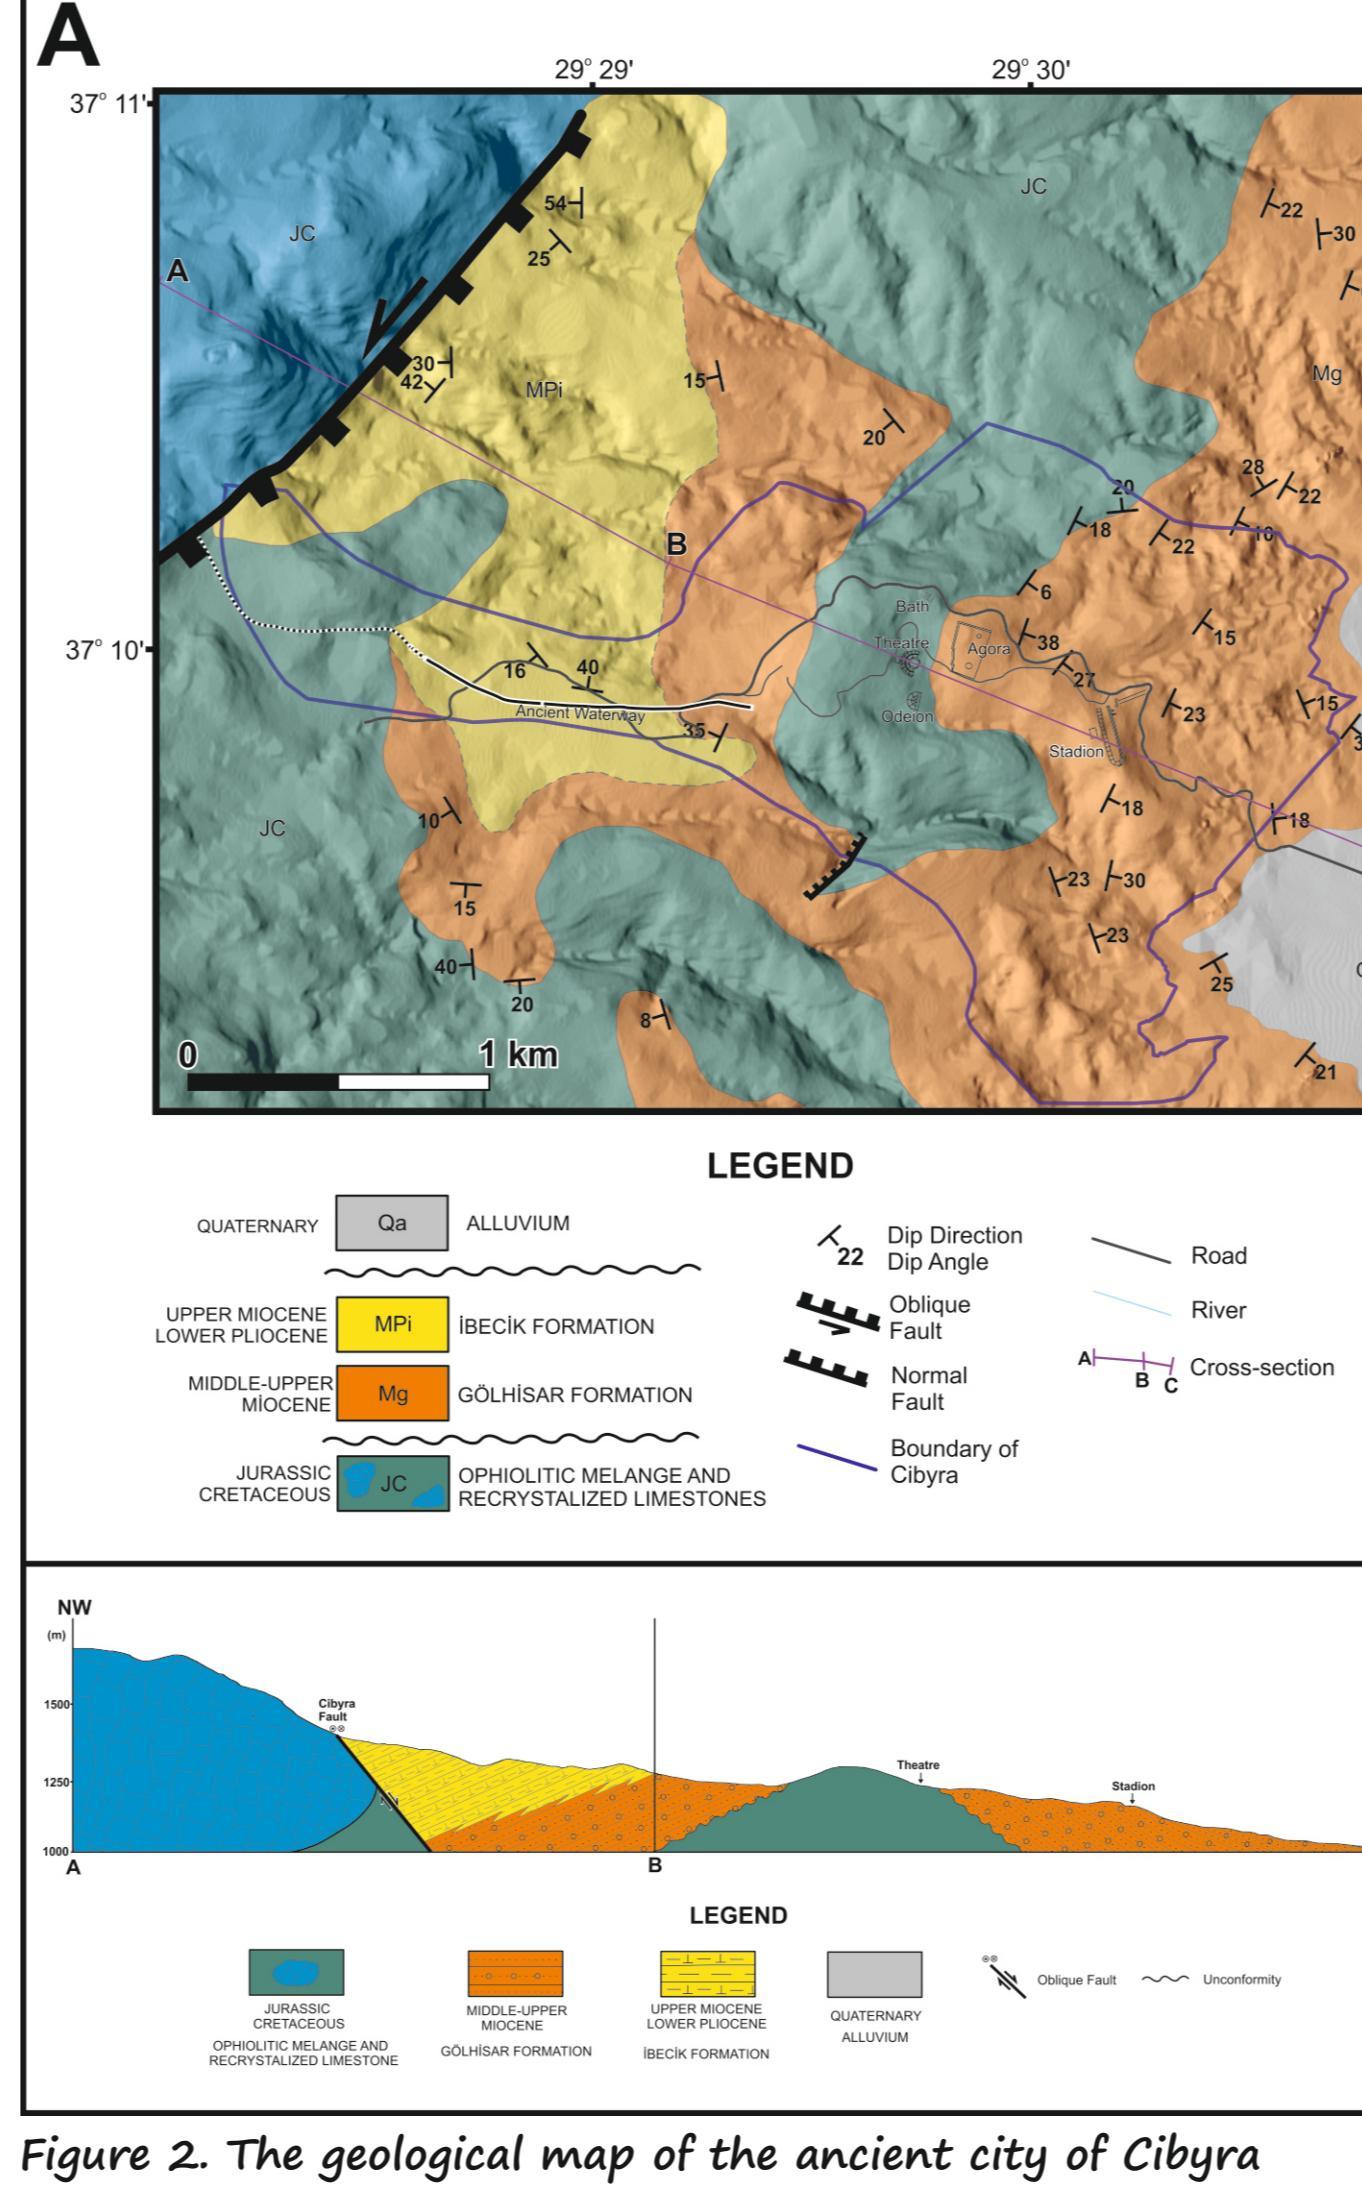
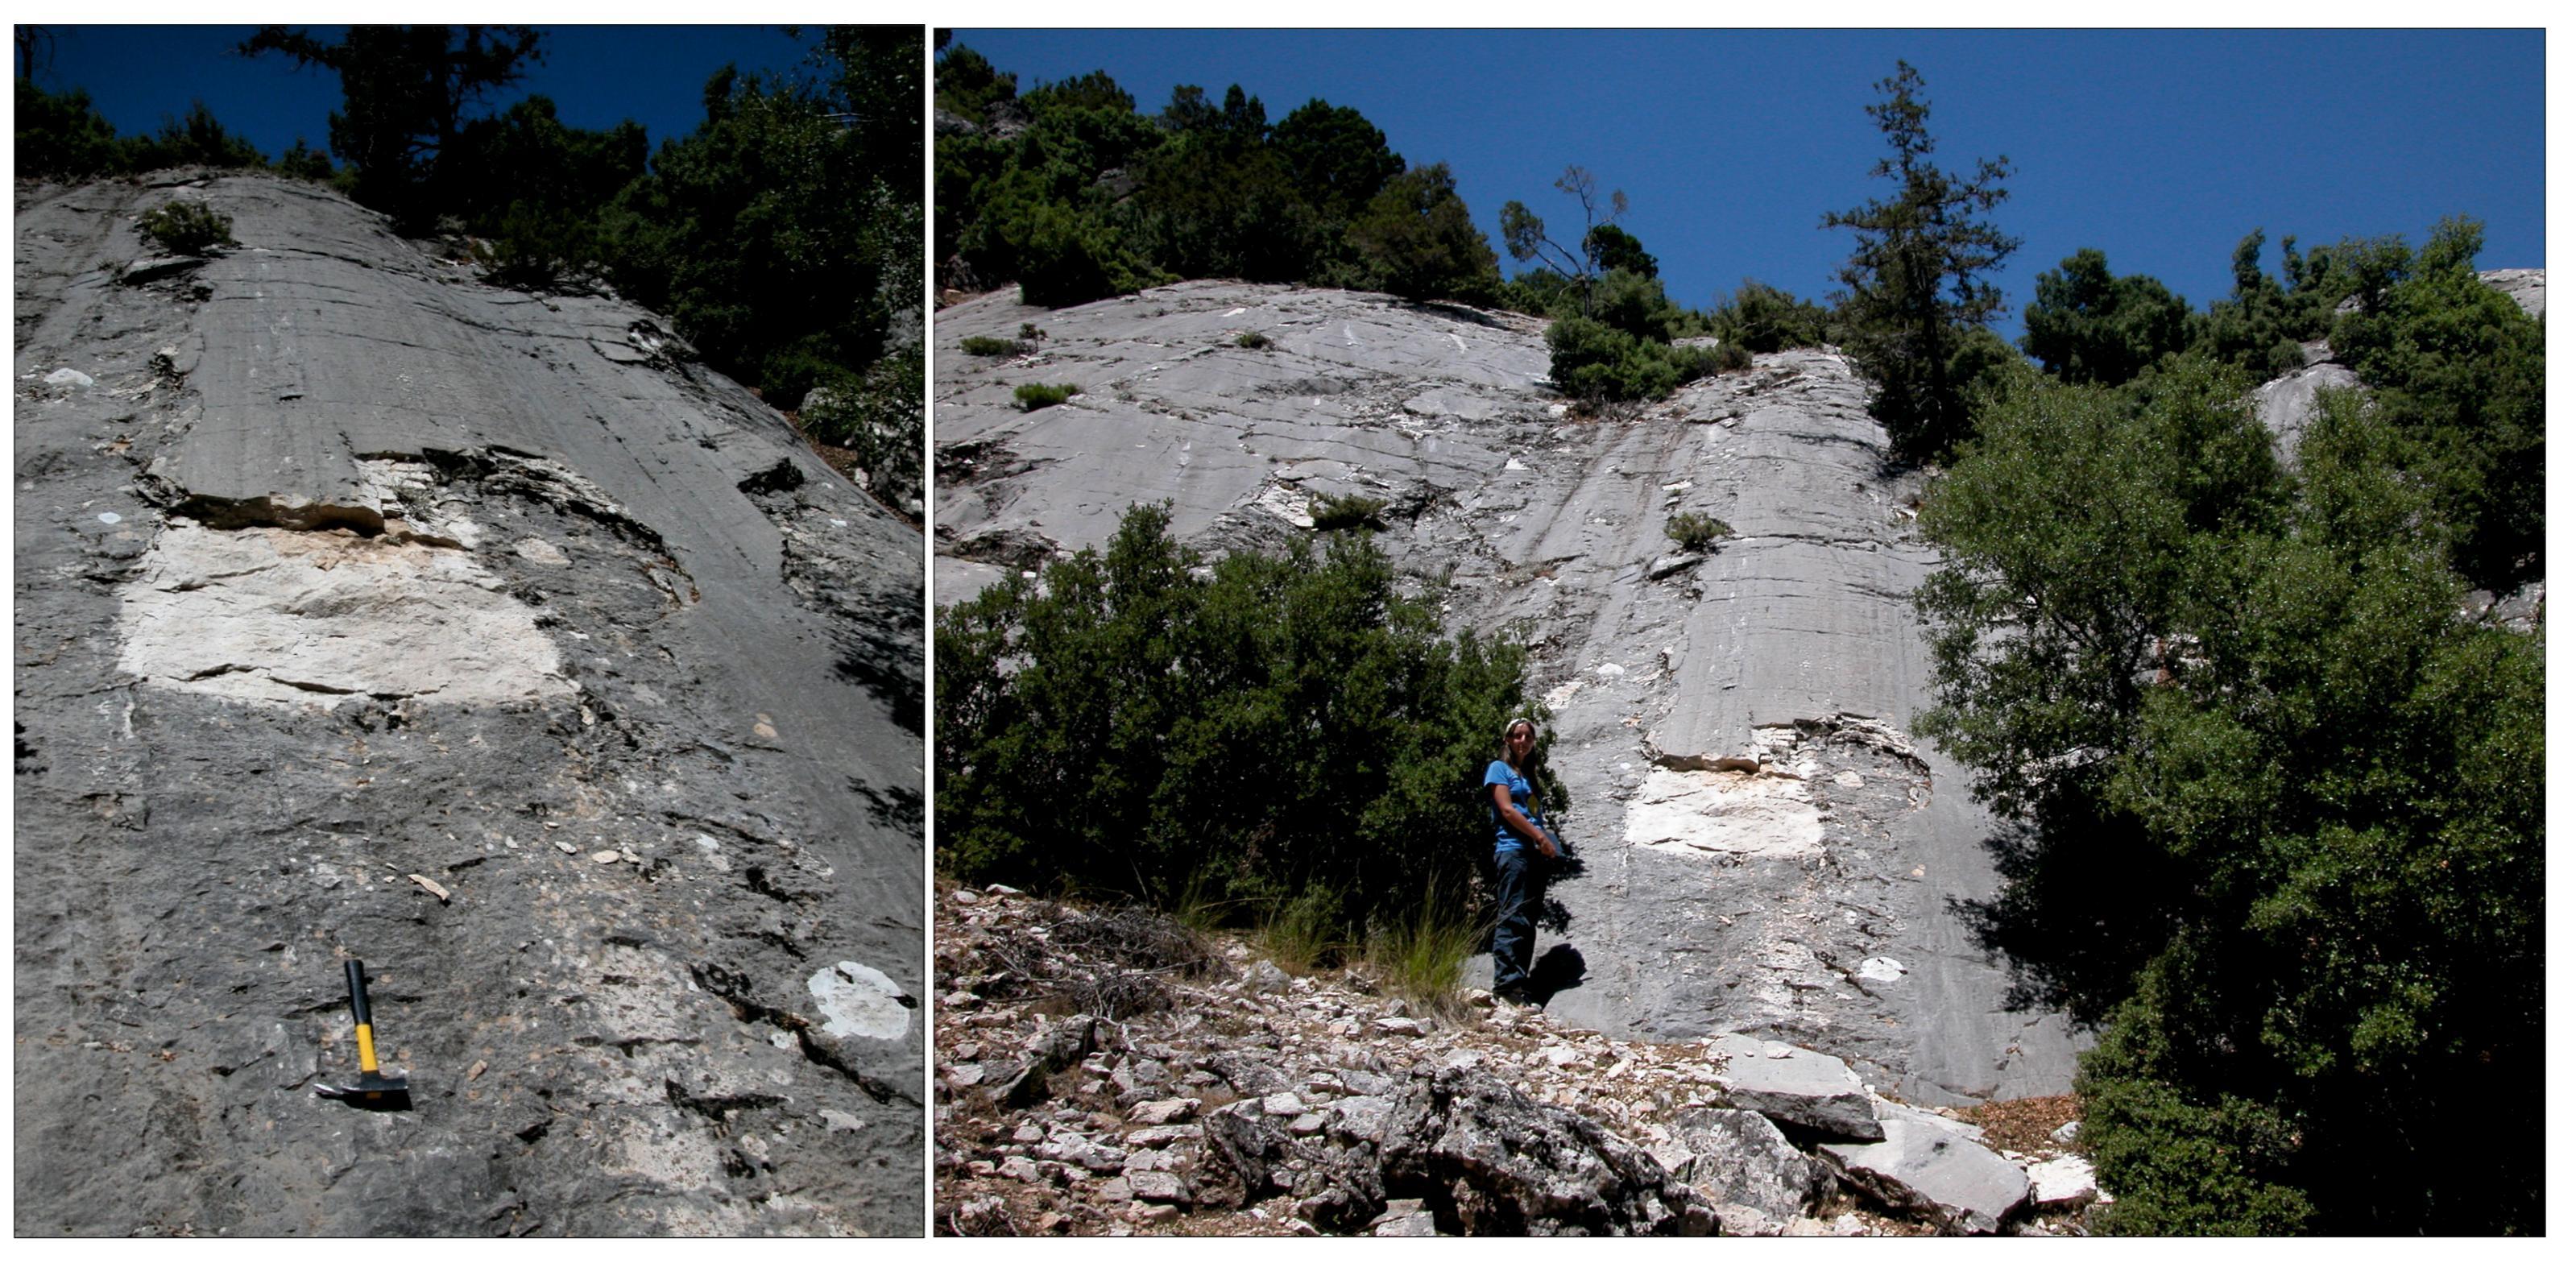
imestones; Middle-Upper Miocene aged coarse-grained onalomerates, sandstones, siltstones and shales deposited in meandering and braided river environments (Gölhisar Formation) and Upper Miocene-Lower Pliocene aged beige coloured claystones, thick bedded limestones, marls and siltstones deposited in delta and lake environments (ibecik Formation) (Figure 2A). The stadion of the city is located on the east-dipping beds of a rollover anticlinal (Figure 2B).

2). Dip direction and angle of dip:126/51SE (view direction: NW)

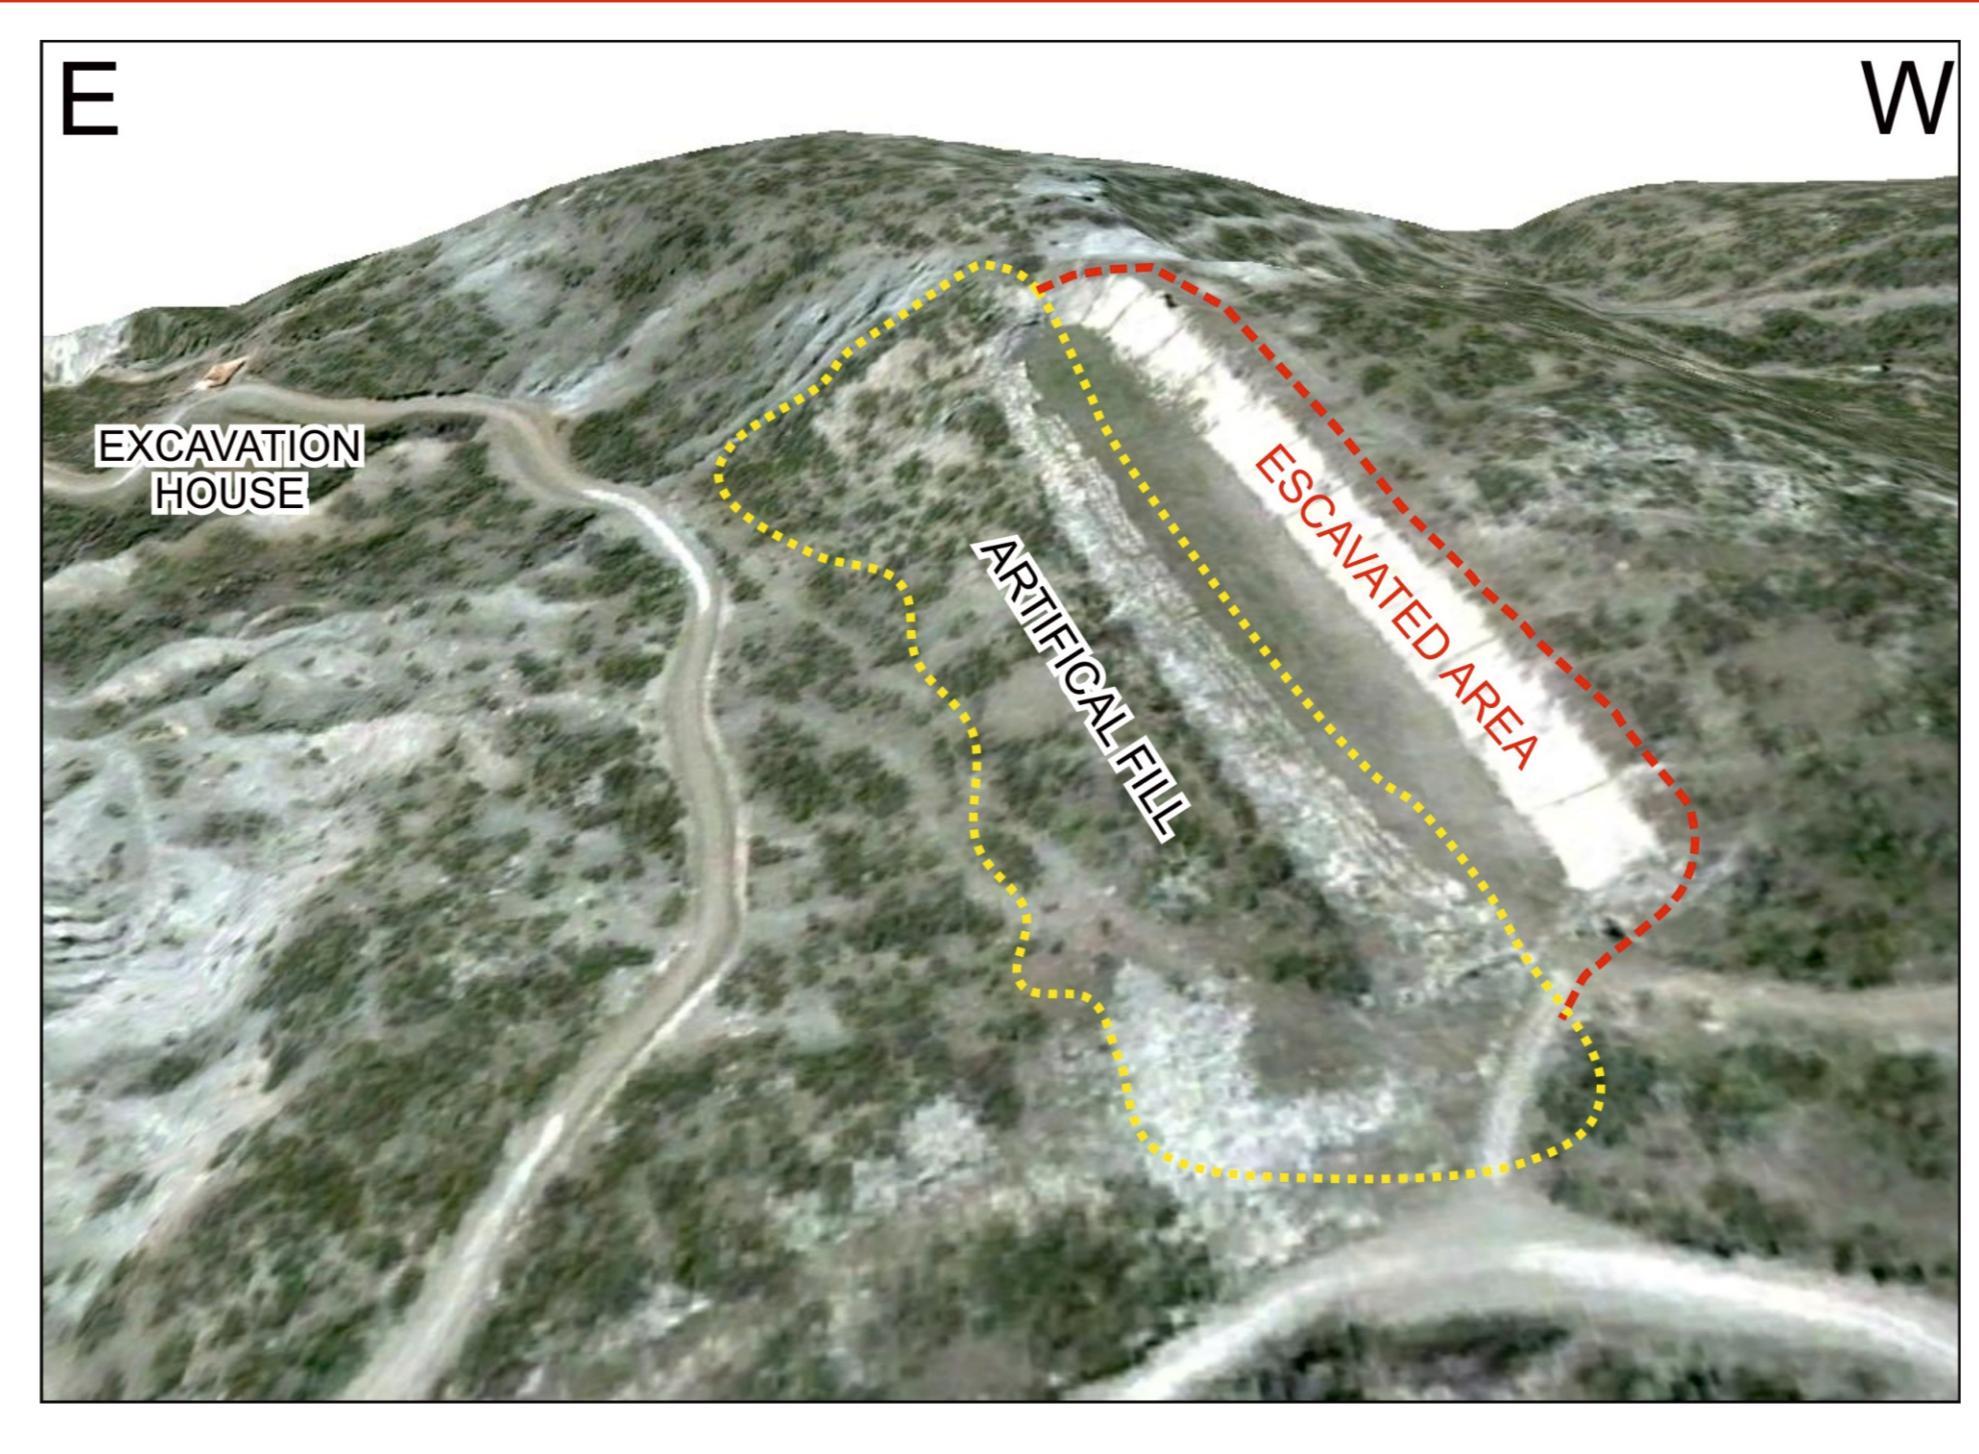
The hand-made fill materials can be classified into three types. One of these is the hand-made fills which were obtained from the construction area. They were produced on the purpose of smoothing the floor and filling the voids. They are apparent on the eastern slope of the stadion. Secondly, the fills with blocks are composed of the pieces cut from bedrock and they can be reputed to be bedrock. This kind of blocks was commonly used at the eastern part of the stadion during construction(Figure 7A).
