INTRODUCTION

EFFECTS OF VERTICAL GROUND MOTION IN BUILDINGS IN THE 2016 AMATRICE EARTHQUAKE AFFECTED AREA (Figs. 9-16)

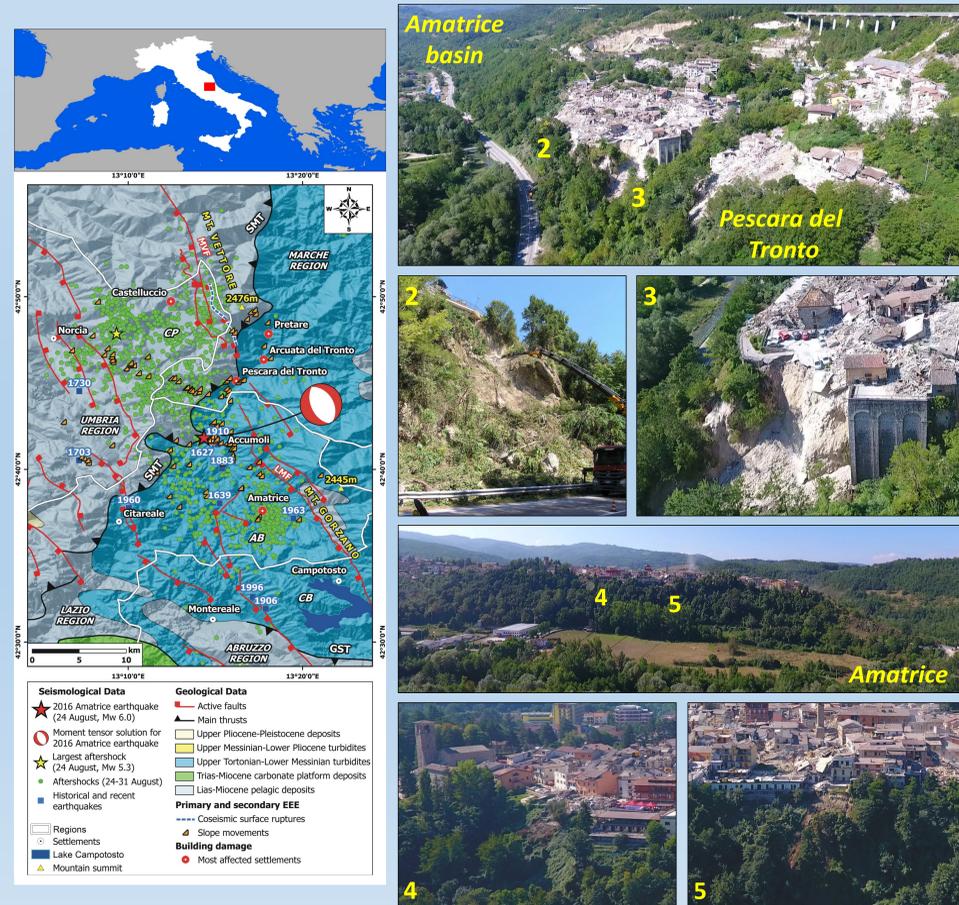
In contrast, slope movements in the hangingwall (HW) were much more (98 localities) than those in the FW (Fig. 1). Their distance from the aforementioned faults was larger, ranging from 0 to 15 km (Fig. 1). They were comparatively of higher concentration and of larger scale causing severe damage to buildings and infrastructures and increasing human fatalities in settlements founded on top of flat hills, especially in Pescara del Tronto village (Figs. 2, 3) and Amatrice town (Figs. 4, 5).

Landslides generated along the steep slopes of the Pescara del Tronto and Amatrice flat hills are attributed to the destructive effect of the vertical component and to topographical amplification of earthquake motion along with the already established instability conditions resulted from river incision and erosion at the base of the hill. They resulted in partial or total collapse of buildings found at the edge of the hills and damage to infrastructures.

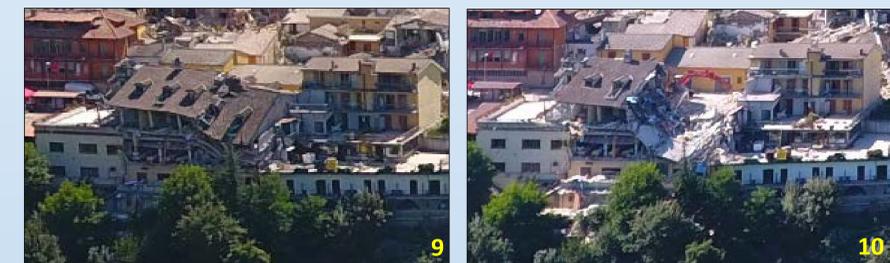
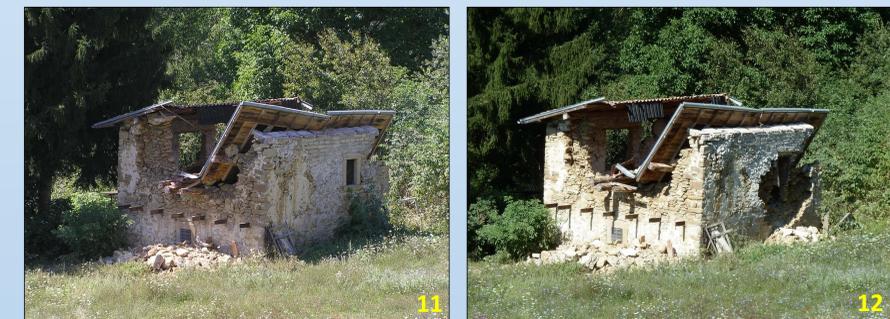
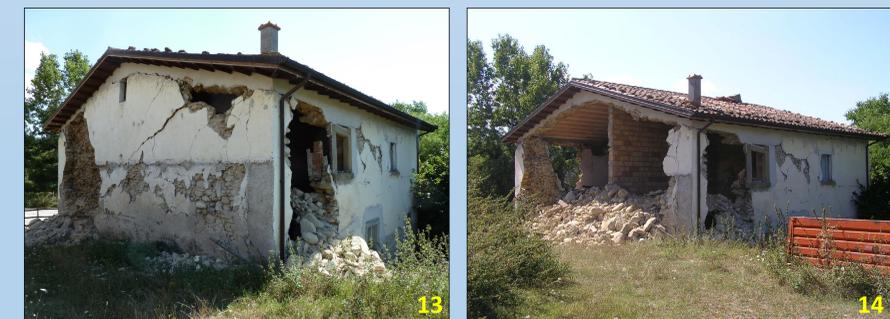
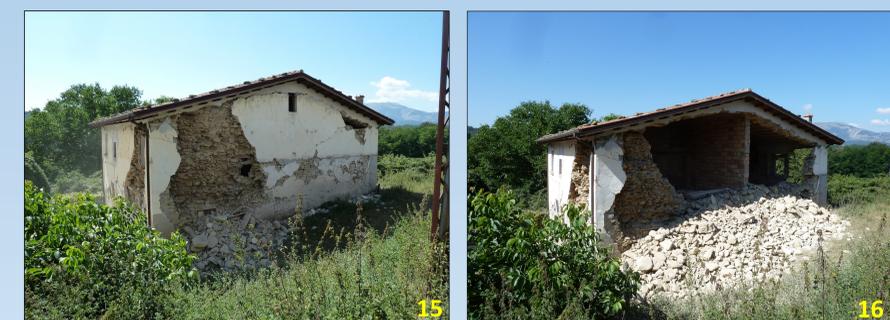
On 2016.08.25, after the main shock

On 2016.08.26 After an Mw 4.8 aftershock
