Evidence of natural hazards in the lower Yellow River: A close look at bank collapses

Lu Gao and Xiangzhou Xu*

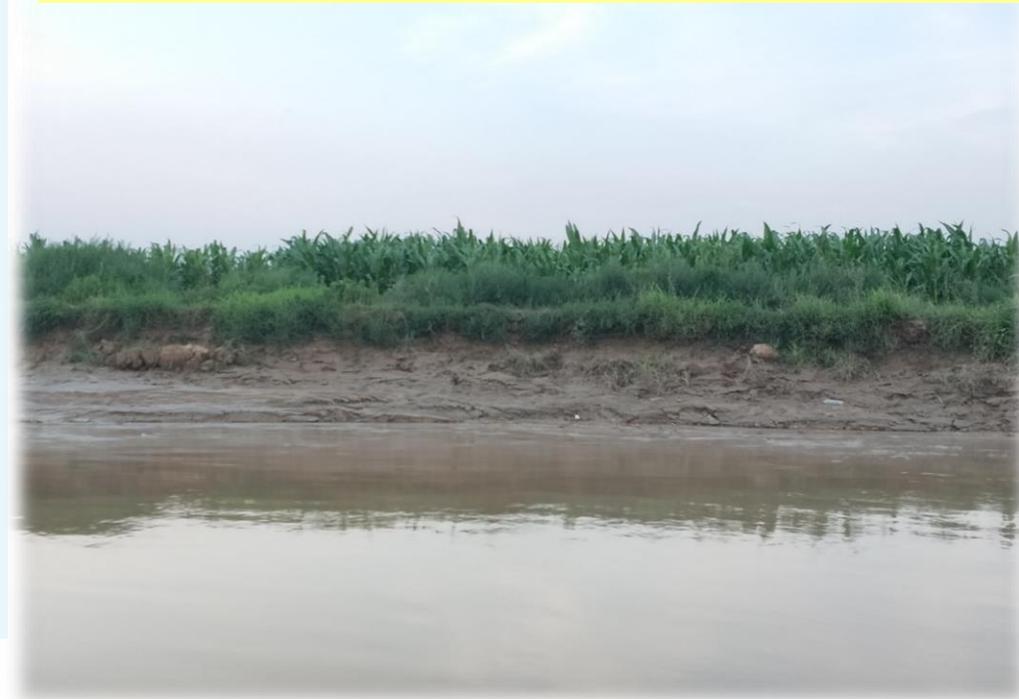
Recent damages caused by bank collapses have been frequently reported in the Yellow River, China.

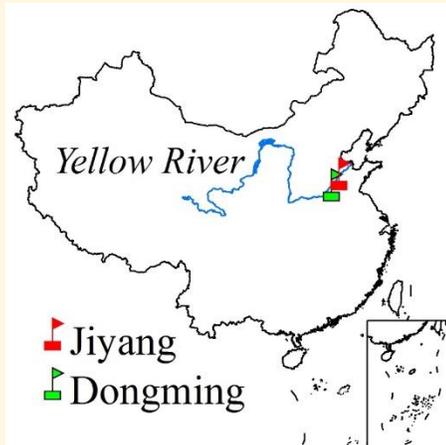
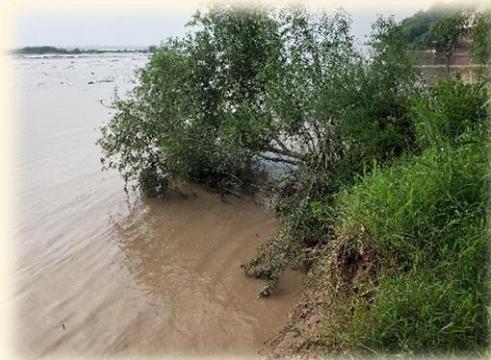
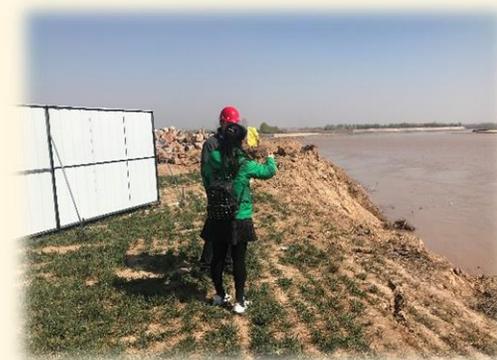
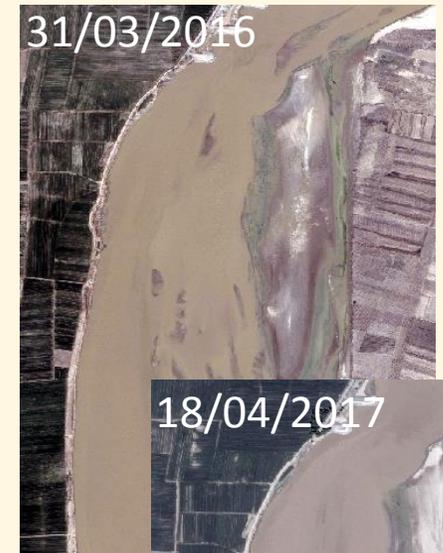
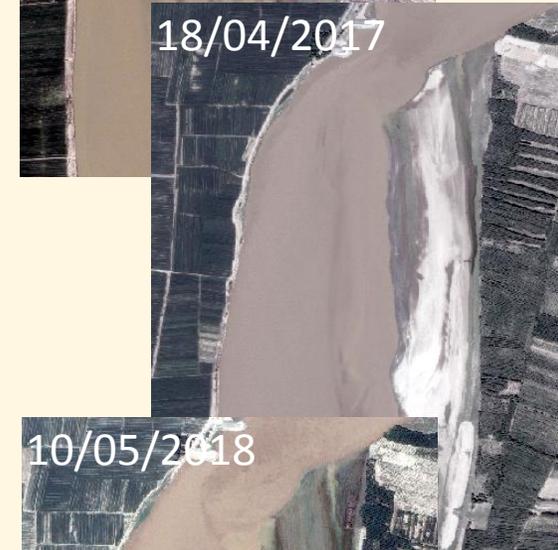
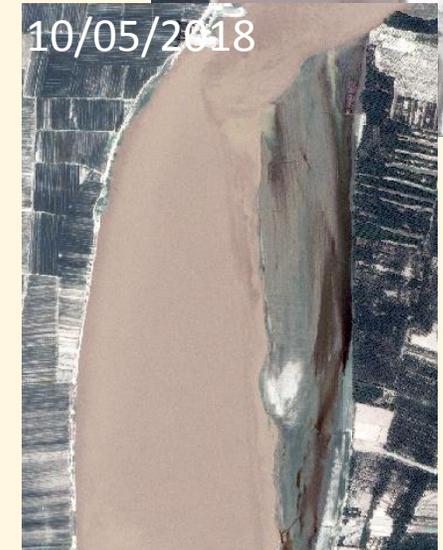
- A variety of on-the-spot-investigations in the **Shandong Reach of the lower Yellow River (Dongming and Jiyang Reach)** were initiated in July 2018 and April 2019.
- Then, the observed cross-sectional profiles data and the Google Earth were used in the analysis of this paper.
- Finally, the software programs ArcGIS 10.2 and AutoCAD 2014 were used to process and analyze.
