# Durability of a ventilated stone facade: A case study of a limestone facade affected by the corrosion of the anchorage system

D728 | EGU2020-3755

The present study aims understanding causes of the **corrosion** of an anchorage system of a **ventilated stone façade** cladded with the Portuguese limestone "Lioz".

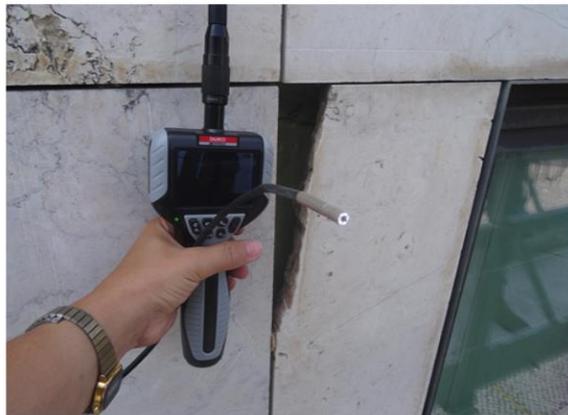
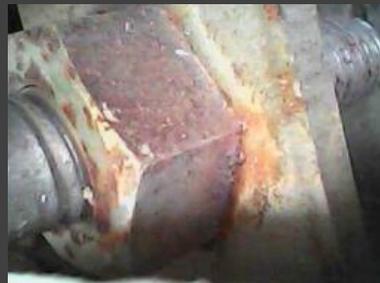
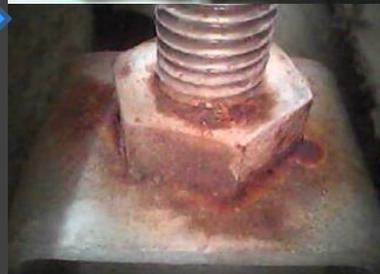
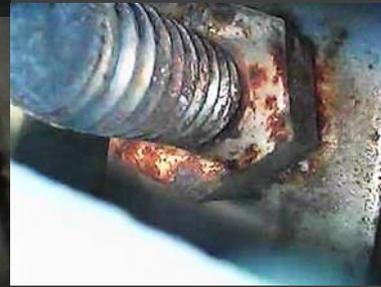
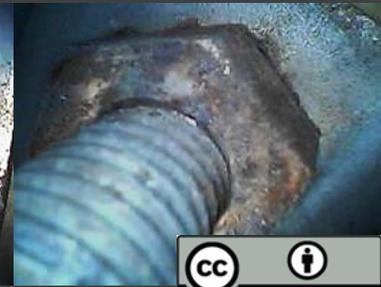
- | 48% issues depicted high risk @ North elevation
- | 27% issues depicted high risk @ East elevation
- | High risk is linked to a higher probability of cladding failure
- | High risk = anchoring system with corrosion + stone slab with critical pathology

- Anchor **item #4** is made of **A1 stainless steel** which is highly unsuitable for the load + slab size + environment.
- **60%** of **#4 anchor items** present severe **pitting corrosion** = environmental+ stress + poor installation combination.

- Most stone drilling was made on site = poor work quality.
- **98%** of the inspected anchor items show corrosion at several levels between severe and mild.

- **Aprox. 60%** of the inspected **stone slabs** were classified has **high risk** for collapse. Replacement was recommended.
- All **anchor items** should at least made of **A4** stainless steel = better corrosion and mechanical performance.
