NH3.13

Nature-based and bio-based solutions for geohazard mitigation on slopes and streambanks ▶

“Nature based Solutions and combined techniques in the immediate vicinity of infrastructure and residential areas - 5 case studies of steep bank stabilization in the Garonne water catchment area in France realized between 1999 and 2022

Klaus Peklo Dipl.-Ing., graduate engineer

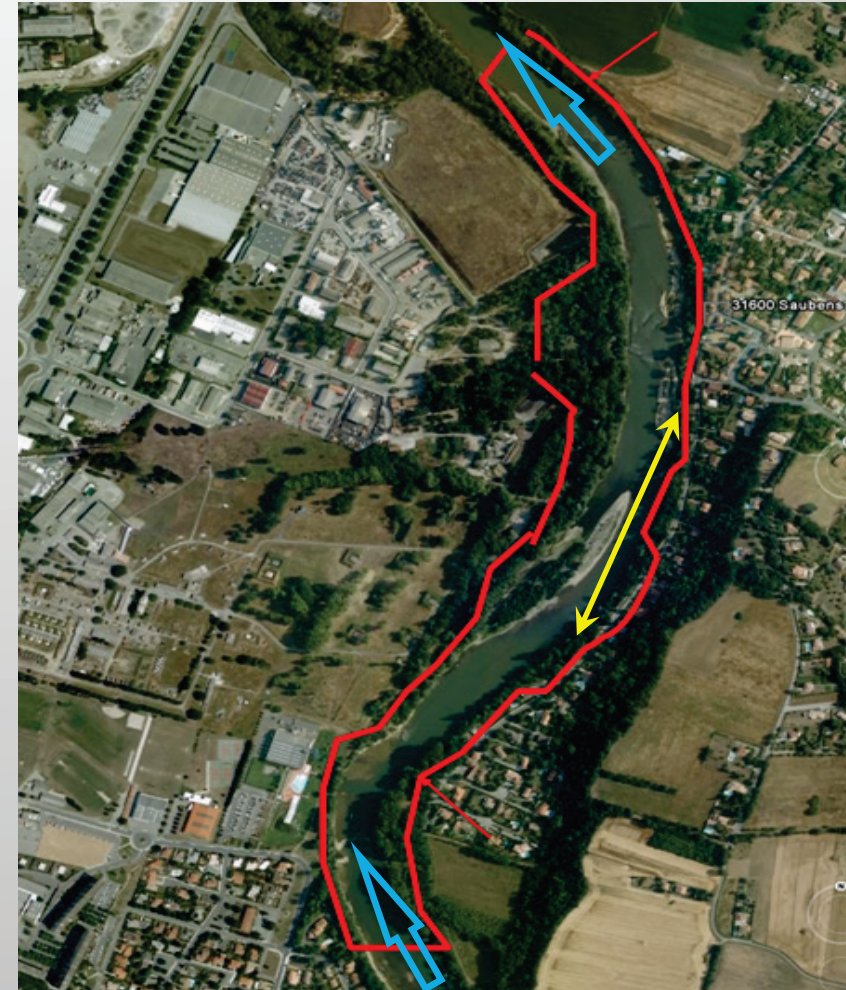
Damage case: Far advanced bed shifting and bank erosion; imminent risk of embankment collapse threatening public space and communal road

Provided longitudinal works: live RipRap, Log Cribwall, live Brush Mattress, Brush Layers, combined drilled concrete injection anchors

Provided transversal works: absolutely necessary but not yet been authorised

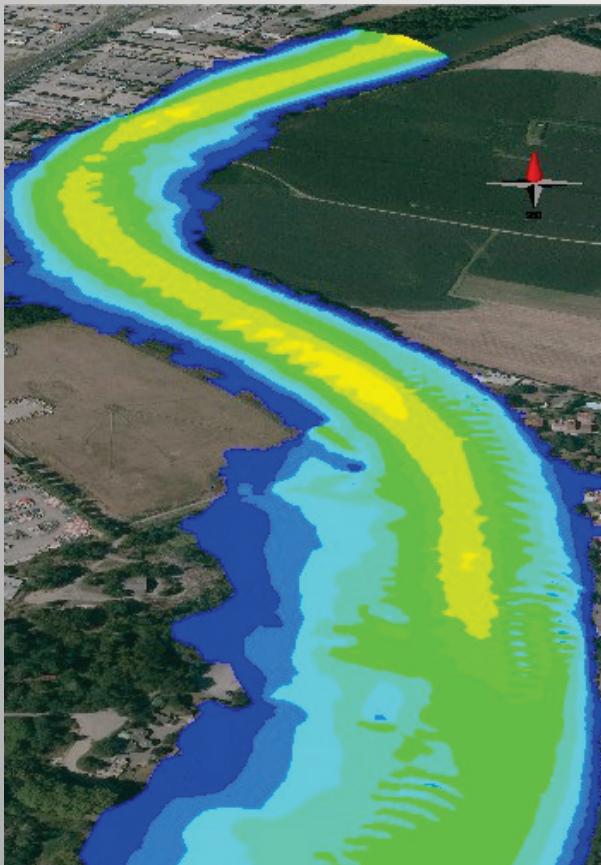
<< Velocity values are computed by TELEMAC 2D for required levels

< Geschwindigkeitsverteilung

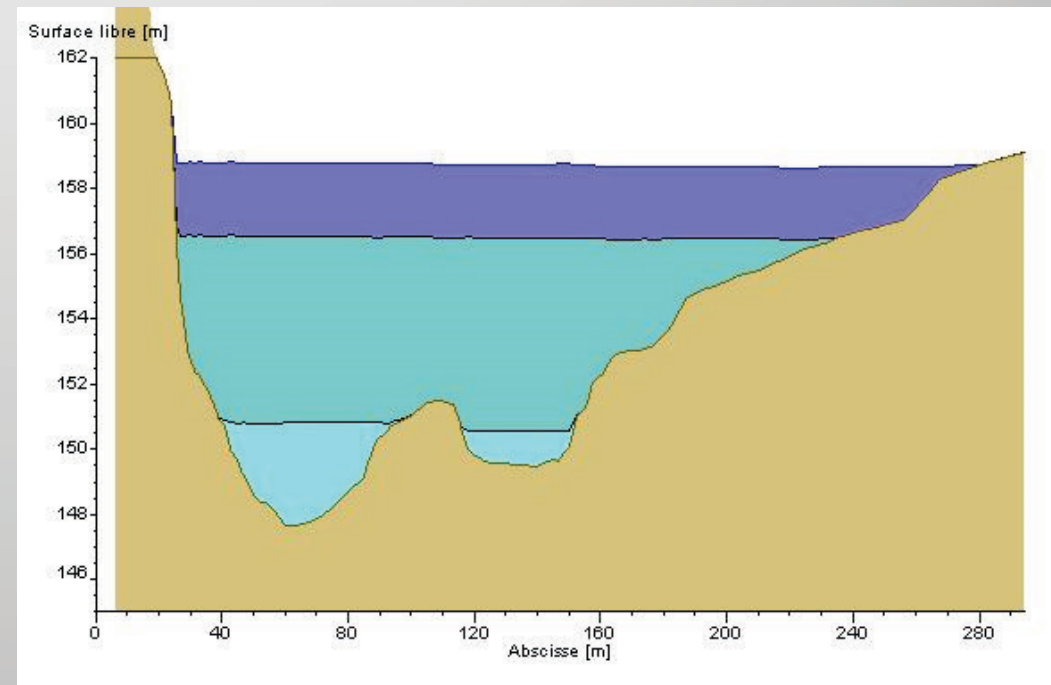
Flood cross-section values are computed by TELEMAC 2D for required levels

< Flussgrund und verschiedene HW Stände

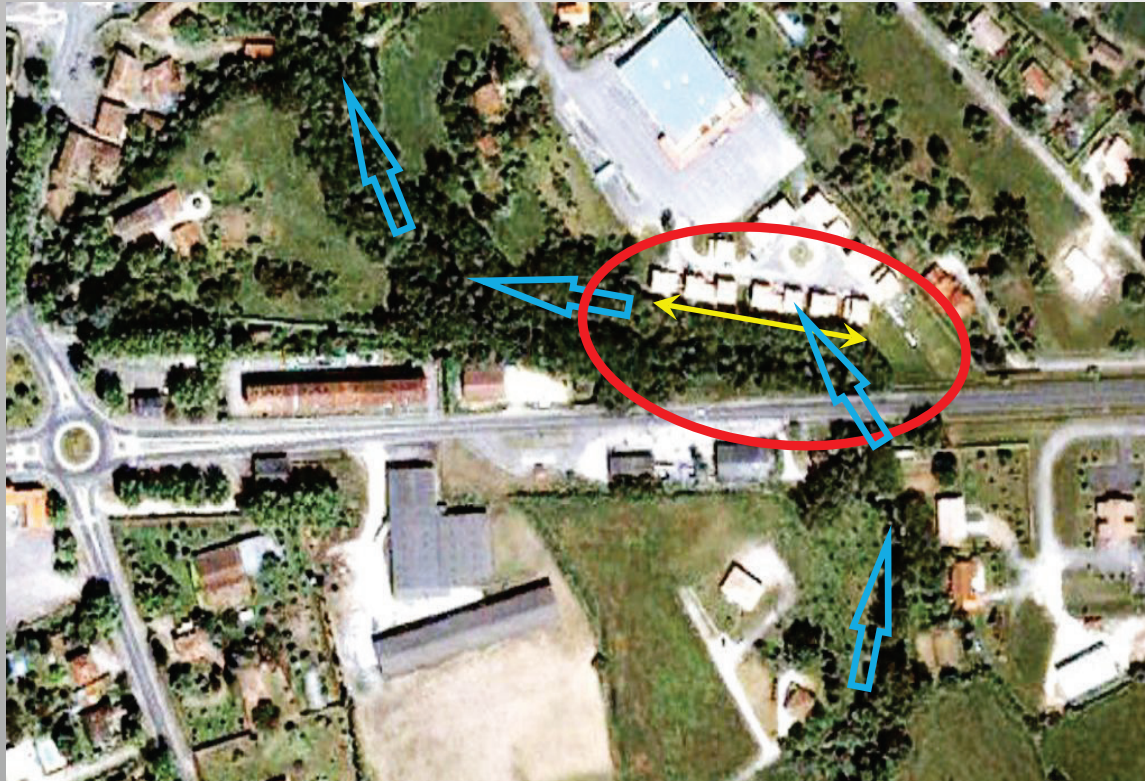
Damage case: Far advanced bed shifting and bank erosion; imminent risk of embankment collapse threatening residential area
Preliminary studies: Topographic data levys, drillings in view of geotechnical assessment and hydrodynamical analysis
Program mission: Project establishment, contract drafting and site monitoring In order to reduce risk of bank erosion

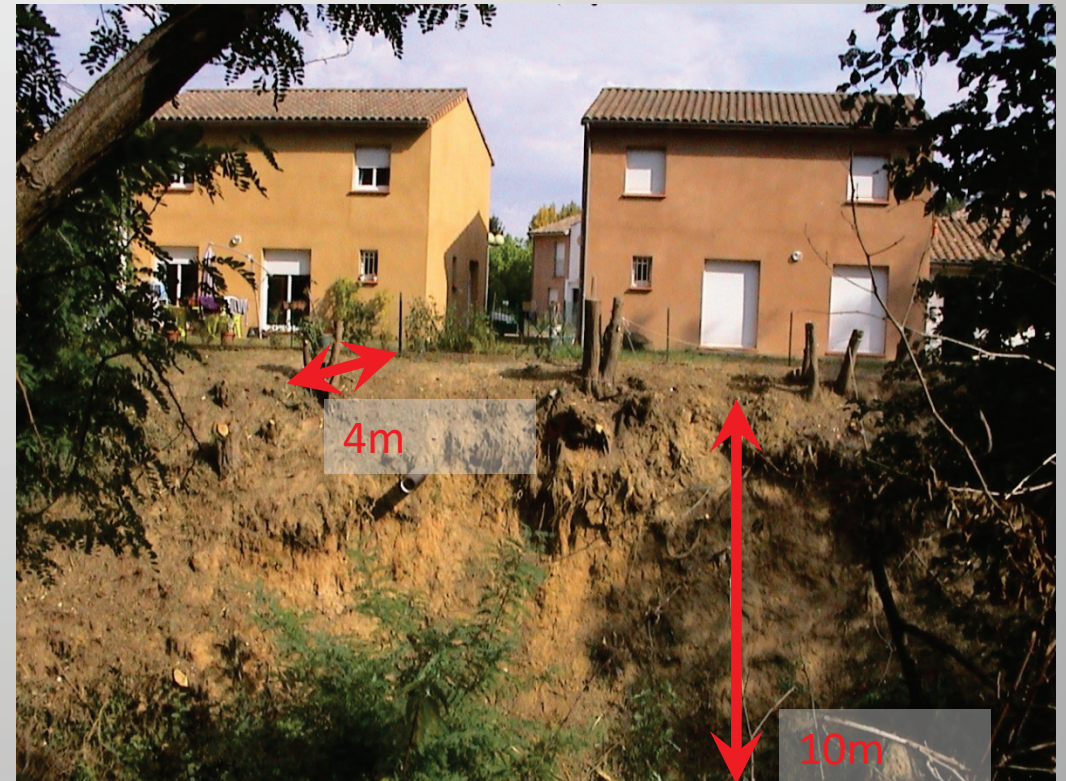
Preliminary study stage

After clearing work we discovered broken sewers, huge building rubbish and a pretty nice groundwater horizon

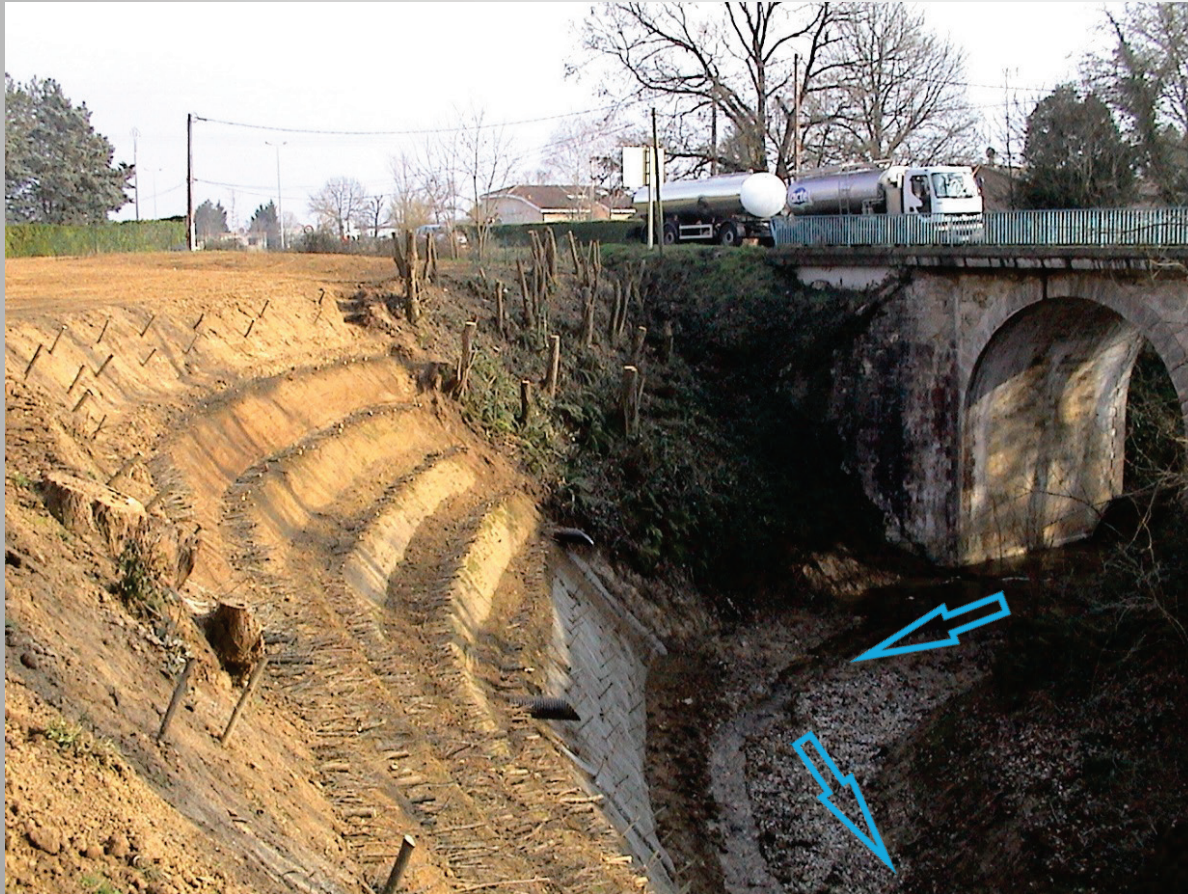
Picture to upstream right riverbank

Completion date: Pictures taken March 2012

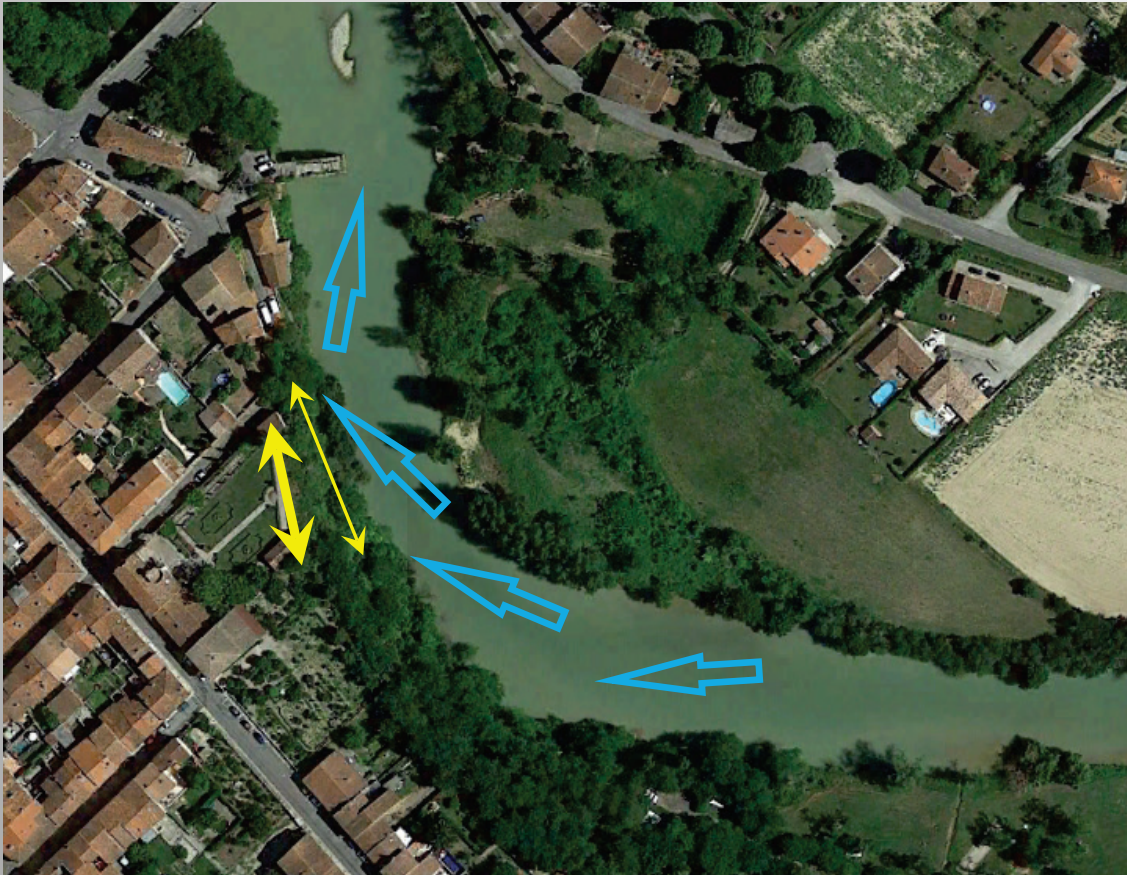
Damage case: Far advanced cliff erosion but less bank erosion problem; imminent risk of upper cliff edge collapse threatening public space
