Exposure to past disasters related to hydrological hazards: the case of Bujumbura city, Burundi

Jean Nsabimana (1-2-3), Sabine Henry (2), Aloys Ndayisenga (3), Désiré Kubwimana (4,5), Olivier Dewitte (1), François Kervyn de Meerendré(1), Caroline Michellier (1)

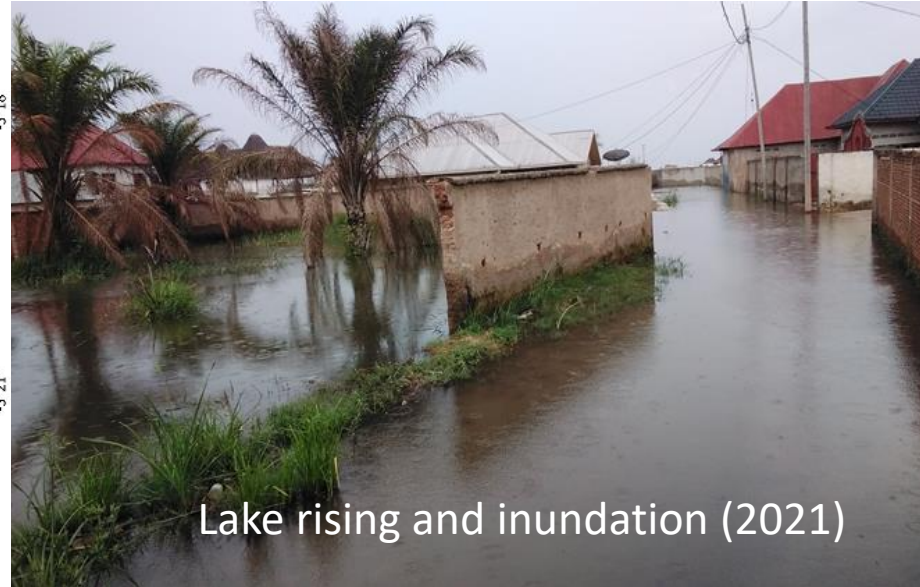
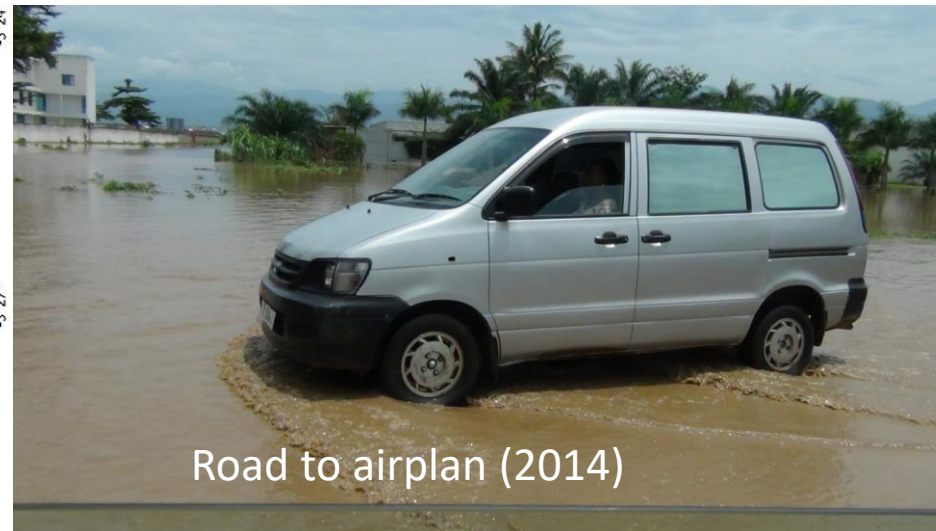
Fig. Flood inventory map

- ❖ *The flood inventory map is based to :*
 - *Historical event ,*
 - *Take into account the occurrences /neighborhood,*
 - *Tanganyika lake rising.*

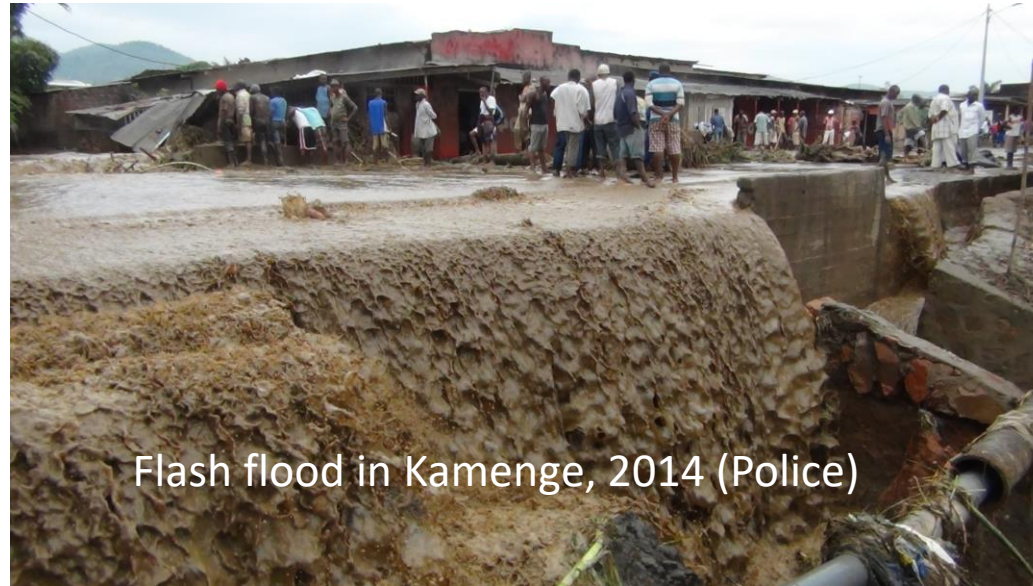
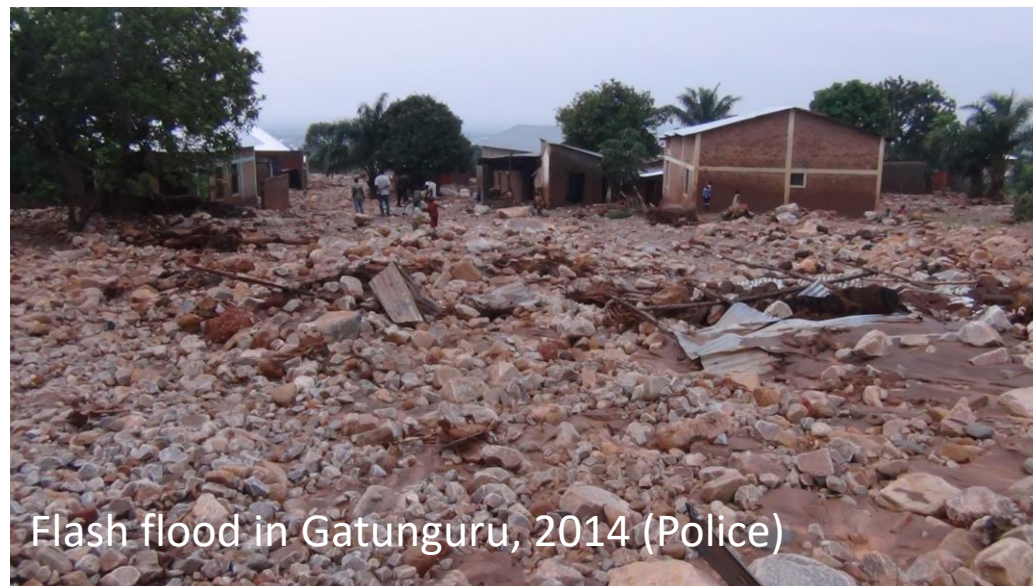
Fig. Flash flood inventory map

- ❖ *The flash flood inventory map is based to:*
 - *Historical event*
 - ,
 - *Take into account the occurrences /neighborhood.*

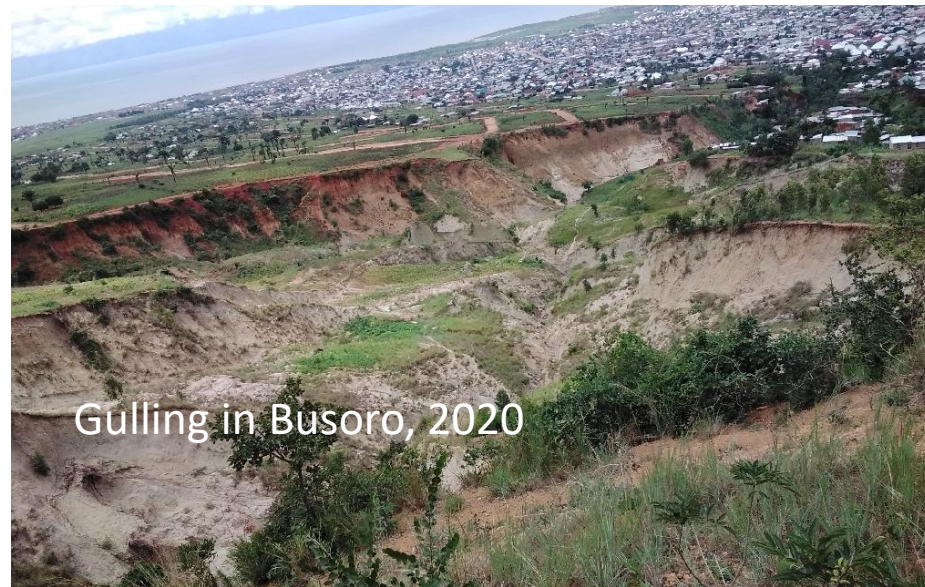
Fig. Gully inventory map

❖ The gully collapses map is based on the collection and googles earth images

- ❖ *Gullies collected:*
- *concentrated at the foot of the eastern foothills,*
 - *total area of gullies 116 ha*

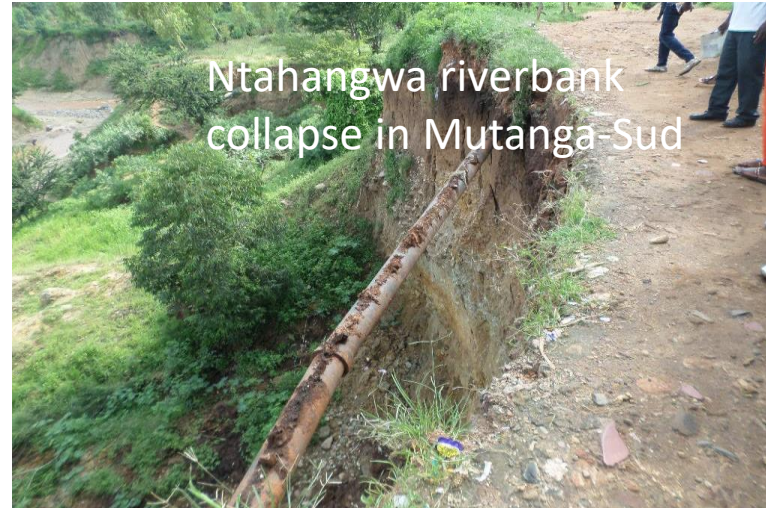
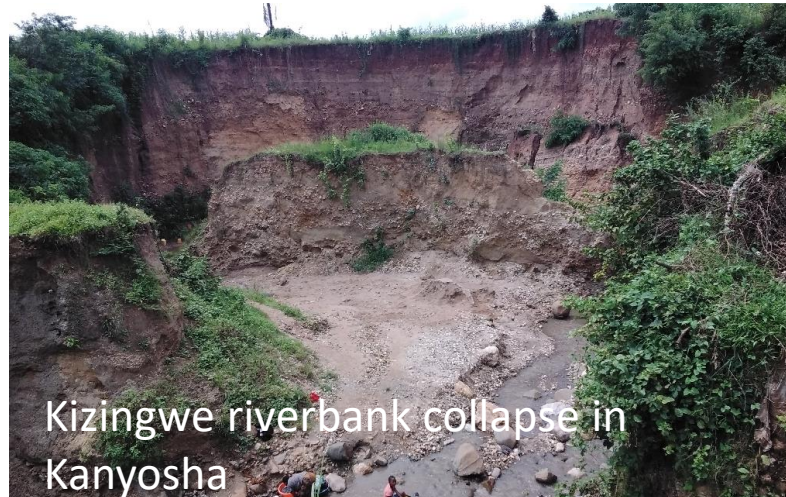
Fig. Riverbank collapse inventory map

- The riverbank collapses map is based on the collection and googles earth images
- the rivers are divided into sections:
- *Highly mobile sections A*
- *Engorgement C and D*

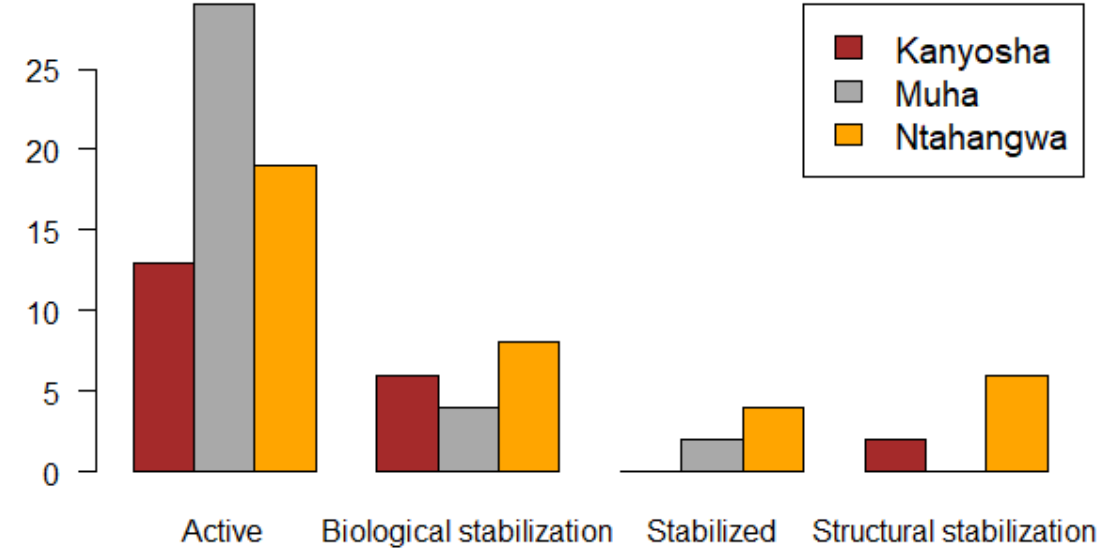
(b) Riverbank activities

- High activity: 66 % active

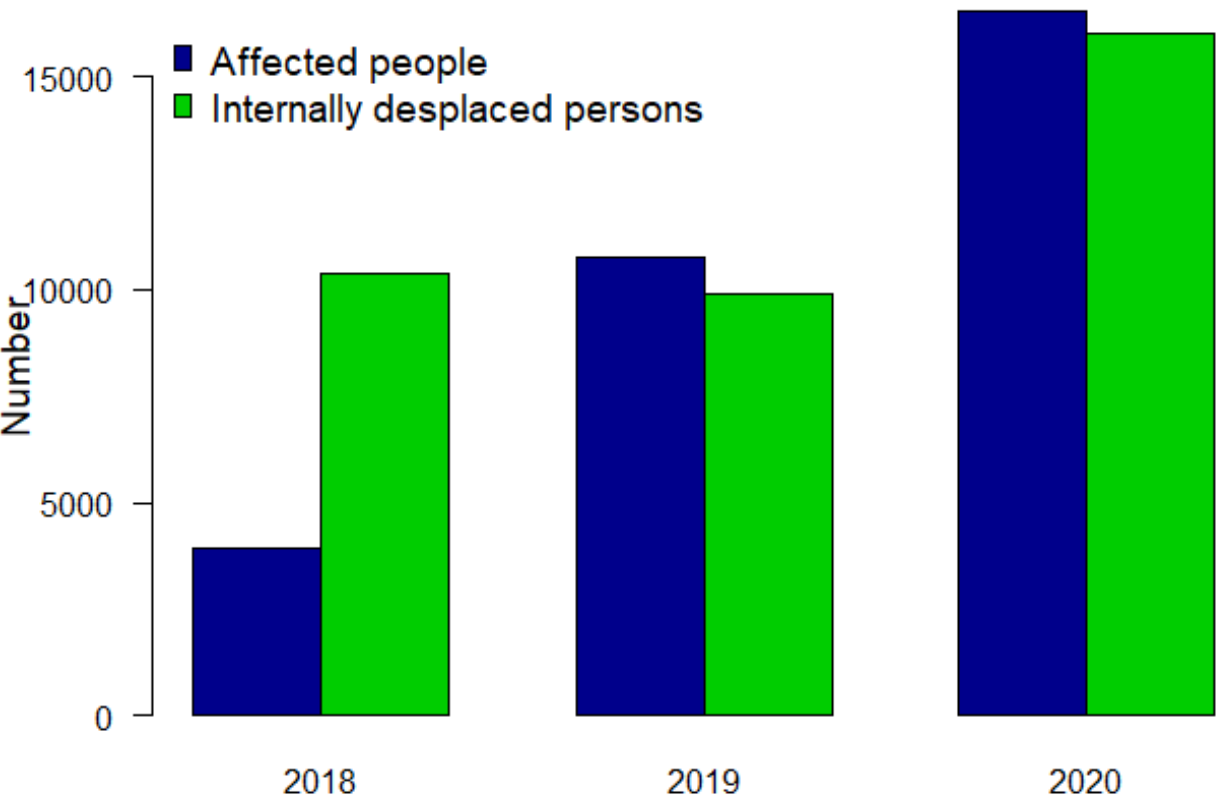
(a) Impacts of the events on the population (DTM/IOM, 2018-2020)

- Over 3 years more than 30,000 inhabitants have been affected and more than 40,000 are displaced.
- A large number of houses are either flooded, partially destroyed or completely destroyed.
