Erodibility of loess depending on its moisture content and weathering state: field experiments

Jan Vojtíšek (h.vojtisek@gmail.com) Jiří Bruthans Faculty of Science, Charles University, Czech Republic

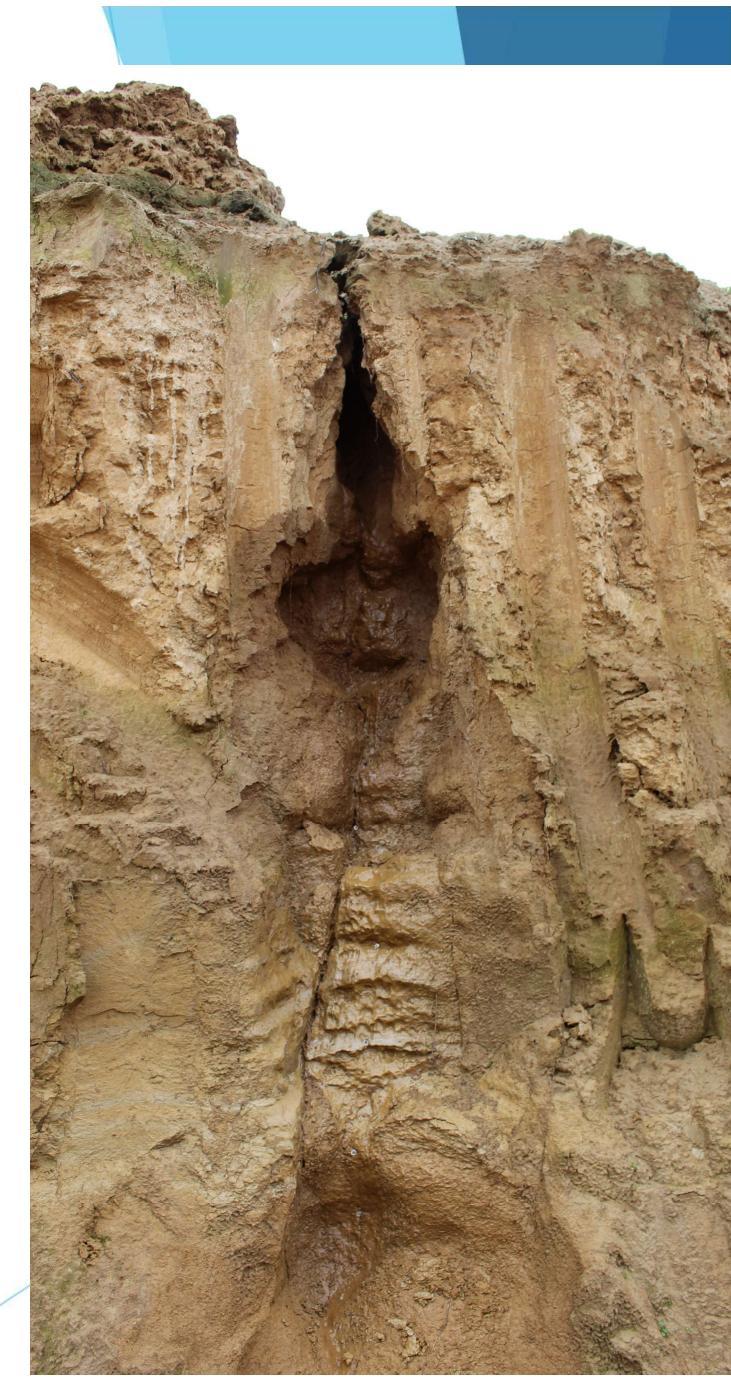
Example of erosional channel in the loess.

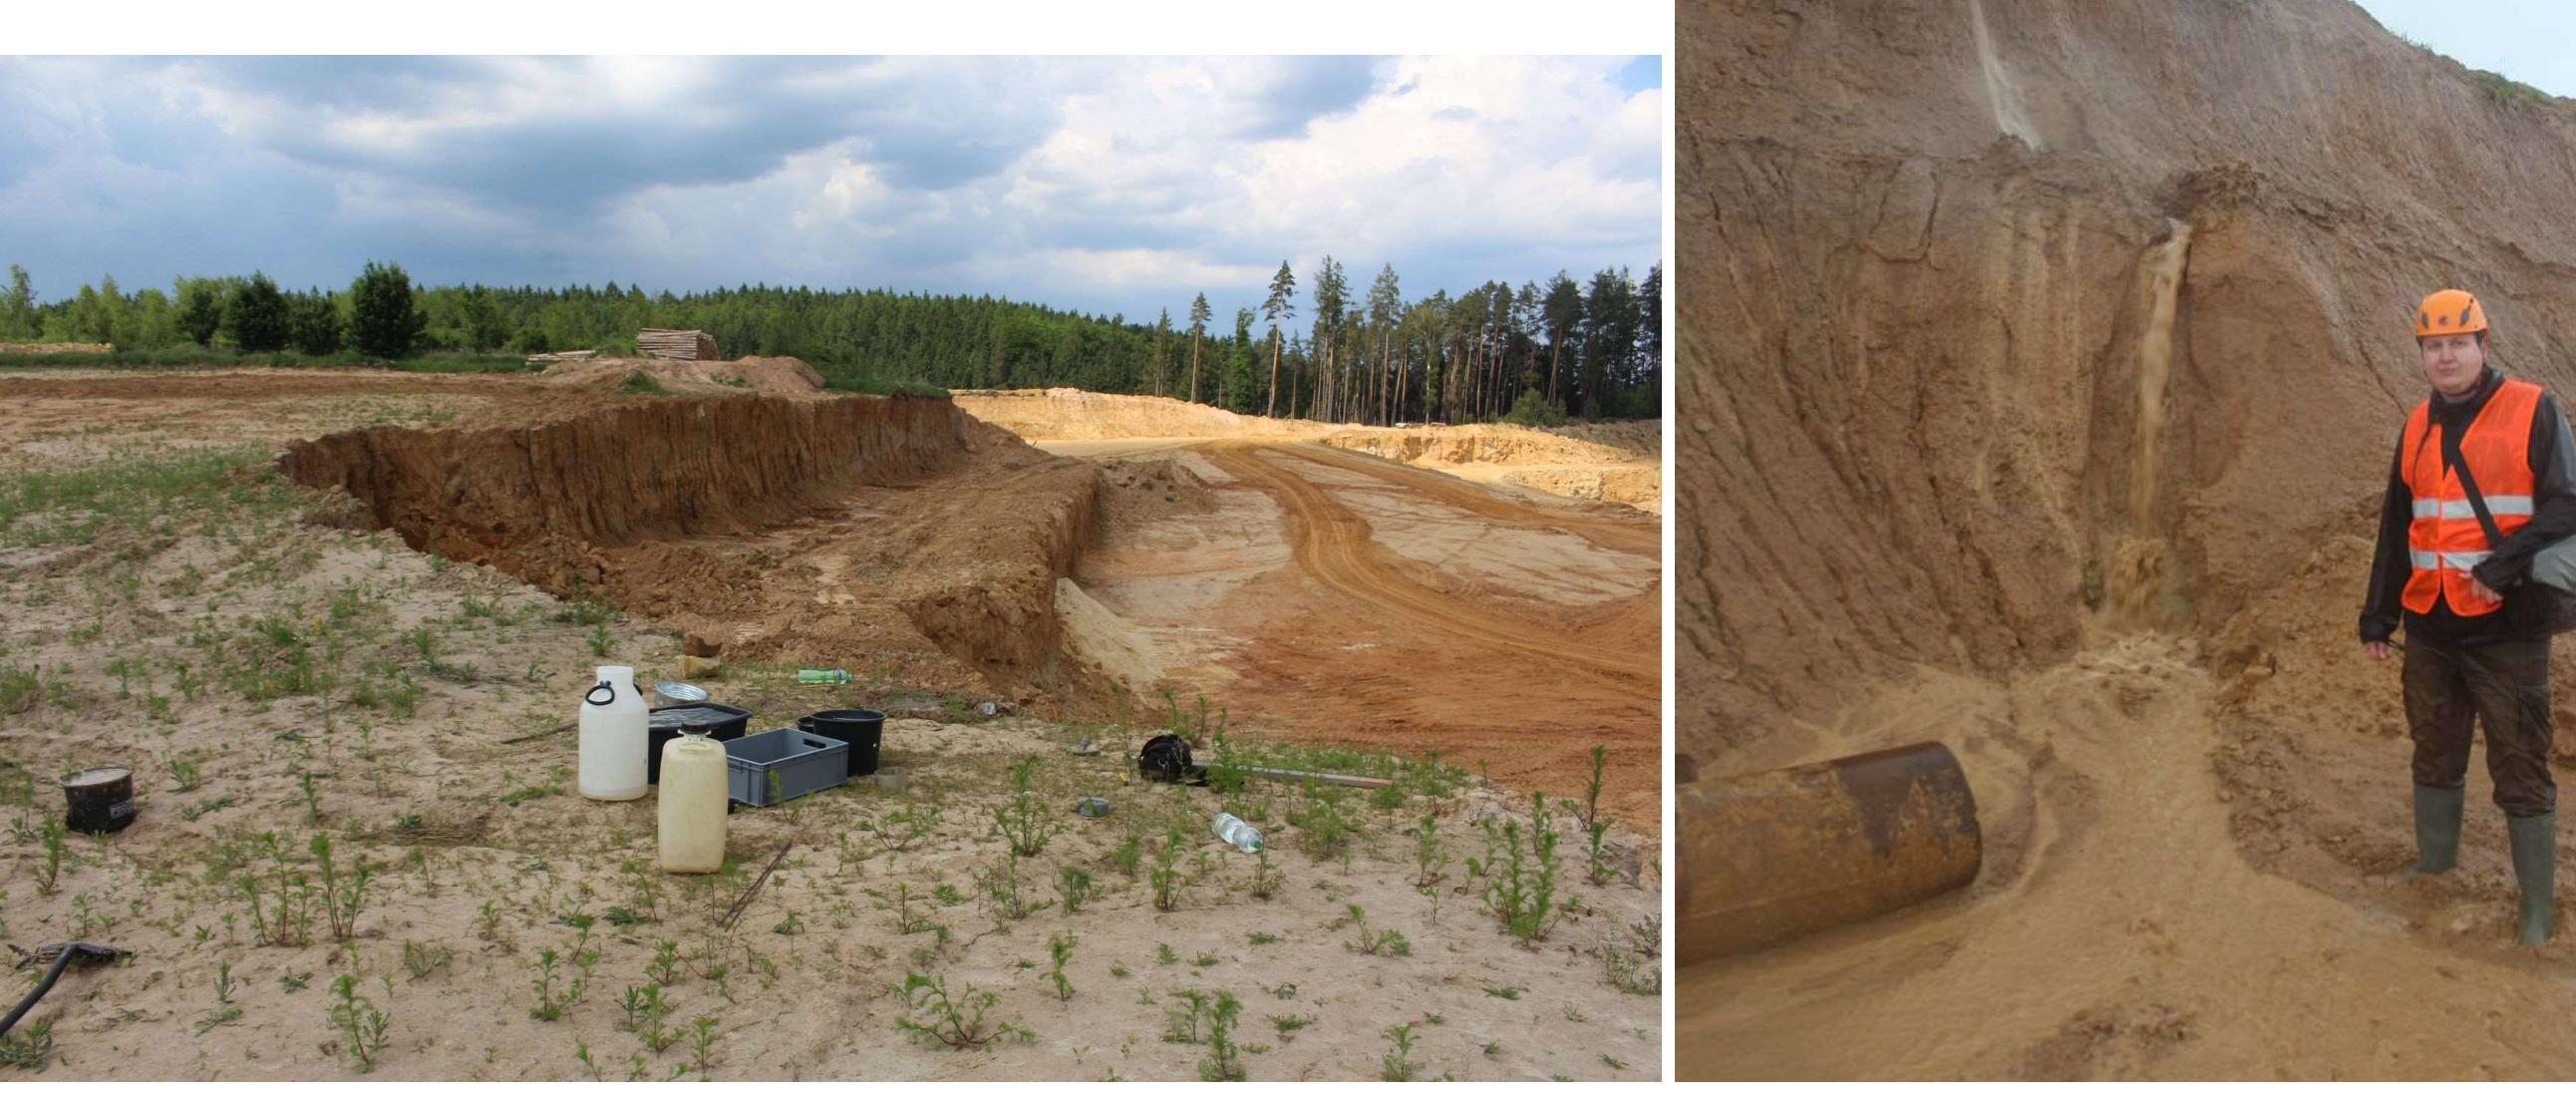
The upper part of the quarry with loess cove, where experiments took place.

Loess erosion in heavy rain.

- Střeleč quarry
 - Quarry located in Bohemian Cretaceous Basin
 - Quartz sandstones are mined, which are covered by about 10 m thick loess cover in the upper part of the quarry
 - In some parts loess contains cracks and macropores
 - Rill erosion and piping conduits are formed in the loess cover at exposed quarry faces

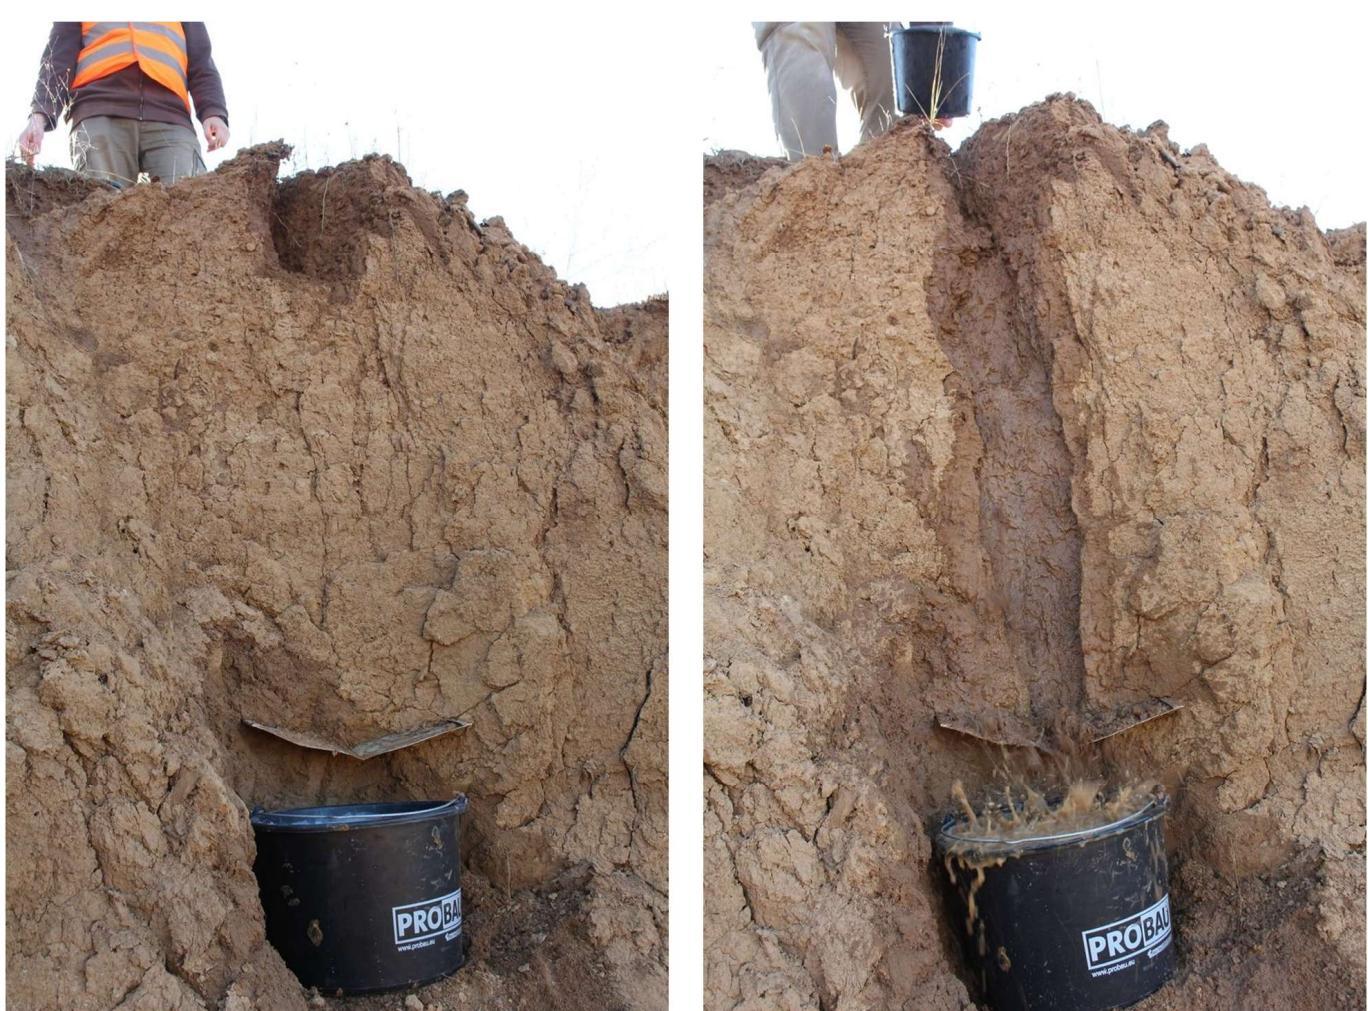
Example of erosion by water trickle at quarry face.

- Water repeatedly slowly poured from a bucket with a volume of 5l (cca 0,1 l/s) with counting the total volume of applied water
- Water poured on a horizontal surface, to small ditch then flowing spontaneously down the quarry face
- Erosion rate of the newly formed rills was measured using long screws screwed directly into the quarry face
 - After every cycle (a certain number of buckets), the loss of material on the screws was measured and photographs were taken

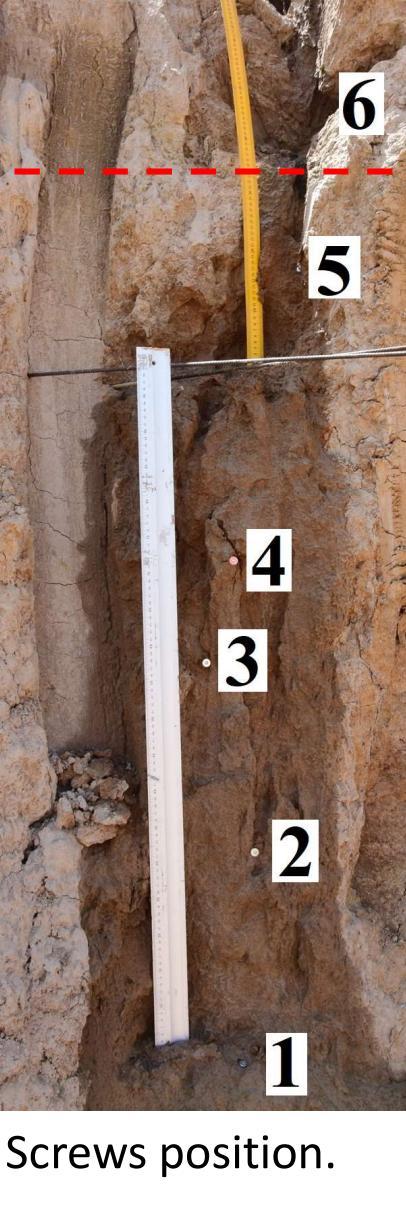
horizons 200 screws (mm) 150 total material loss on 100 50 80 100 20 40 60 120 140 total amount of poured water (I) Relationship between erosion retreat of surface and

volume of applied water.

Few tens of cms thick surficial zone of loess with structure damaged by biogenic activity, wetting/drying and freezing

Loess with undamaged structure in deeper

- Experiment with pouring water into horizontal ditch, from which water spontaneously flowed into vertical face of quarry
- At the beginning the erosion was rapid, then it gradually slowed down and at most measuring points it ceased
- Only at screw 6, which was situated in uppermost part with shallow loess with structure damaged by freezing in winter and biogenic activity (roots, earthworms) the erosion²⁵⁰ continued
- This shows that while loess with damaged structure is highly erodible (retreat 200 mm of loess/120 l of water applied) the underlying loess with intact structure is easily erodible only close to surface, where is probably damaged by repeated drying
- Undamaged loess in situ showed surprisingly low erodibility (few mm/100 l of applied water)

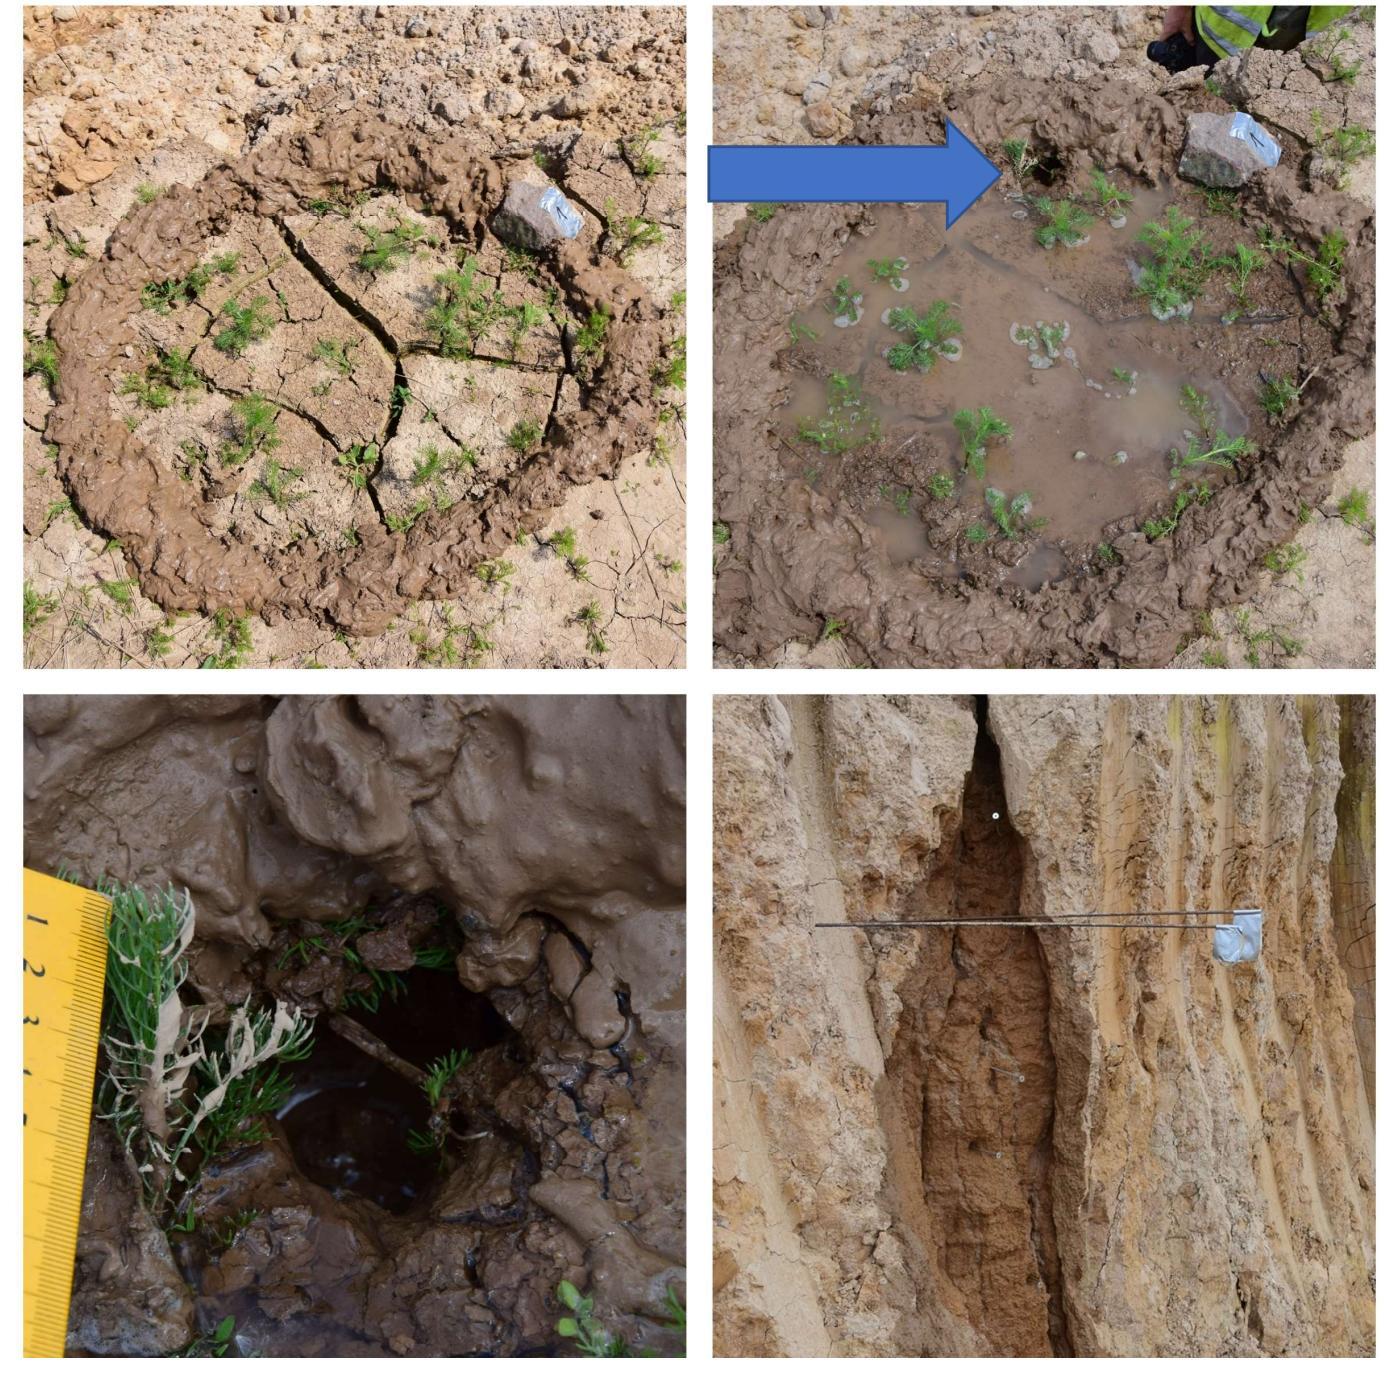
- Small piping conduits developed rapidly by pouring water into small desiccation cracks on the loess surface with damaged structure
- Inlet of the newly formed conduit is marked on the photo (upper-right) by the blue arrow
- The bottom-right photo shows an eroded vertical quarry face below the outlet of the newly formed conduit
- About 150 l of water was poured into desiccation cracks within experiment

Desiccation cracks on the surface, newly formed conduit and eroded vertical quarry wall.

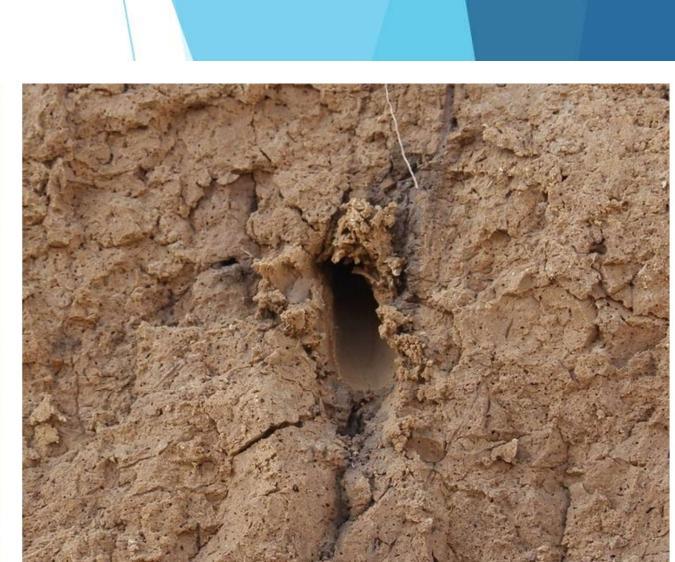
Drill hole at the beginning.

- drill hole 10 mm in diameter and X0 cm in length was drilled through the edge of quarry face (from horizontal surface into vertical face), then roughly constant water flow was applied through it by a garden watering can
- 8 l of water were poured into the hole
- surprisingly the pre-drilled hole was not expanded by erosion at all except its mouth in loess with damaged structure where about 1 kg of material was eroded
- this indicates that piping in loess with undamaged structure might need either the existence of some discontinuities or preexisting macropores (fractures, burrows) or that loess needs to be damaged
