"NbS and combined techniques - Case studies of steep bank stabilizations in the Garonne water catchment area in France - Constructions in very close proximity to residential areas and infrastructures"

EGU General Assembly Vienna April 2023

Case study 1) 1999: Hers Vif River – 120m Rehabilitation work of River embankment Construction time 3 months – Pre-tax costs 75.000 € (64.500 £ 10/2016 rate)

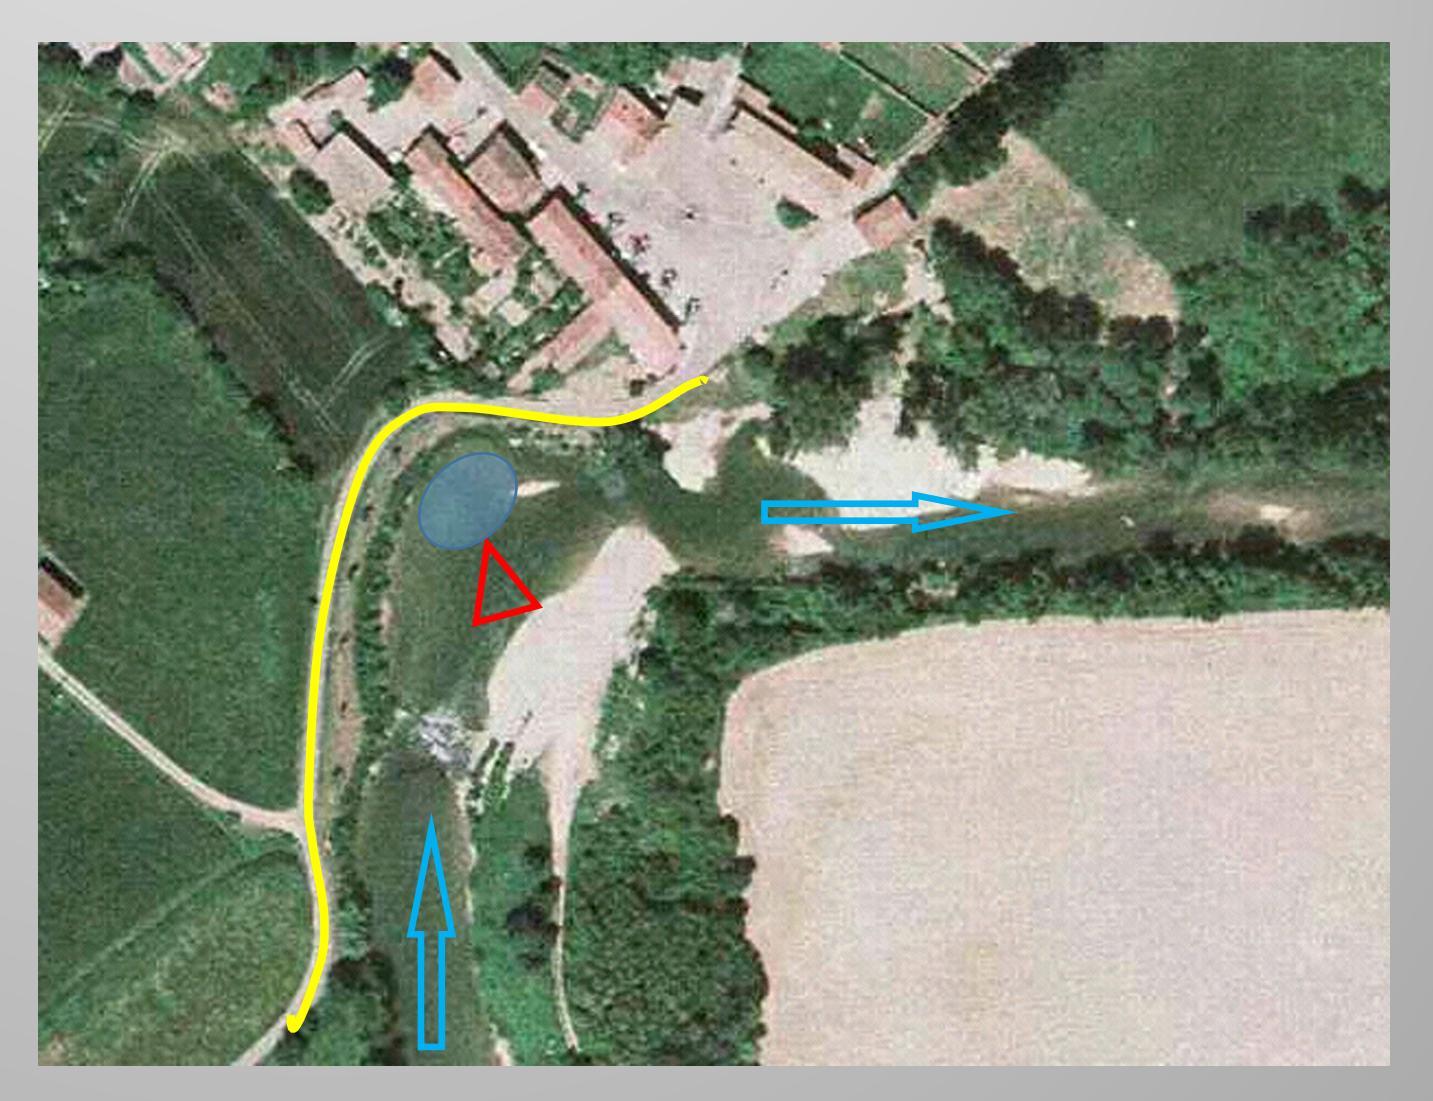
Temporary riverbed shifting to right bank and Log Cribwall **construction stage** during the end of octobre 1999 on left bank

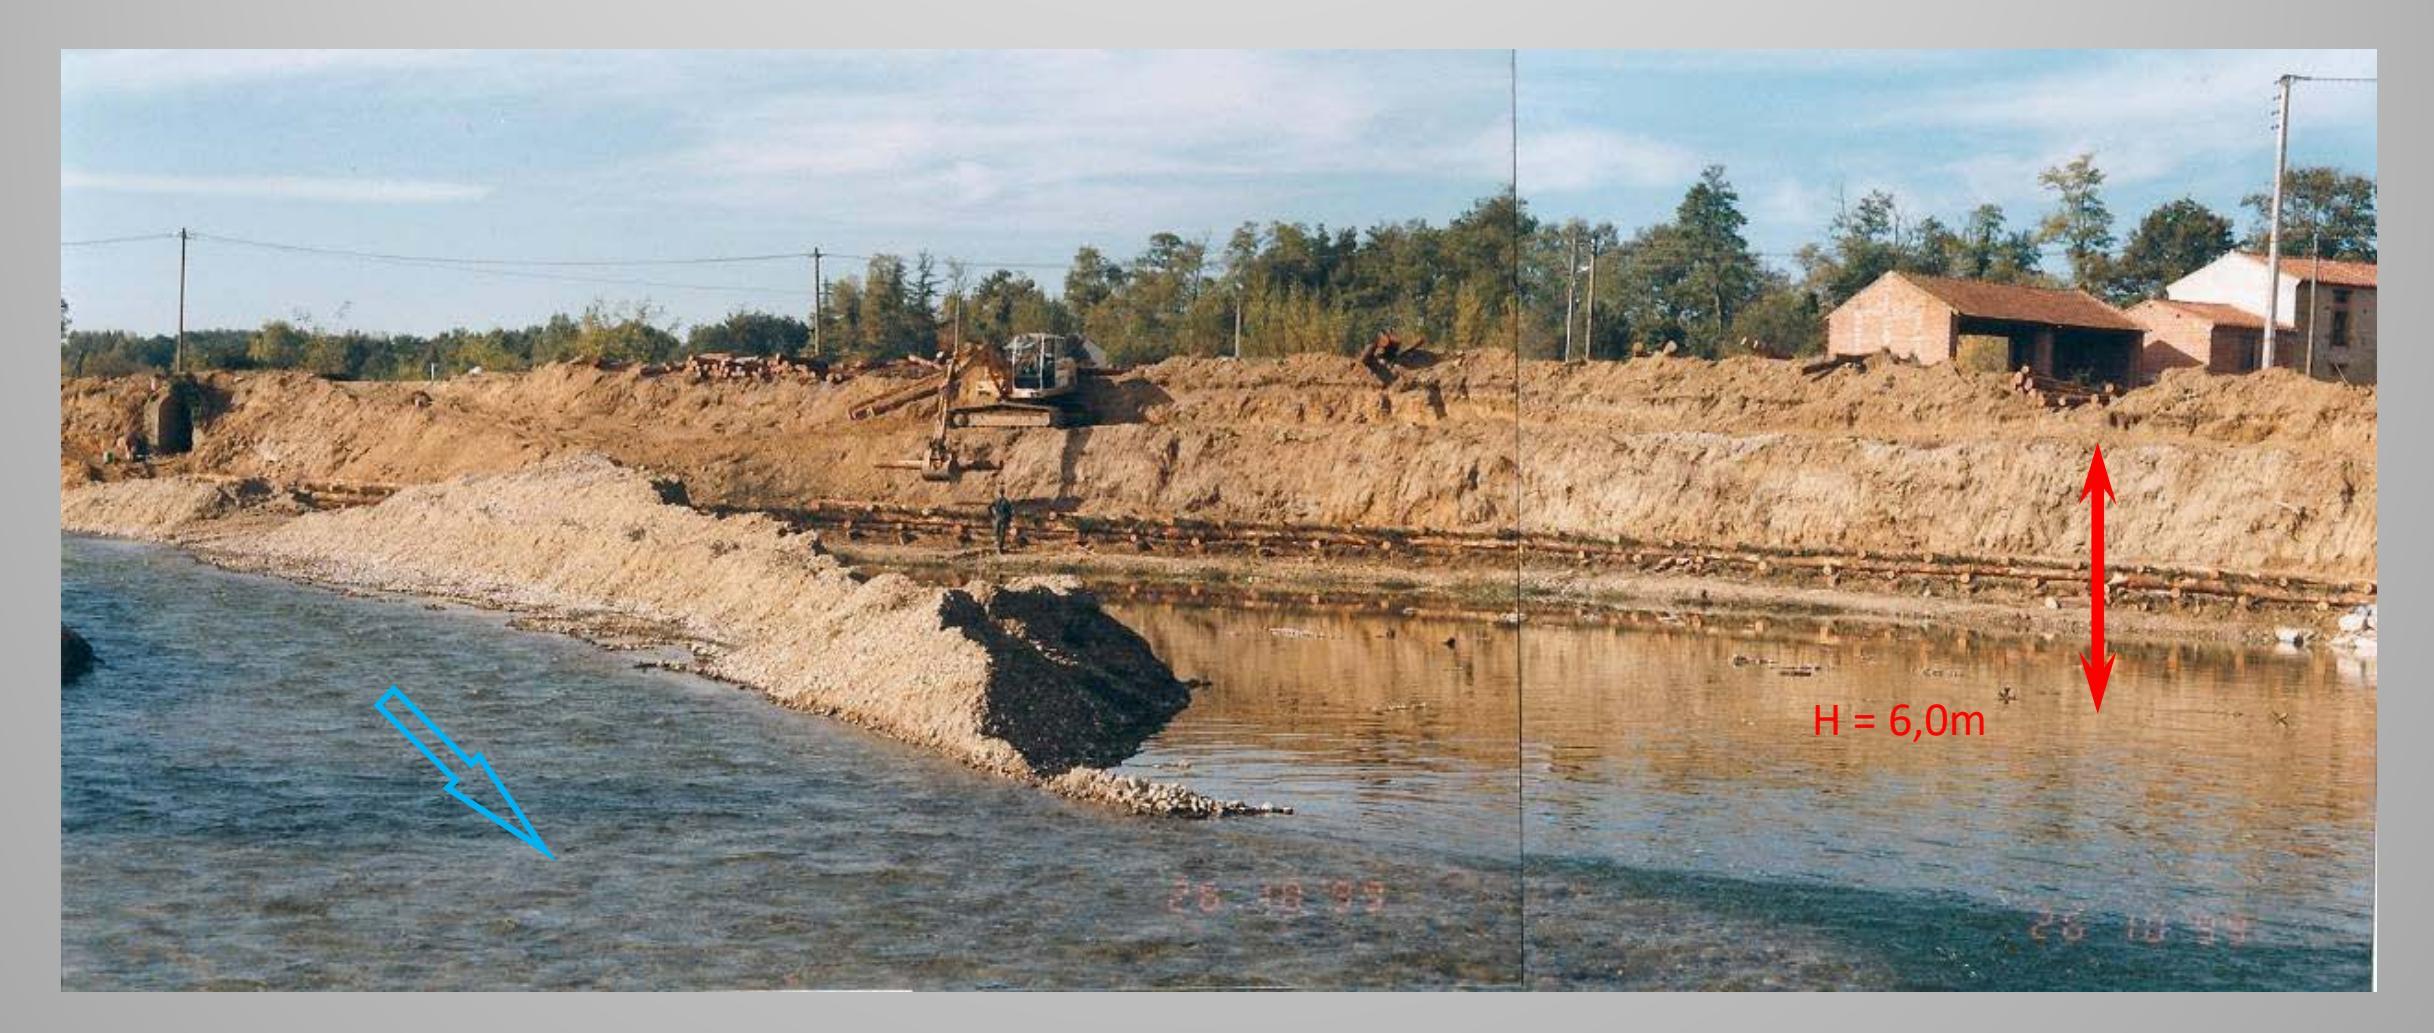
Construction stage during winter 1999: Longitudinal left bank protection as vegetated Log Cribwall

Anchoring depth =2,50m strengthend with local plant cuttings in order to obtain a riparian Salix shrub stratum

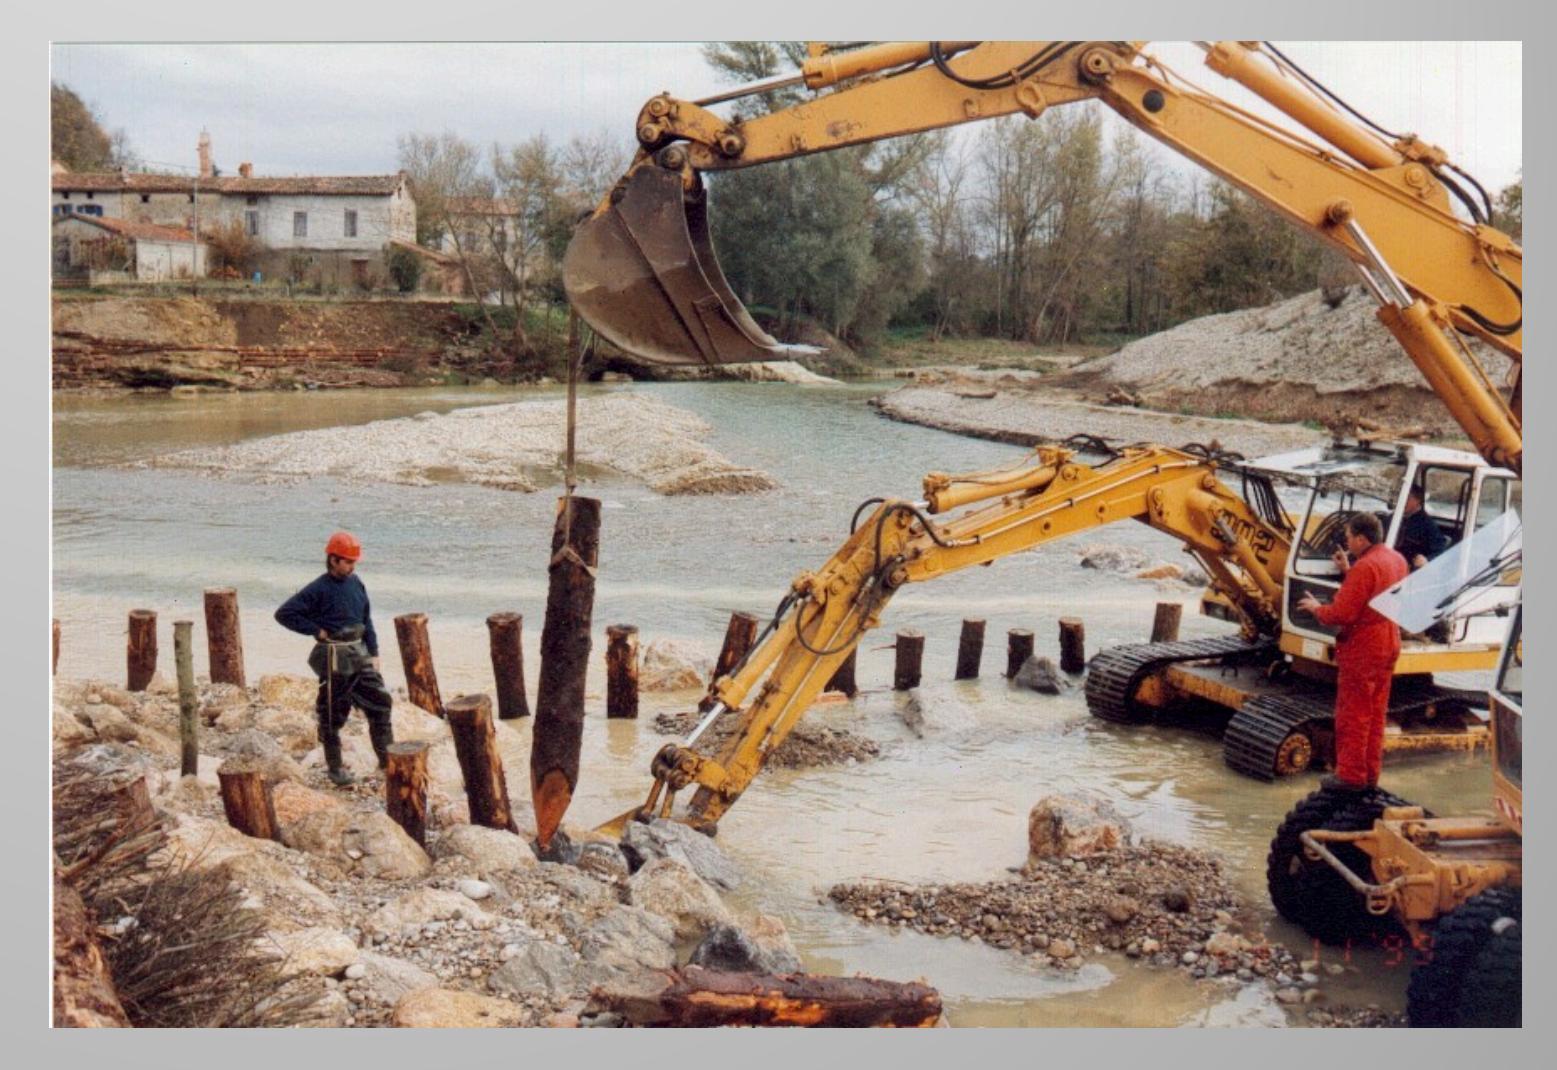
Pile driving activity into river alluvium in progress >>

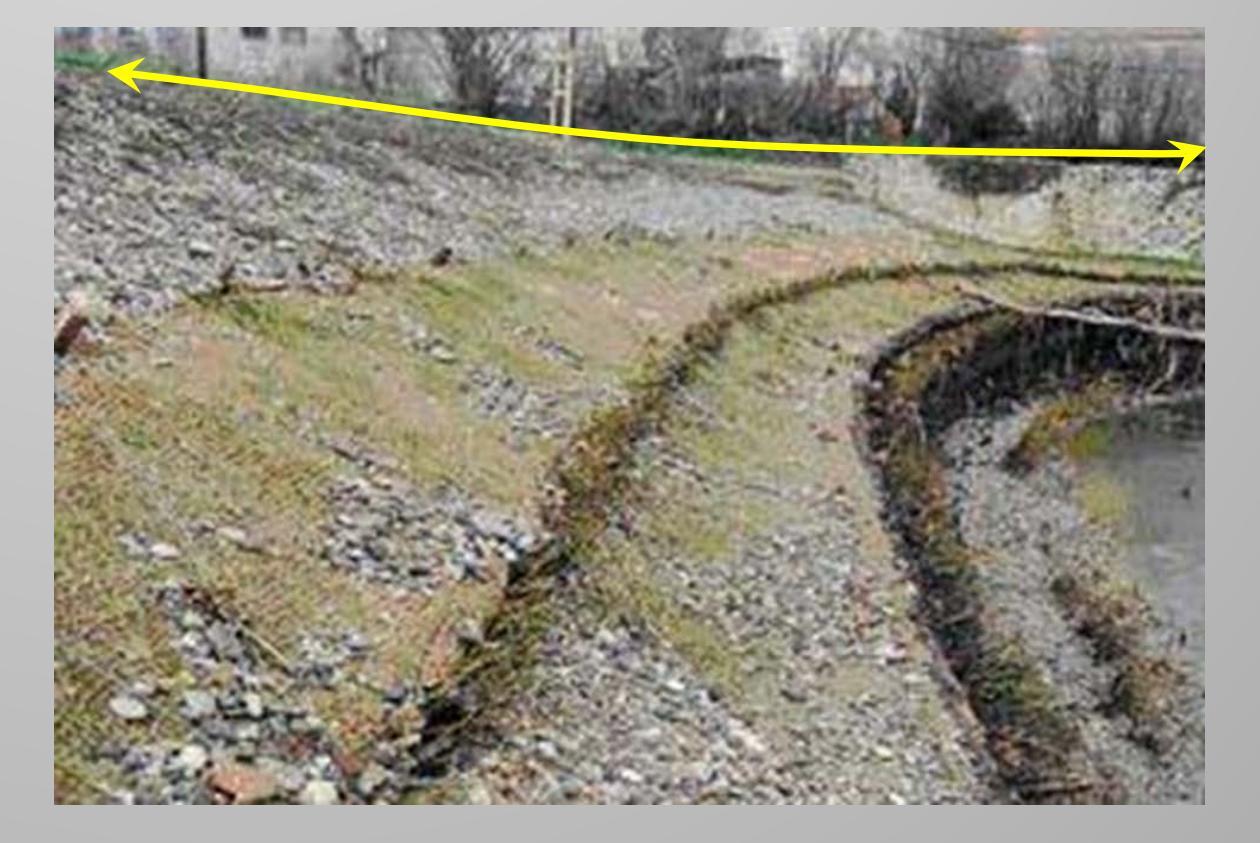
April 2000, 5 months after completion, a floodevent occuring of ~ 6,50m height

The yellow line indicates the position of the communal road also the highest floodlevel

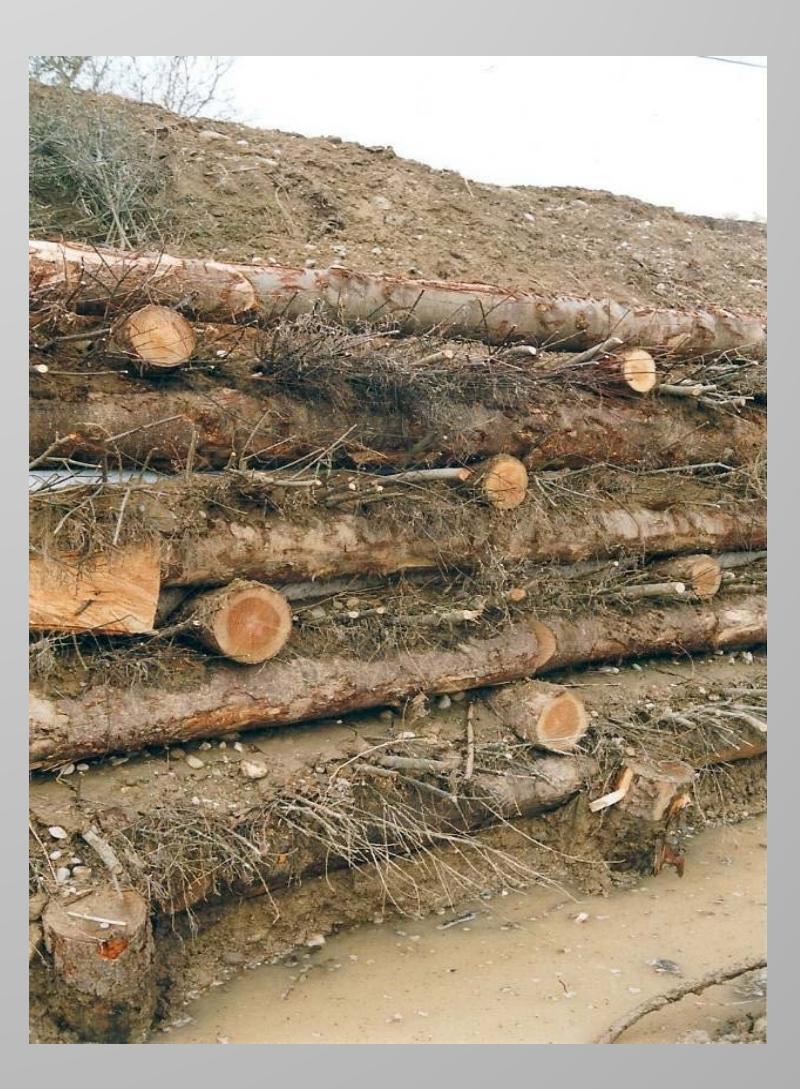
Case study 1) 1999: L'Hers Vif River – 120m Rehabilitation work of River embankment Detail of Log Cribwall – notice the off-centered position of wooden cross pieces Picture taken after 600m3/s flood event in April 2000

Face of vegetated reinforced Log Cribwall constructed with Larix decidua felled in the highlands of the Pyrenees >>

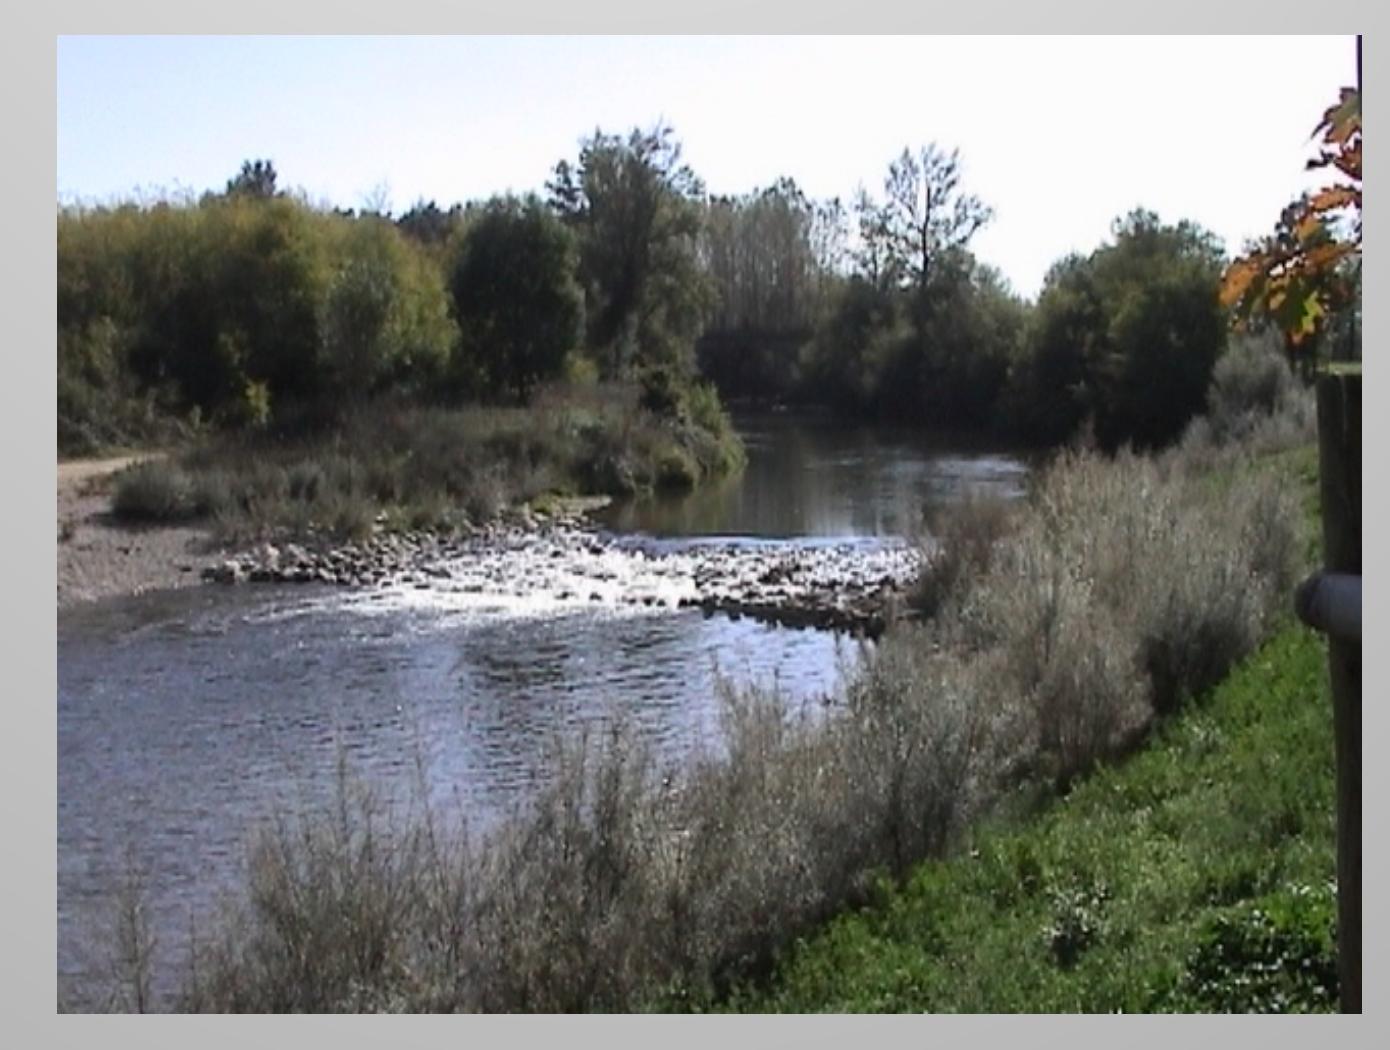
Monitoring stage in 2005: Upstream picture towards 3D Hydraulic Rough Ramp anchoring into right bank

Background: Vegetated RipRap integrating anchoring on both Riversides >>

View towards upstream in 2005 of the 3D rough boulder ramp and the flanking vegetatively reinforced bank. The intended river bottom elevation in upstream to obtain velocity reduction through sediment deposition is clearly visible

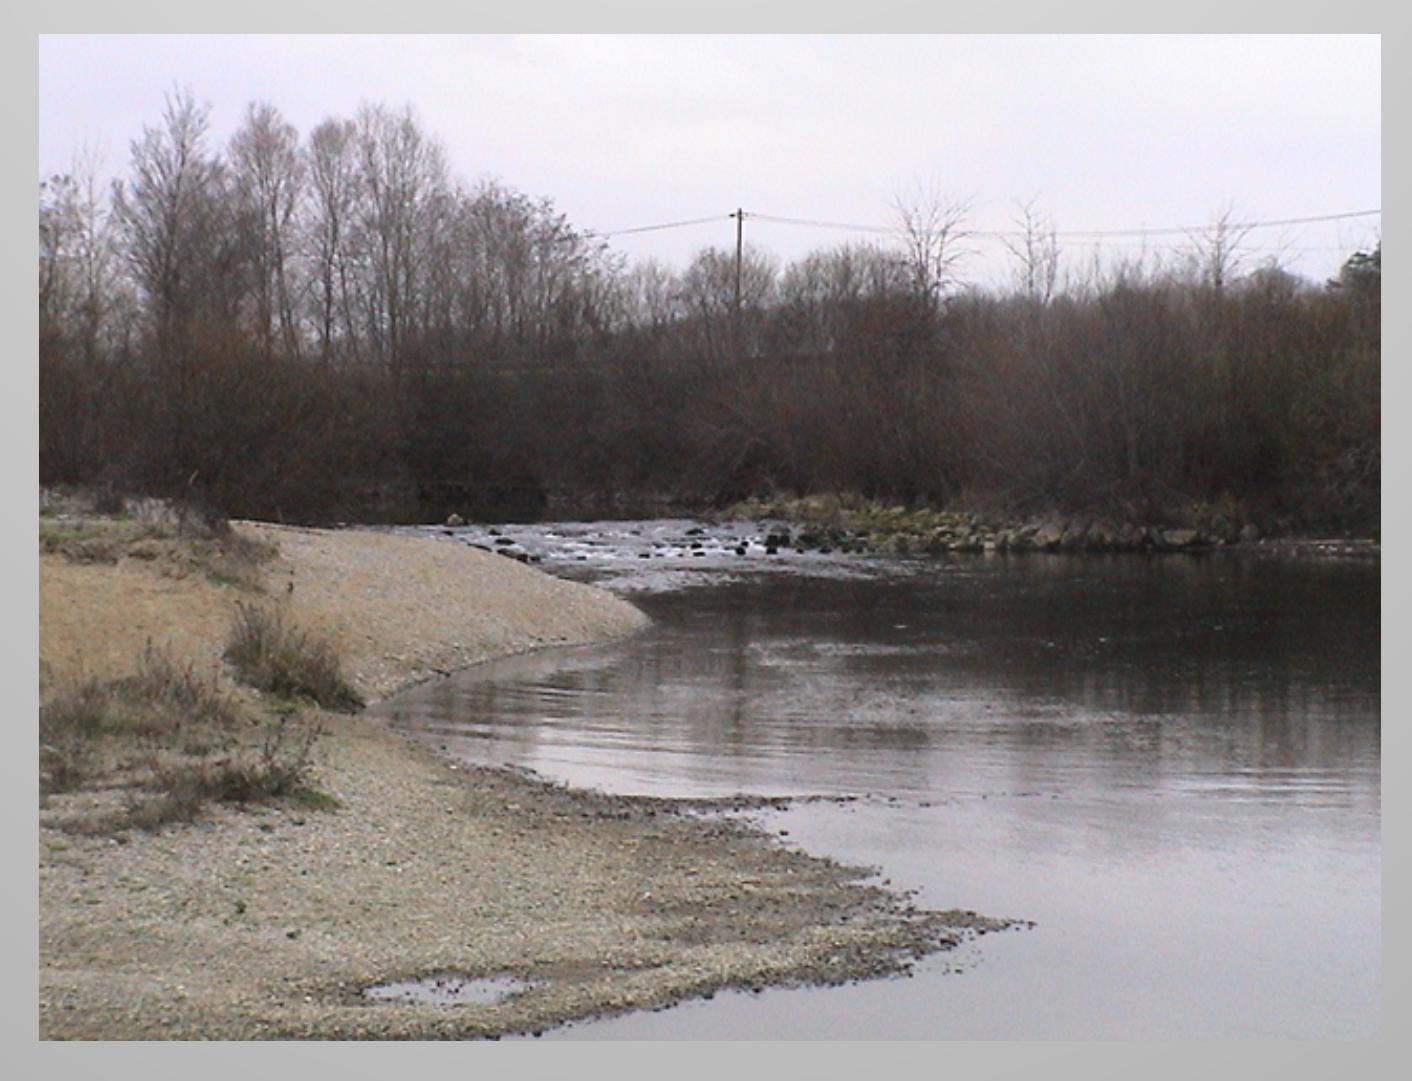
Monitoring stage winter 2007: Upstream picture towards Rough Ramp anchoring into left bank

Always working in perfect condition, the Rough Ramp avoids erosion damage on LRB by deviating floods to RRB and provides free river oxygenation and supplies for bathing >>

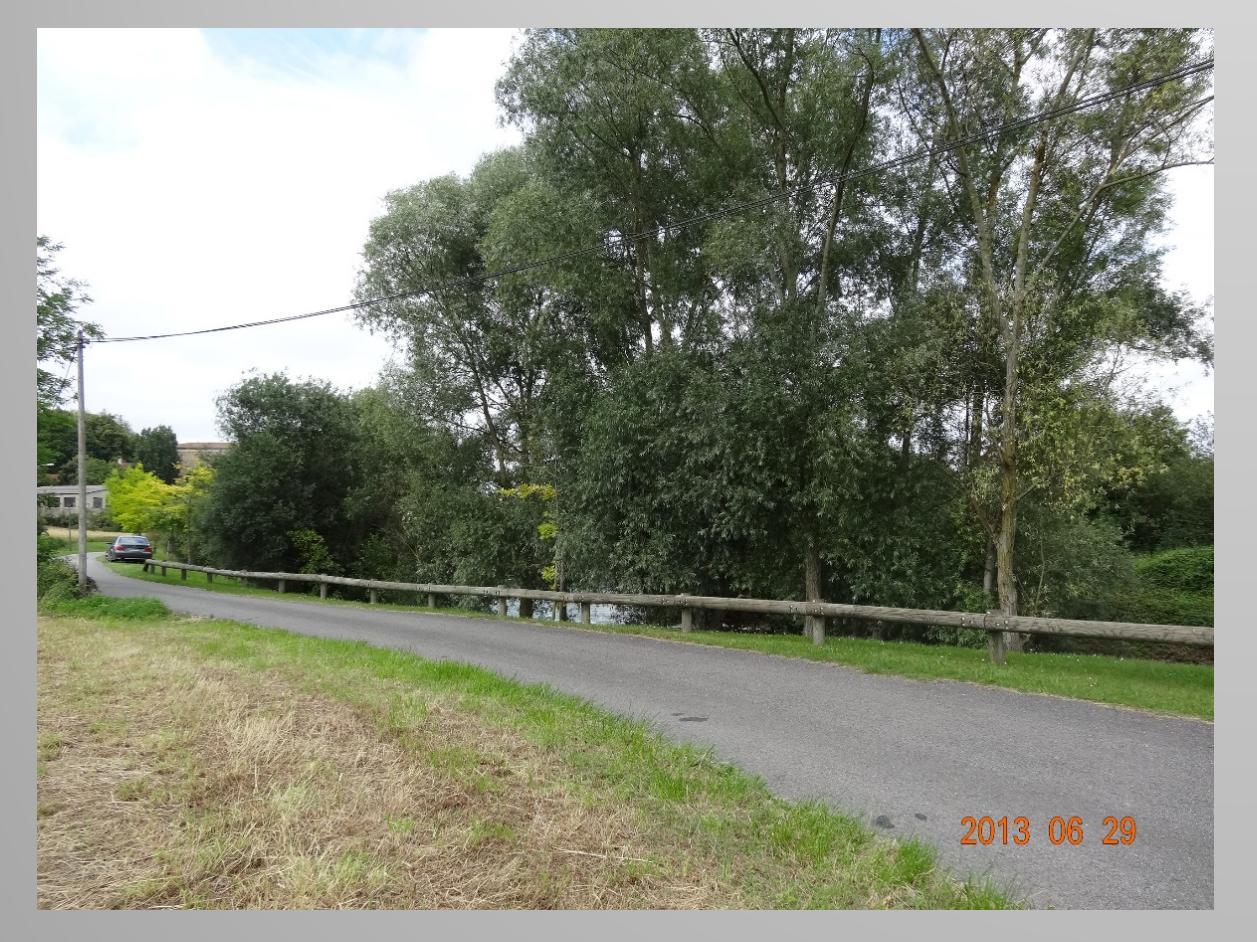
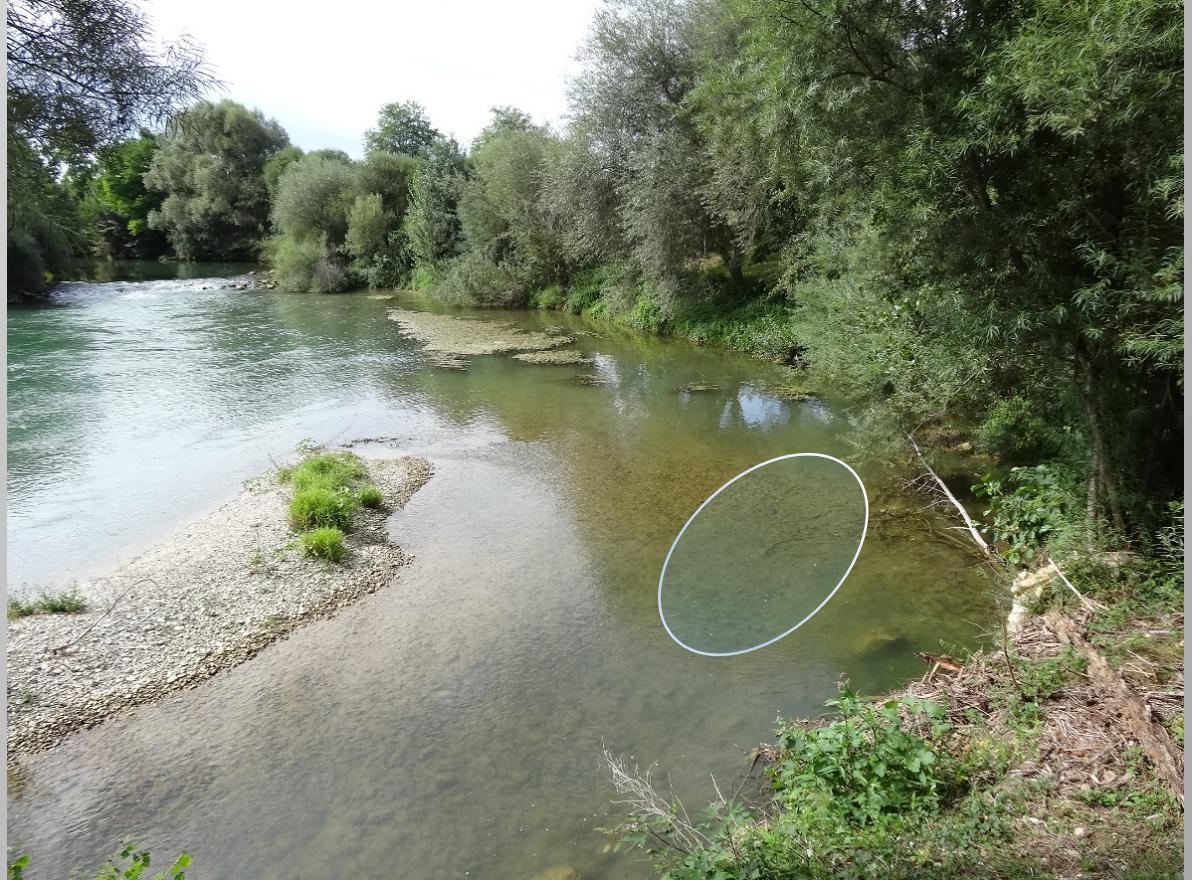
Monitoring stage in 2013: 4 years after completion date

View to lower left bank

View to upper left bank: no more undermining!

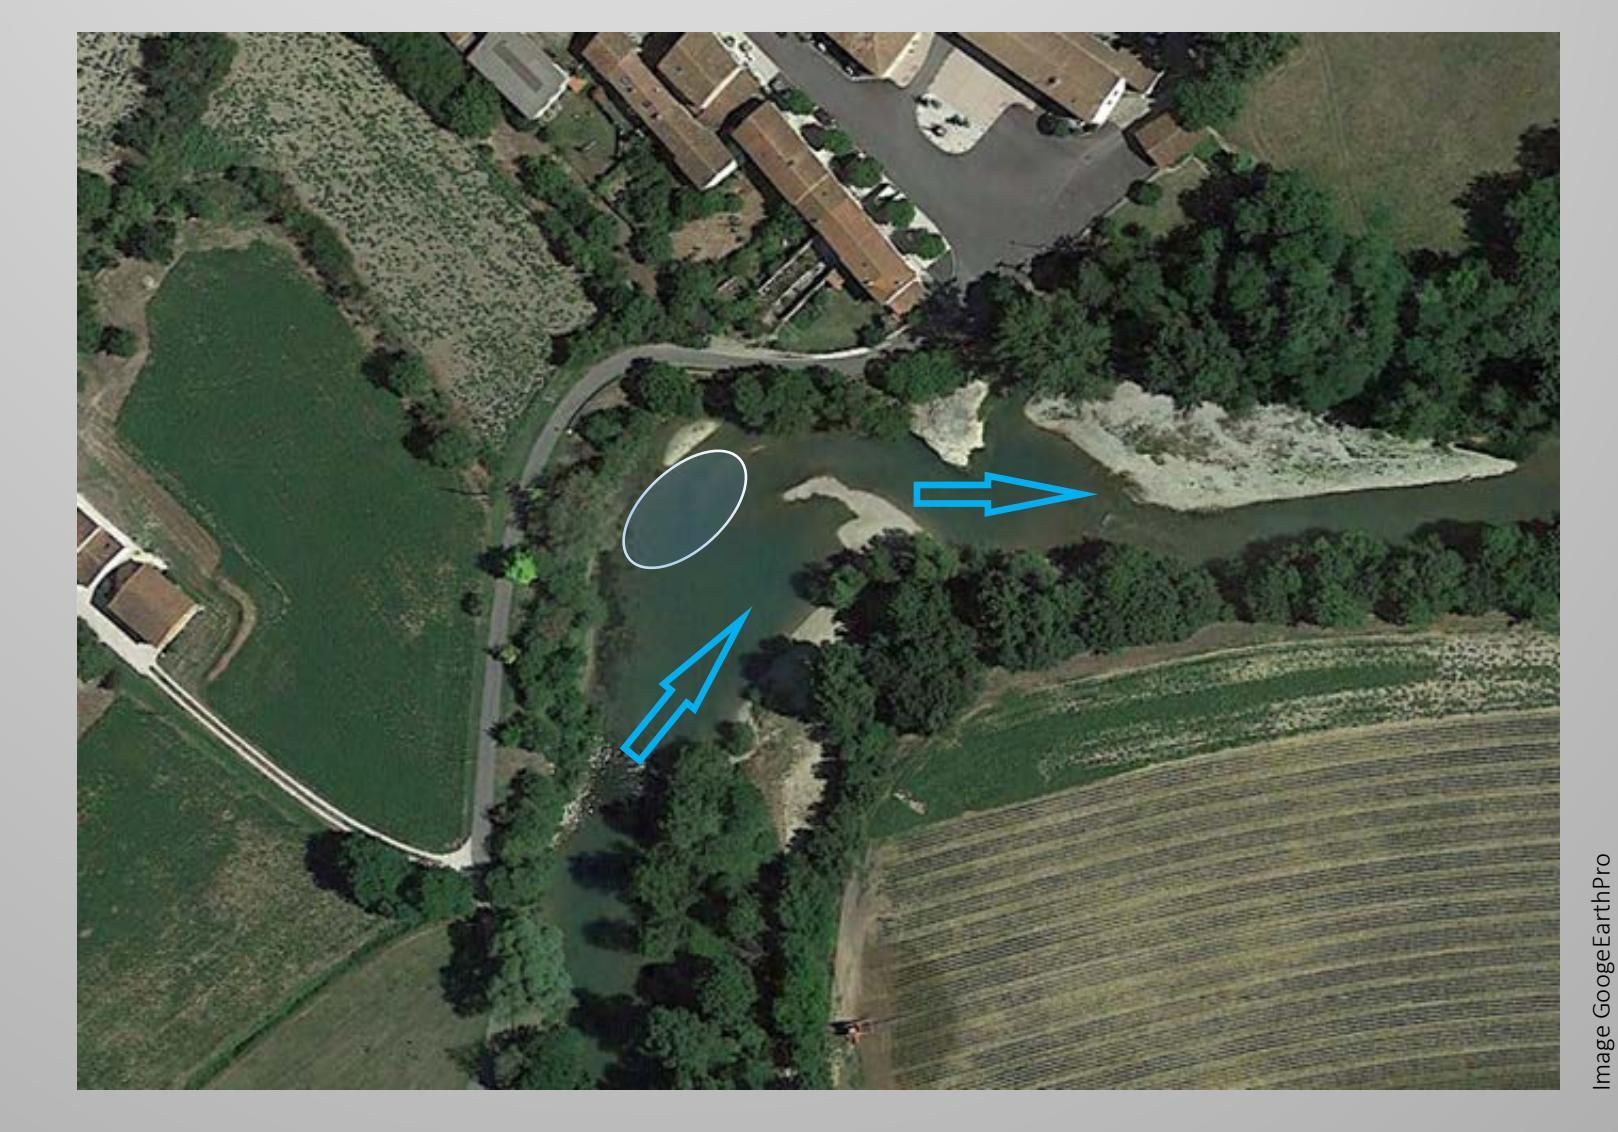
Satellite view indicates current state of construction: no more undermining as sedimentation now protects public road in the meander arch

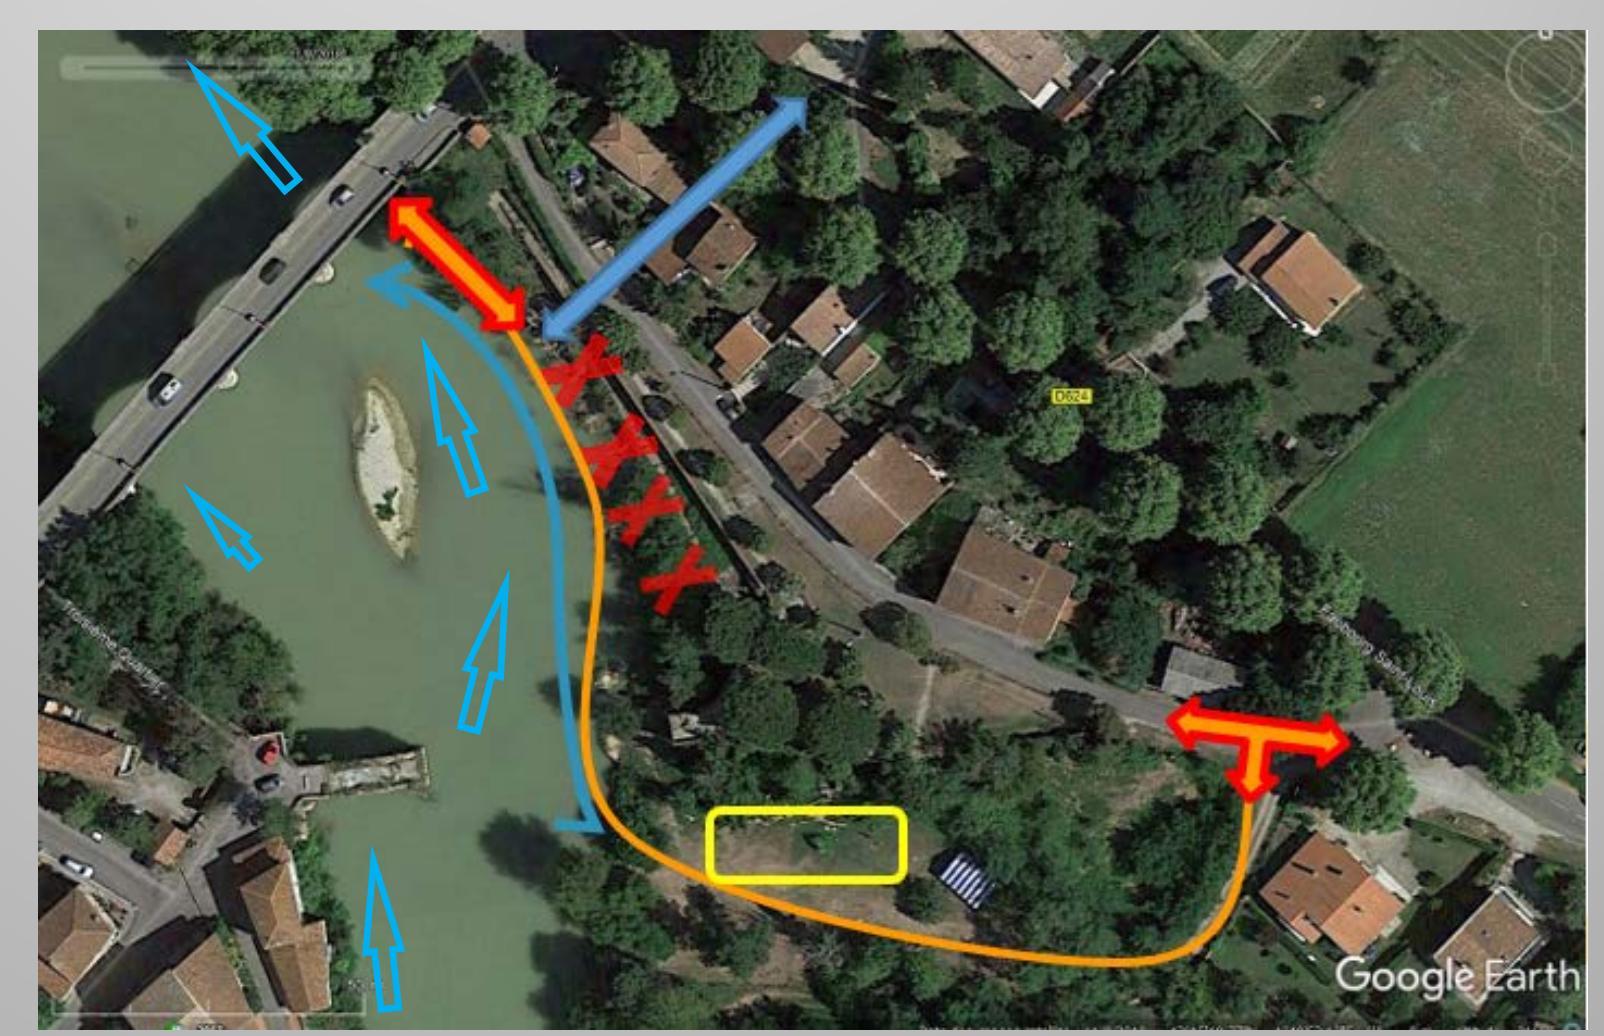
Both satellite view and X are indicating the most damaged right river bank in front of the resedential area.

Yellow rectangle is the site equipment position.

Blue arrow is the position of longitudinal construction provided.

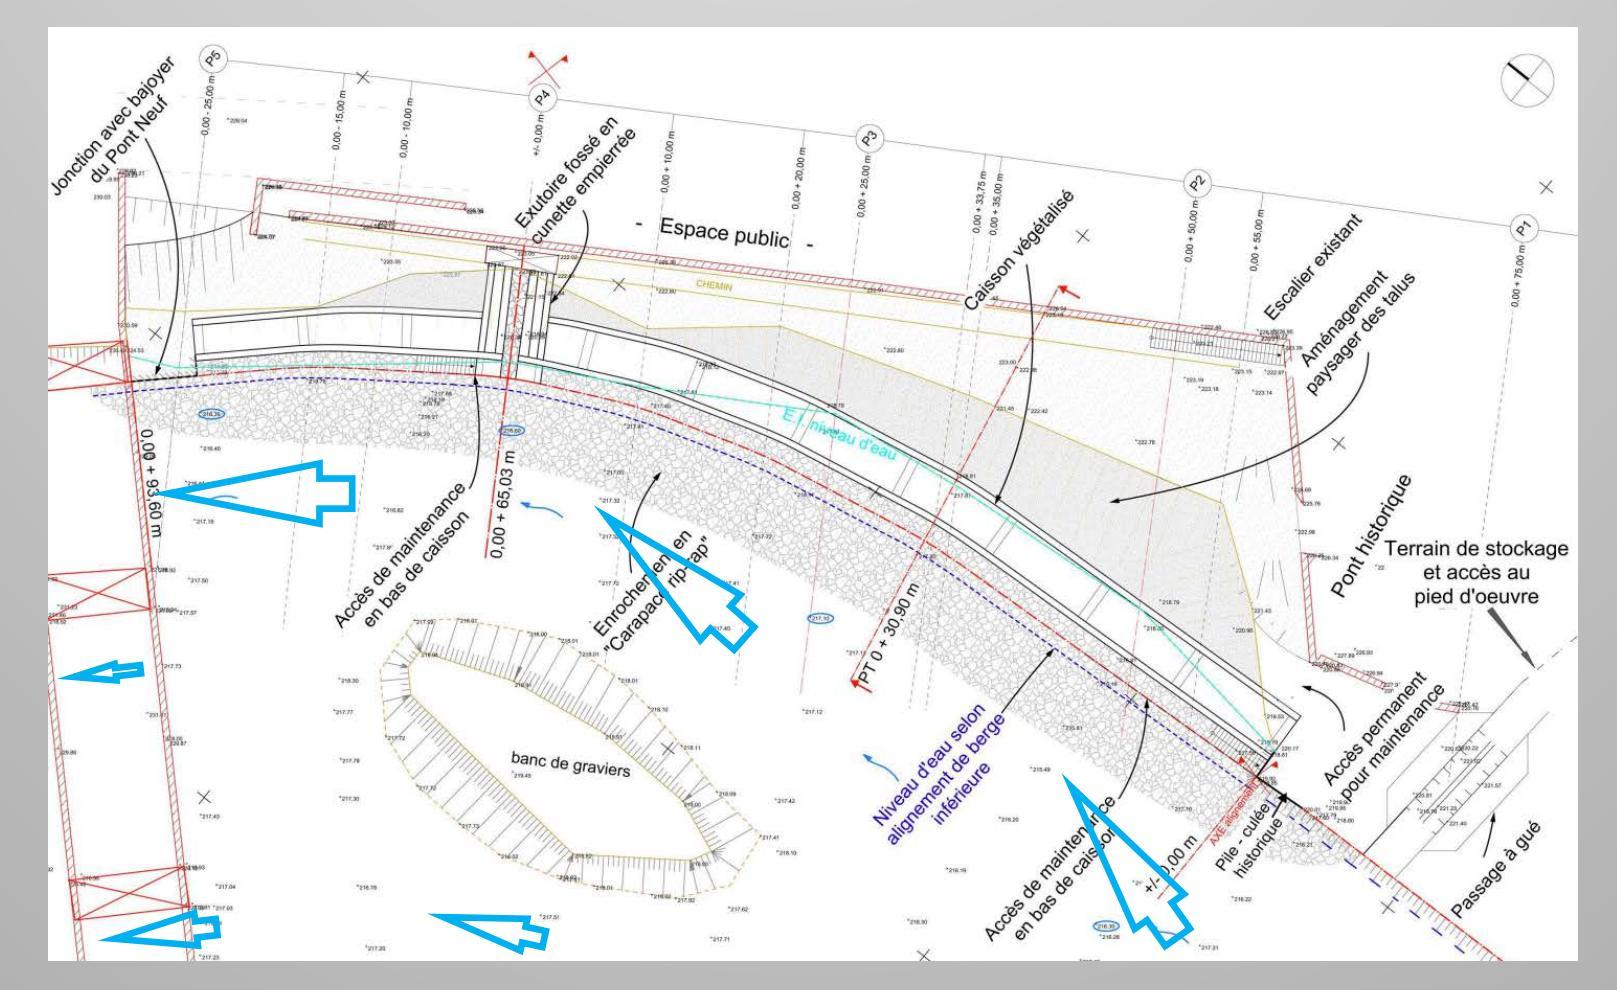
Design stage: The final exécution plan for public tender.

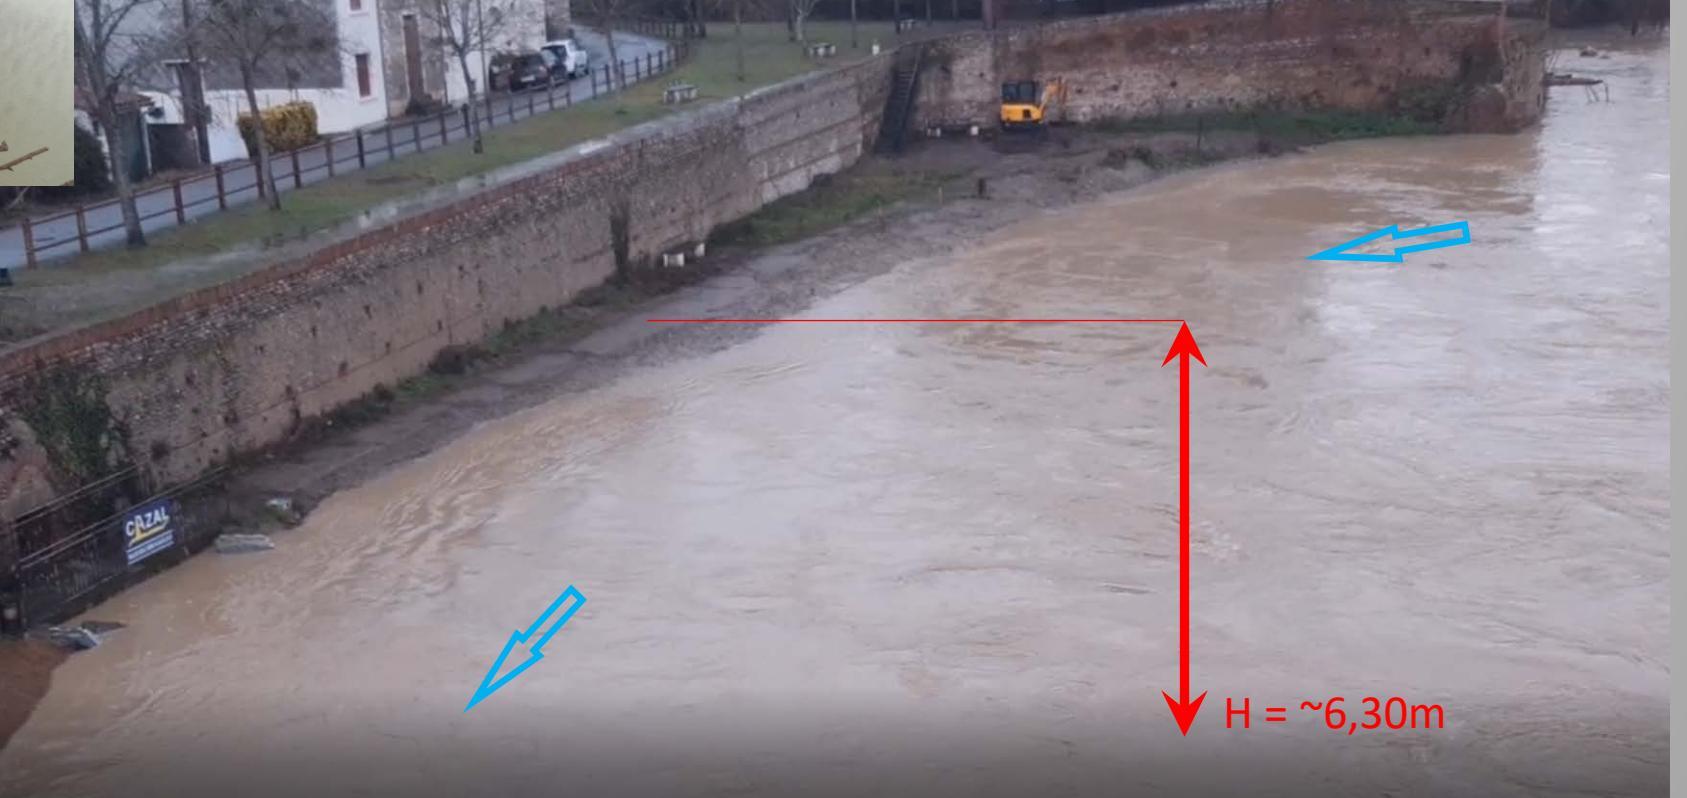
Work in progress on 11/12/2019

Construction progress stopped in april due to 50 year flood estimated about 650m³/s

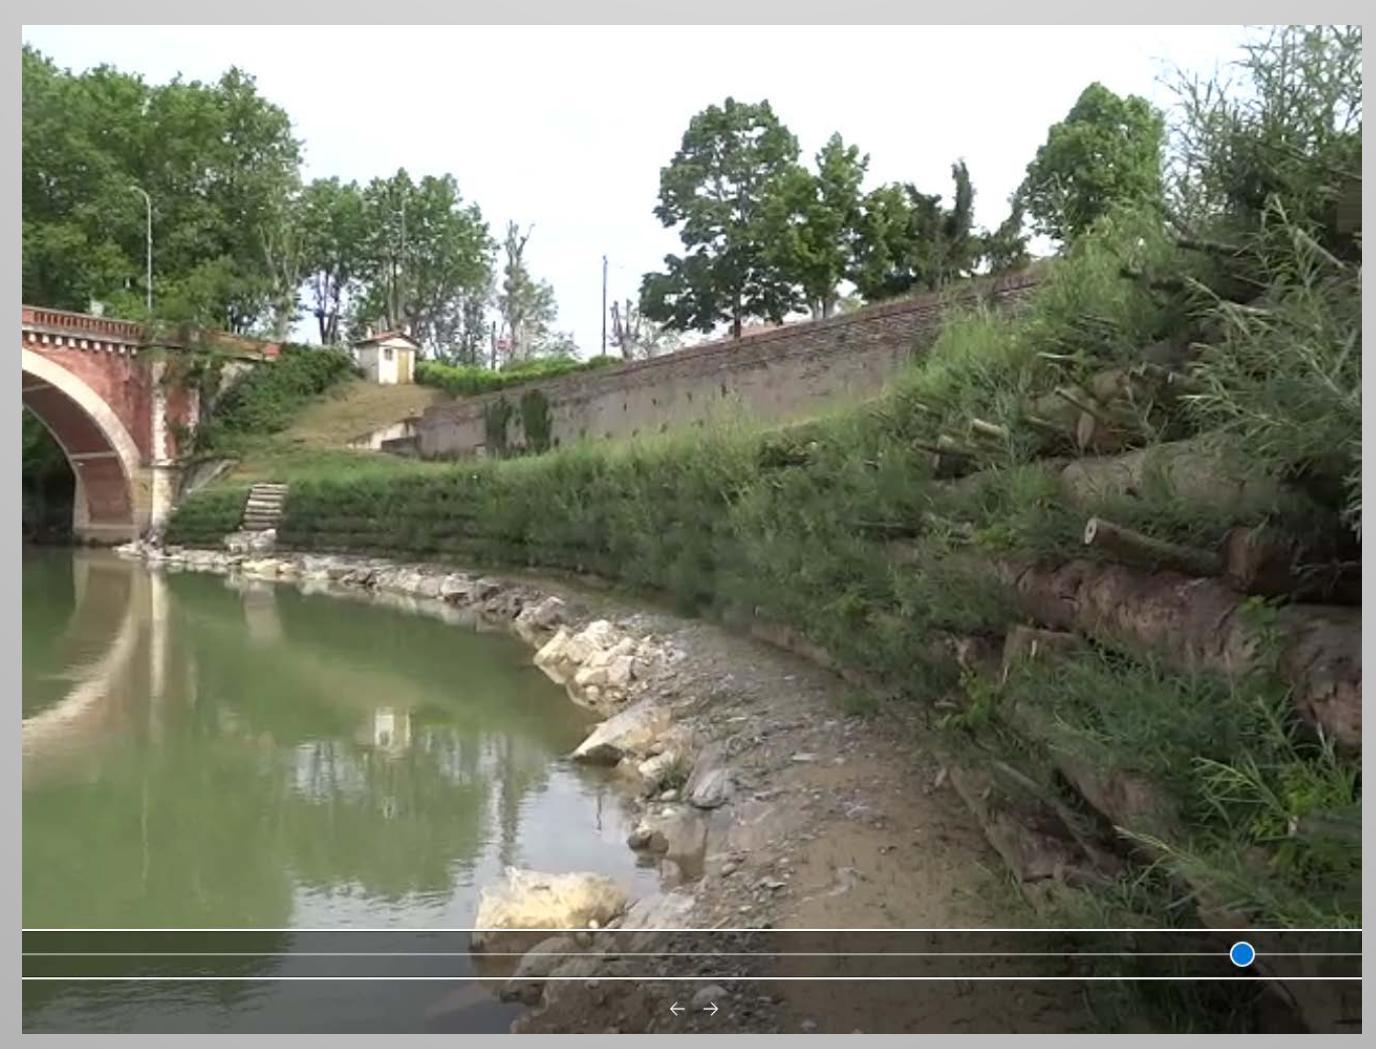
Development of willow wood 4 months after the beginning of planting

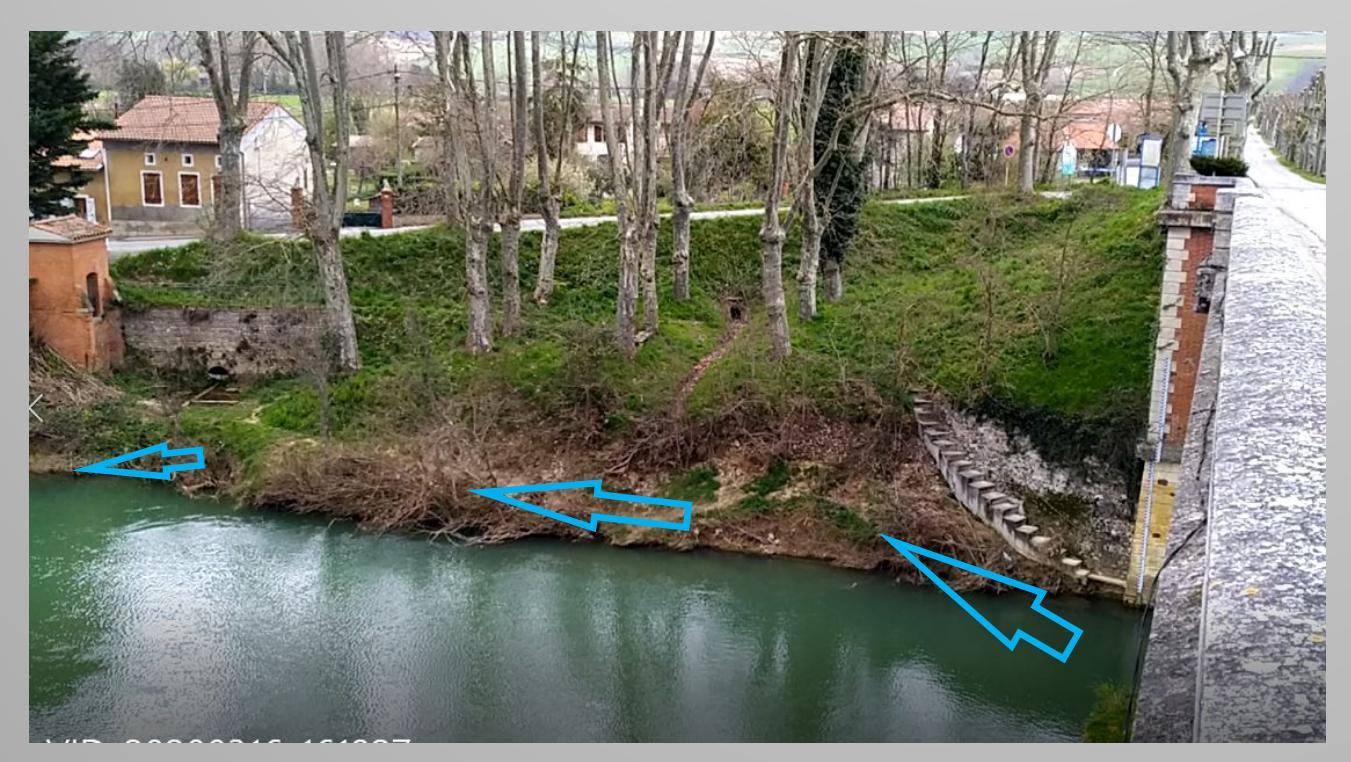
<< Frontview Current health state in march 2022: 50m erosion process is ongoing in diretion to public space
