"NbS and combined techniques - Case studies of steep bank stabilizations in the Garonne water catchment area in France - Constructions in very close proximity to residential areas and infrastructures"

EGU General Assembly Vienna April 2023

Case study 1) 1999: Hers Vif River – 120m Rehabilitation work of River embankment Construction time 3 months – Pre-tax costs 75.000 € (64.500 £ 10/2016 rate)

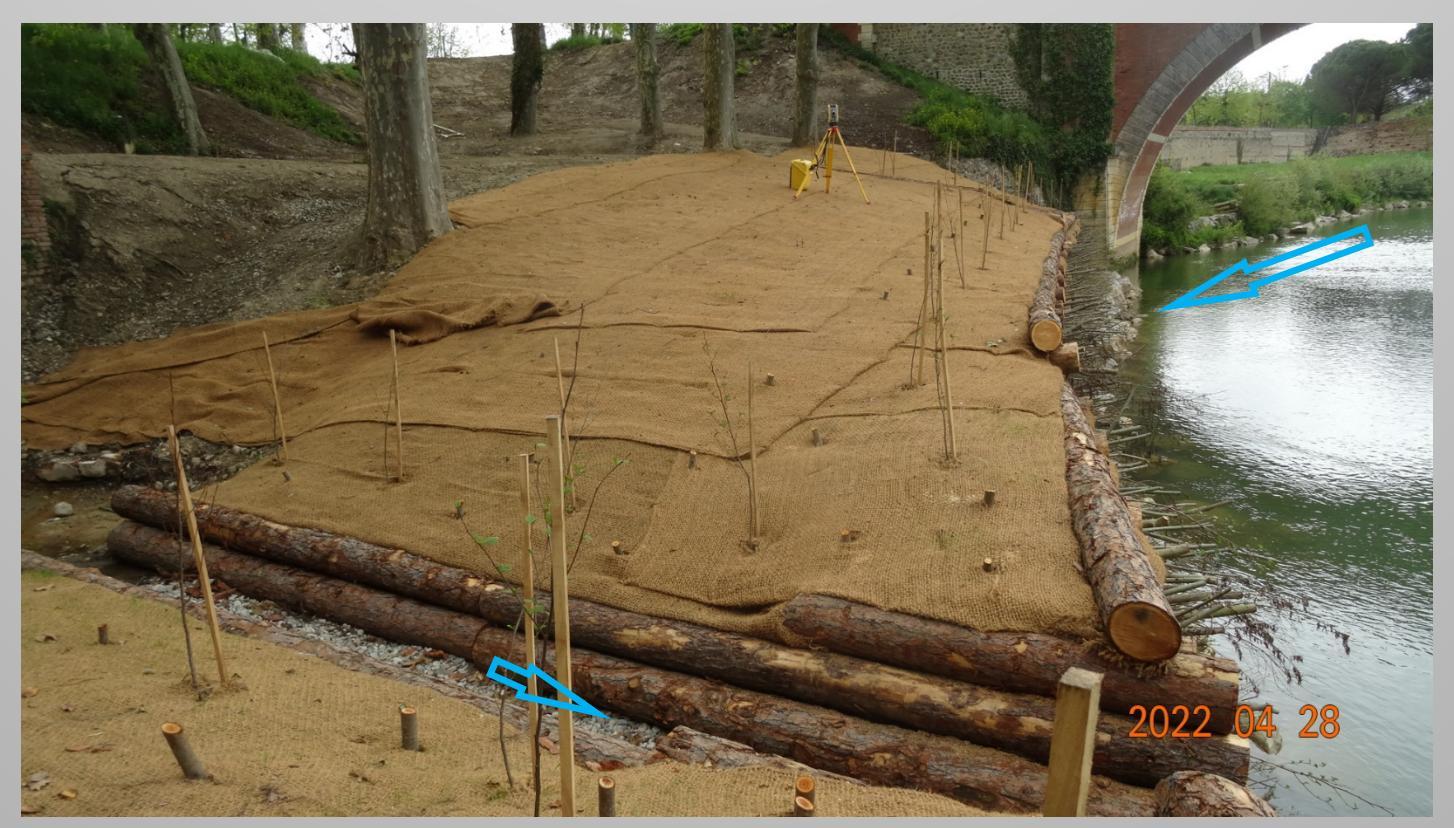
View to upstream: 50m erosion process stopped by building a vegetated Log Cribwall

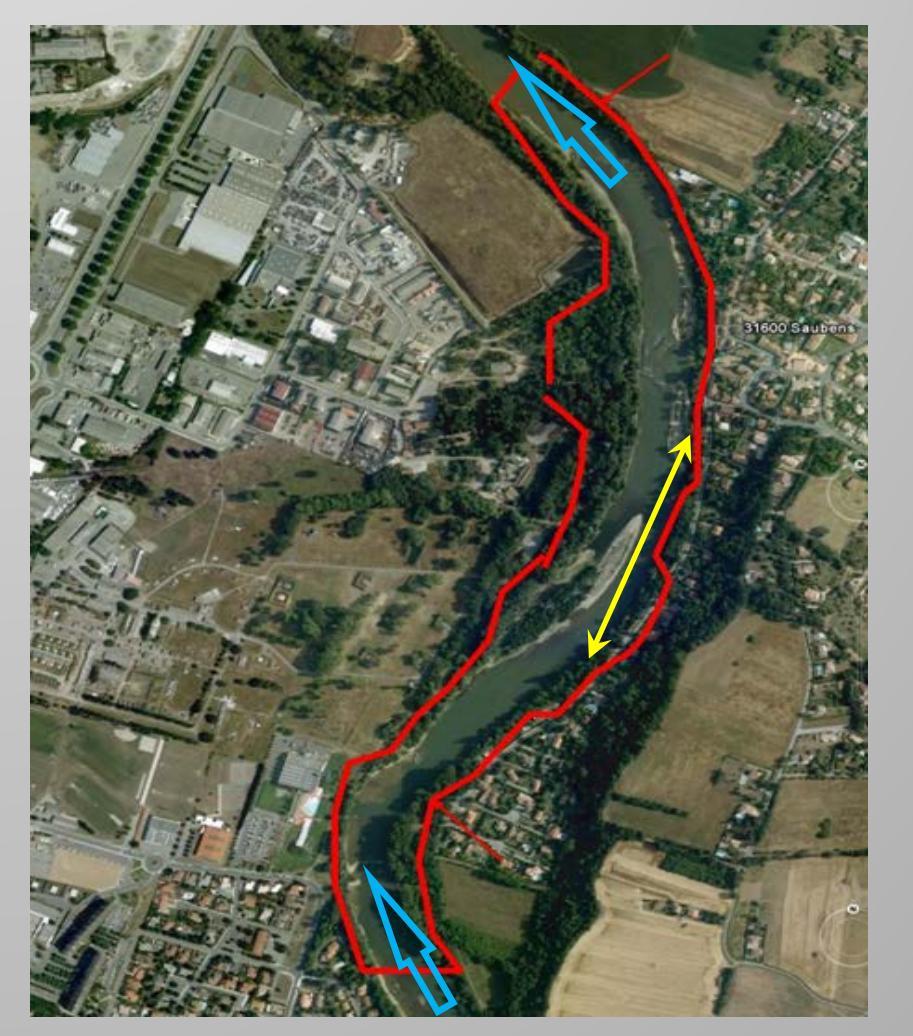
Geometric flow sector shape: Variable bed width 80/150/200/80m; bank height 10/12m, variable slope gradient 30/45/55;

Provided longitudinal works: live RipRap, Log Cribwall, live Brush Mattress, Brush Layers, combined drilled concrete injection anchors

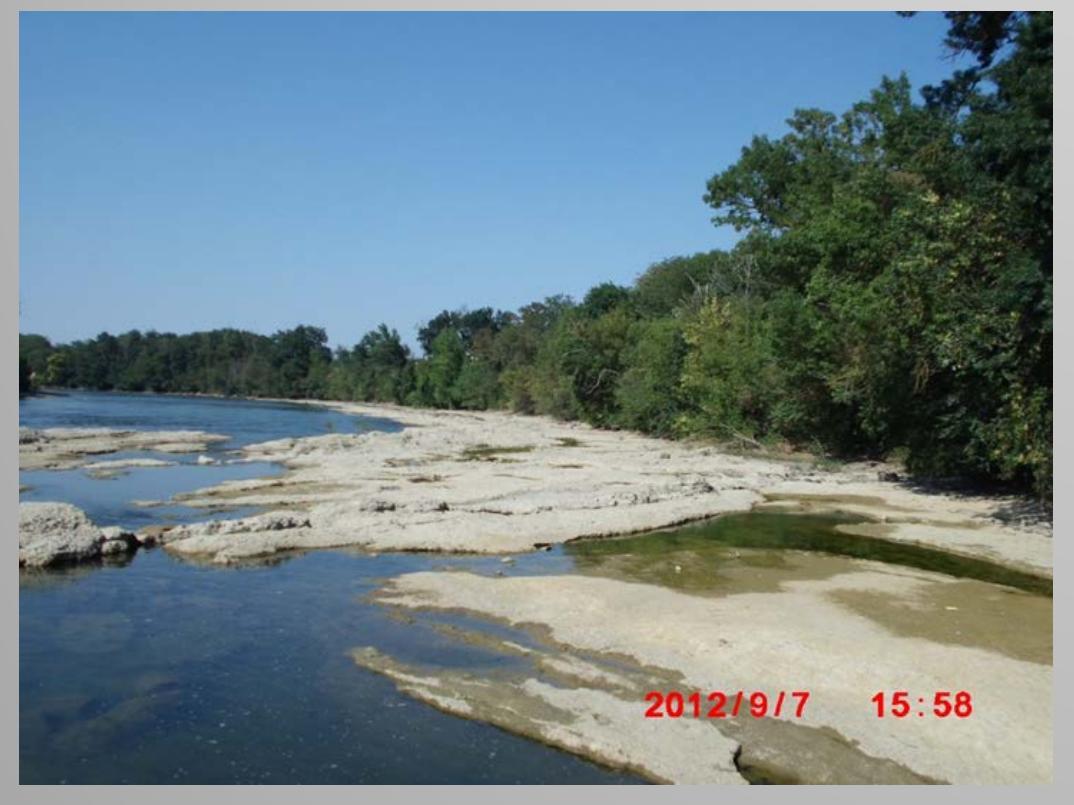
Preliminary survey stage: Diacronic analysis results in both bed shifting and bank erosion have progressed up to 6,5m over the last 50 years

2012: Far advanced bed deepening due to lack of bedload caused substratum outcrop

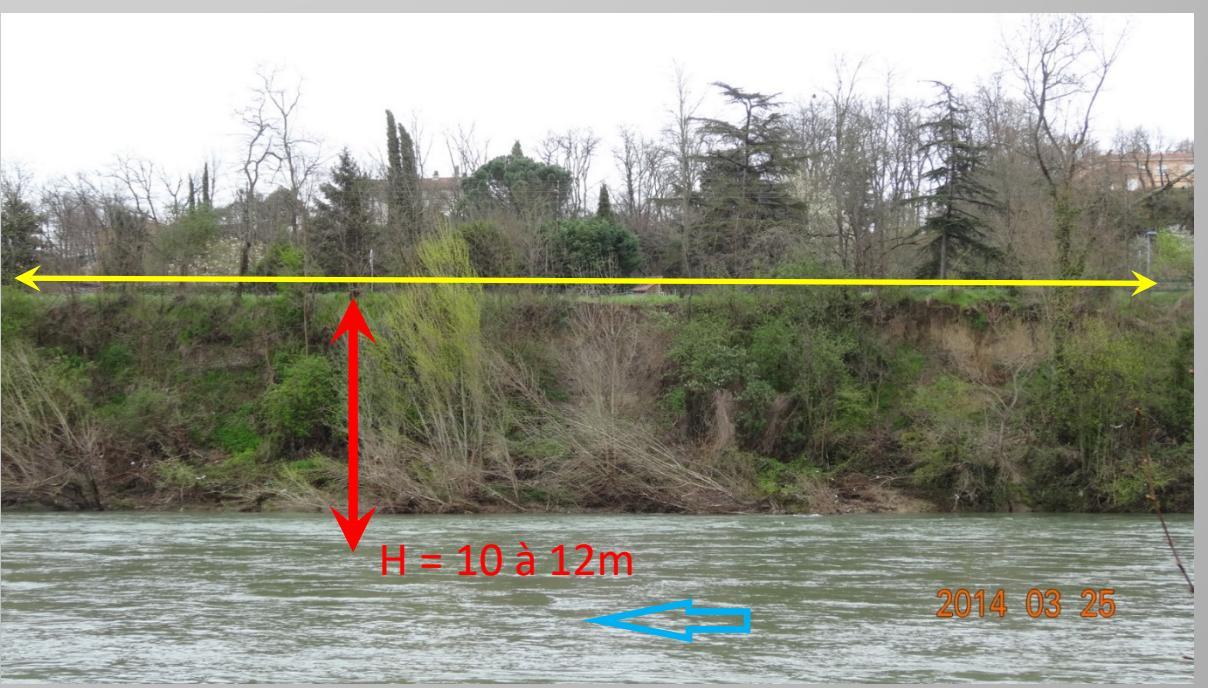
2014: Lateral movement continues and causes bank collapse close to the residential area access (position in yellow line)

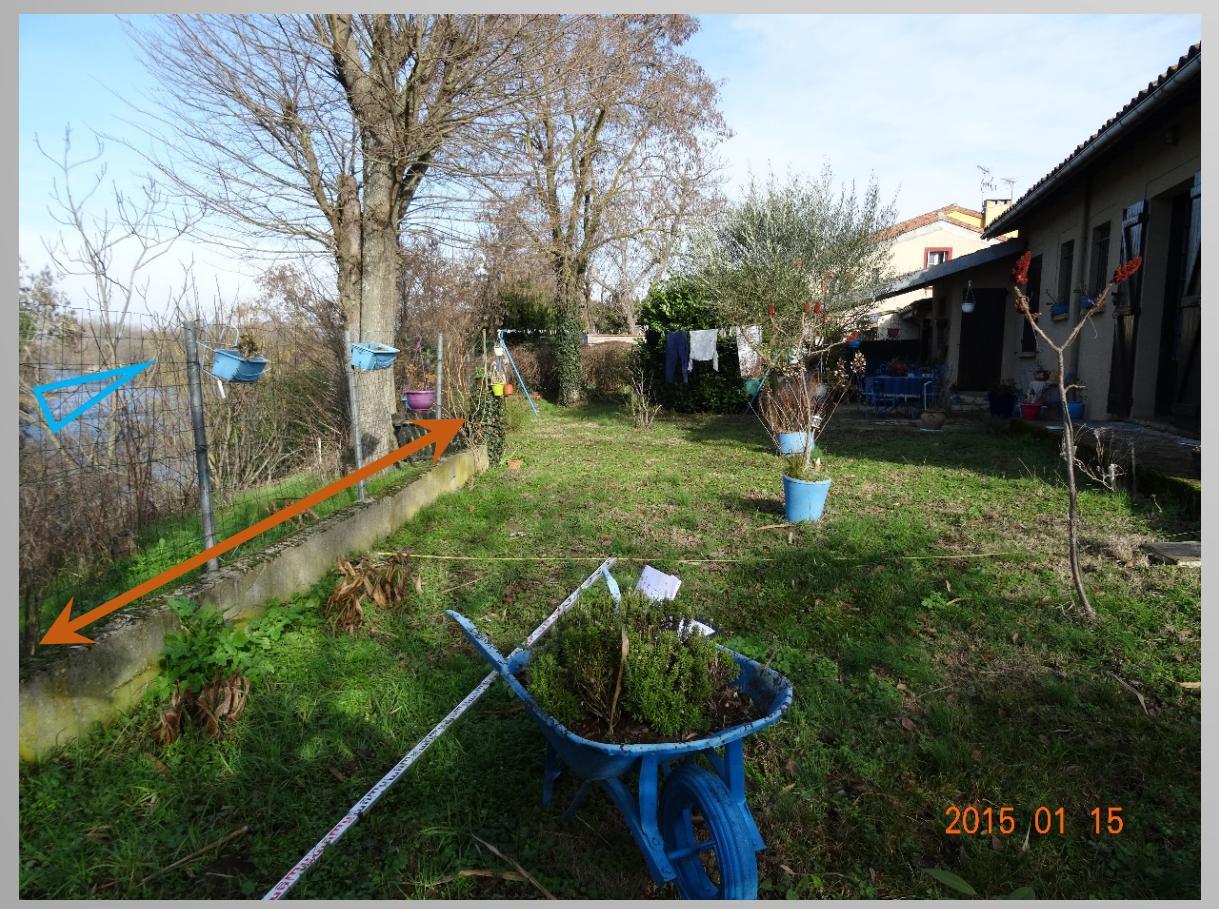
Important upper bank erosion in close proximity to residences (brown line is garden's border)

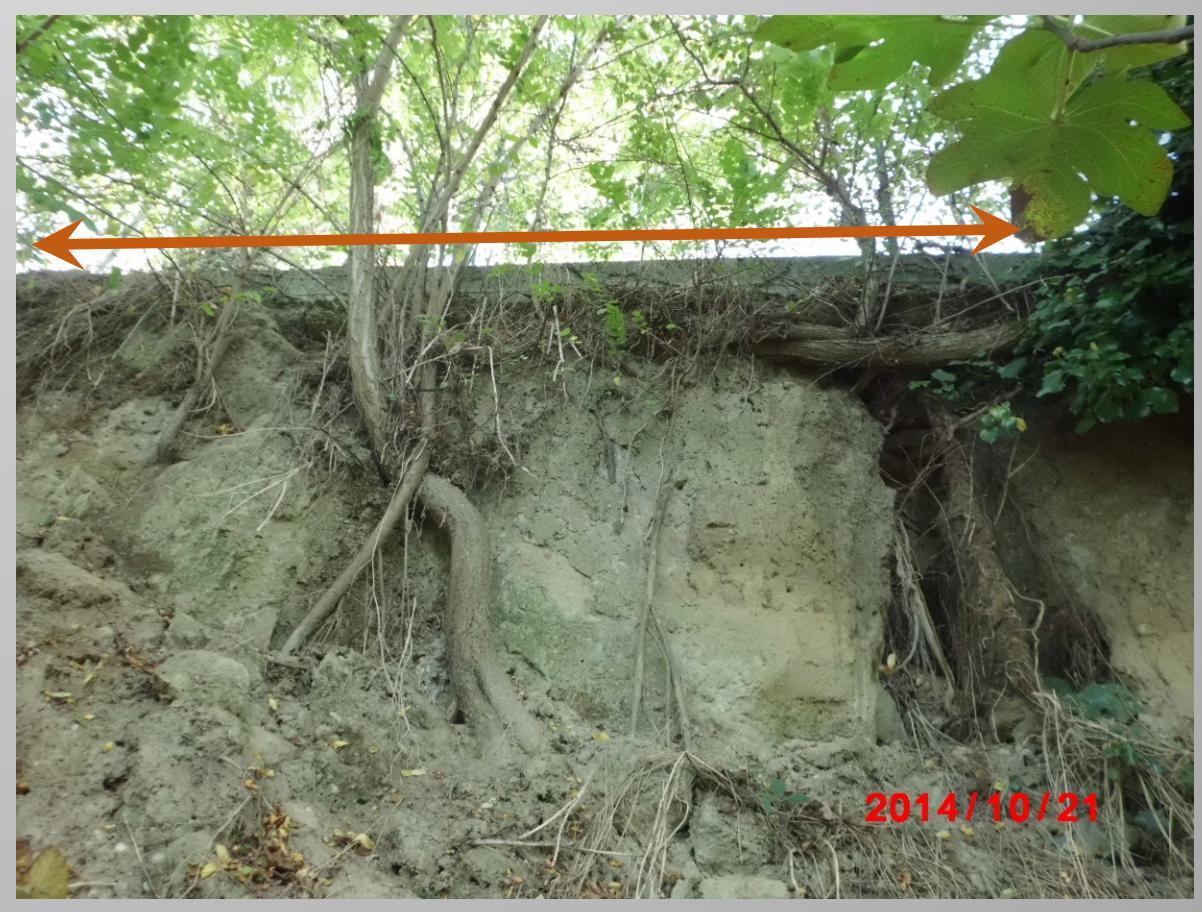
Same propertie, garden border shown by brown line

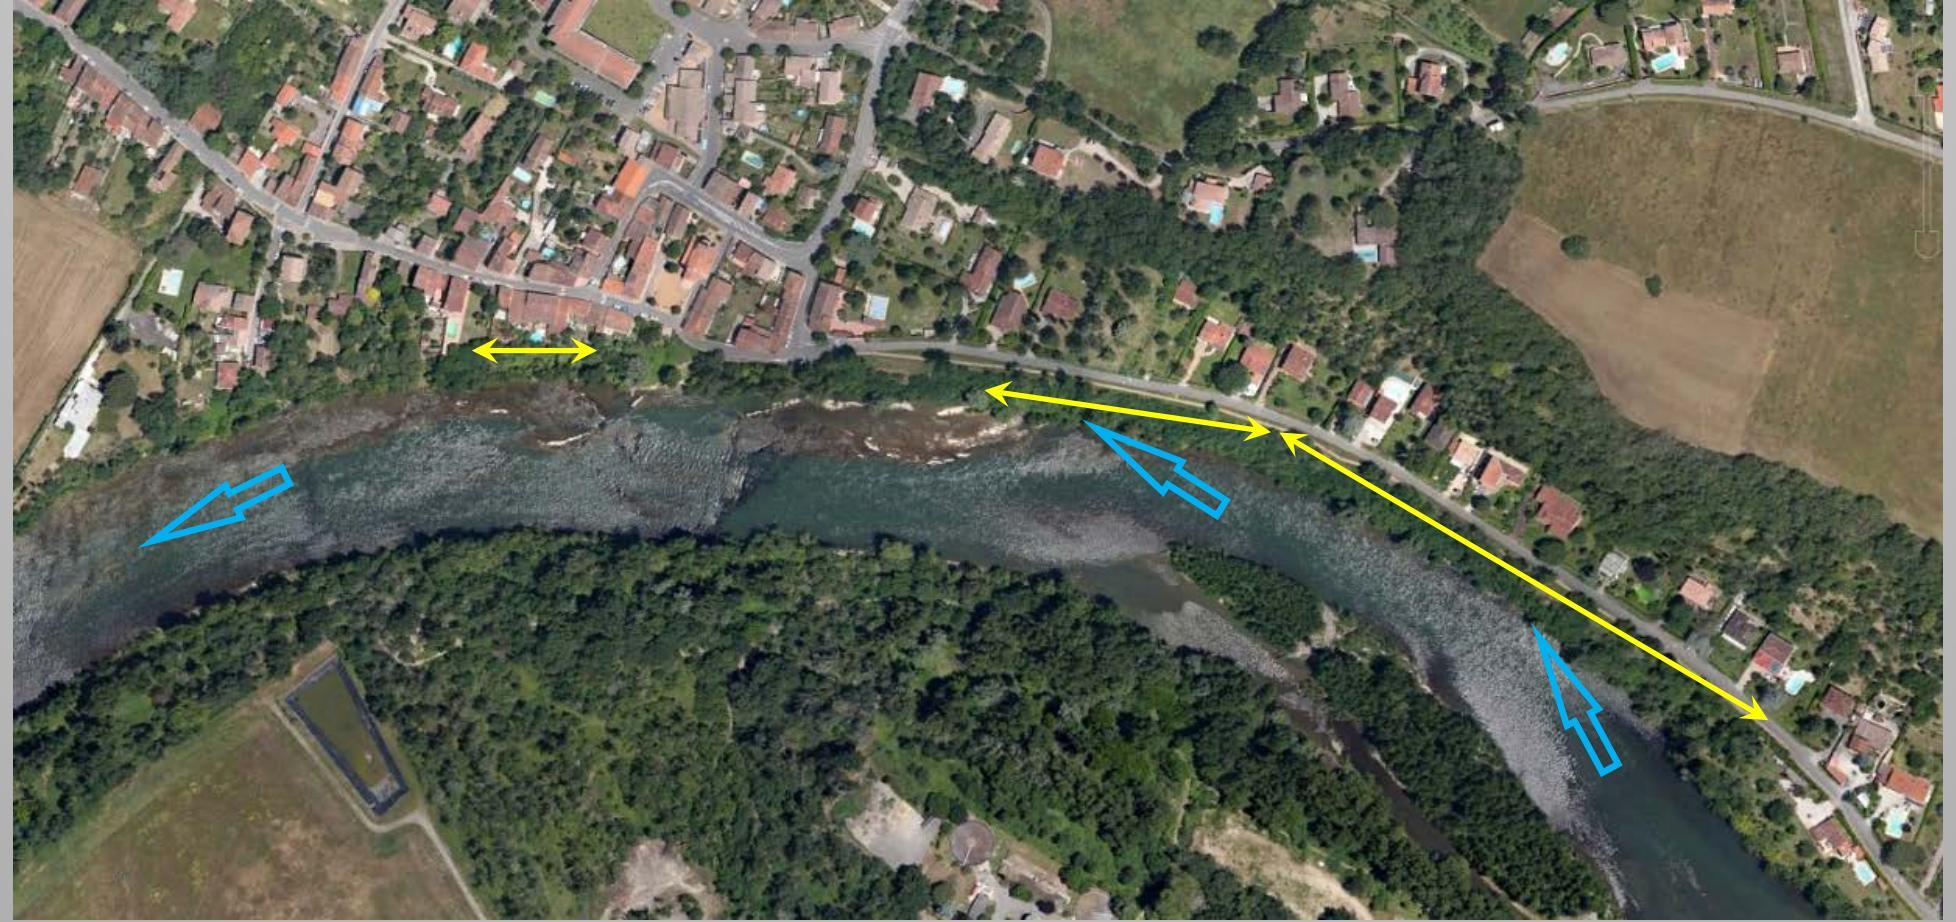
GoogleEarthPro 2012: Yellow line indicates the most urgent job sections in NbS and combined techniques (total L ~ 500m)

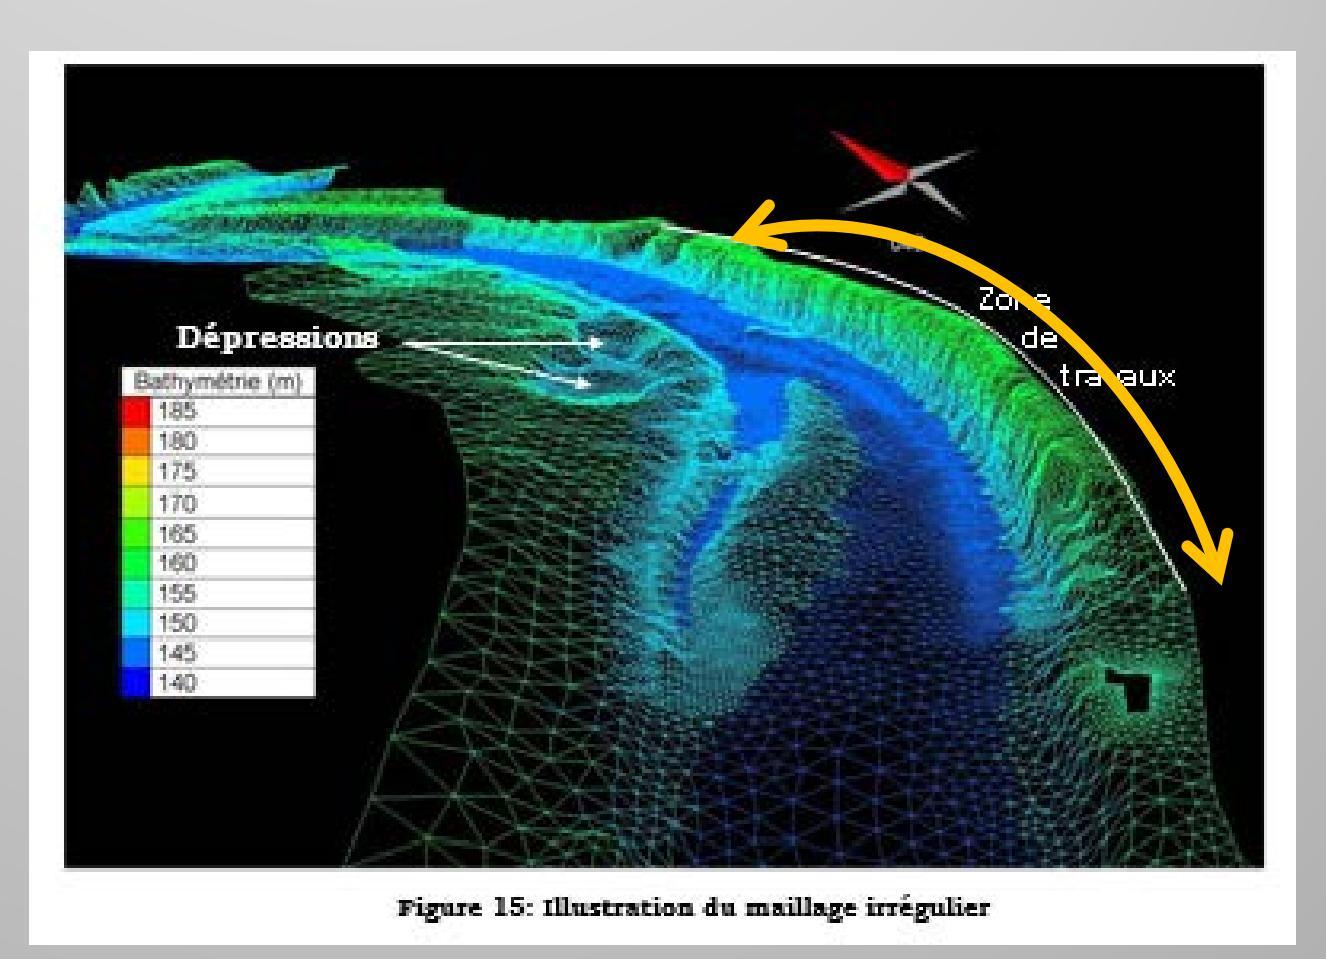
Design stage: Our first preliminary study, based on a terrestrial 3000m long DTM covering area of centennial flood $Q_{100} \sim 2,780 \text{ m}^3/\text{s}$, was to compute the channel morphology (TELEMAC 2D software)

River bank reconstruction parameters <u>*Flow rates:*</u> Q_{min}=150 m3/s, Q_{max} 4.350 m3/s (1952)

Design base: Slope _{average} I = 0,0023 H_{max} = riverbed bottom + 10/12m V_{max channel} = 4,0m/s HQ100 = 2.780 m3/s

Shearstress $T_{max bankborder} = 160N/m^2 > 220$ N/m²

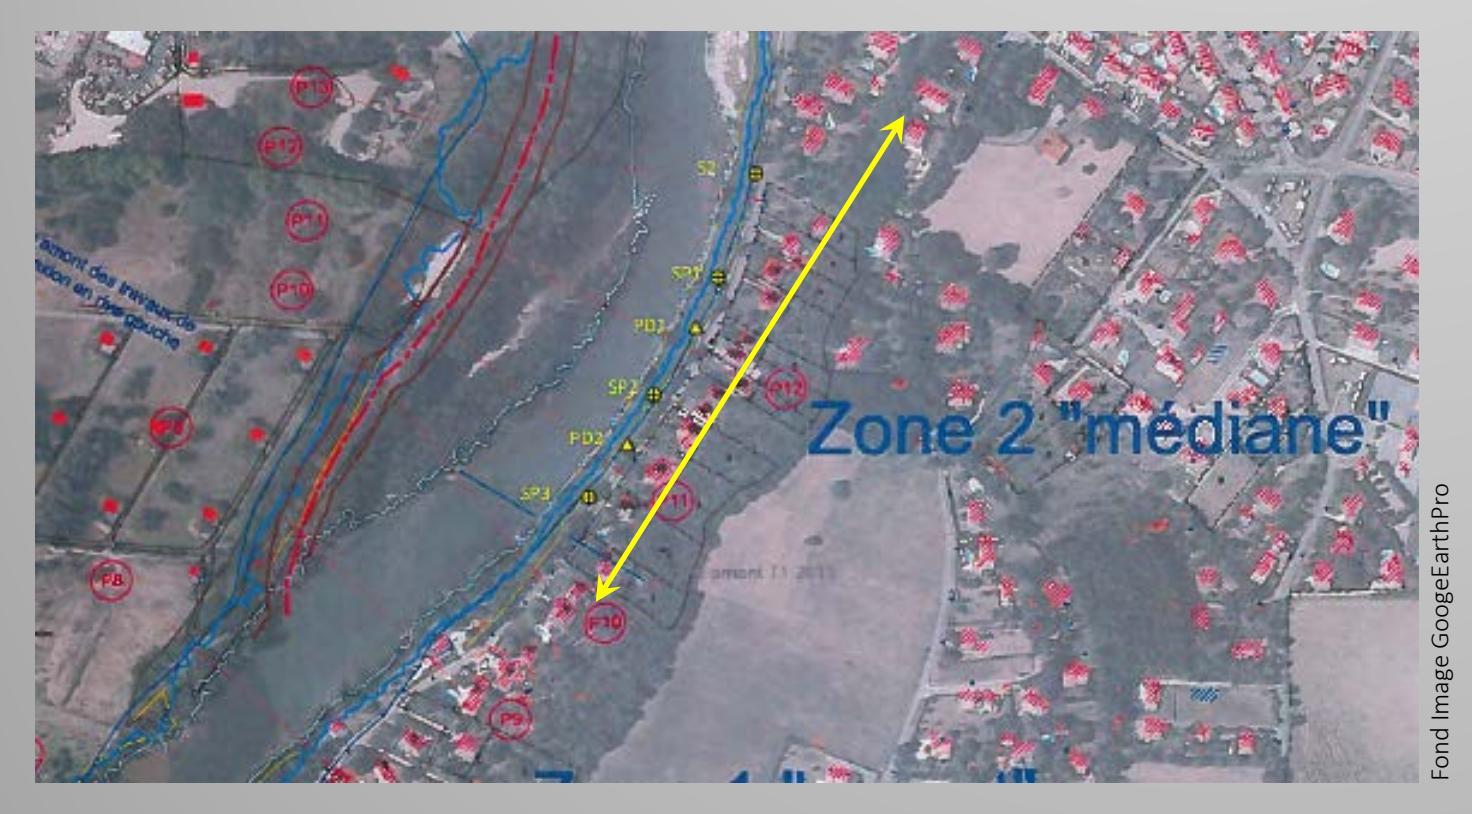
Yellow line indicates drilling positions

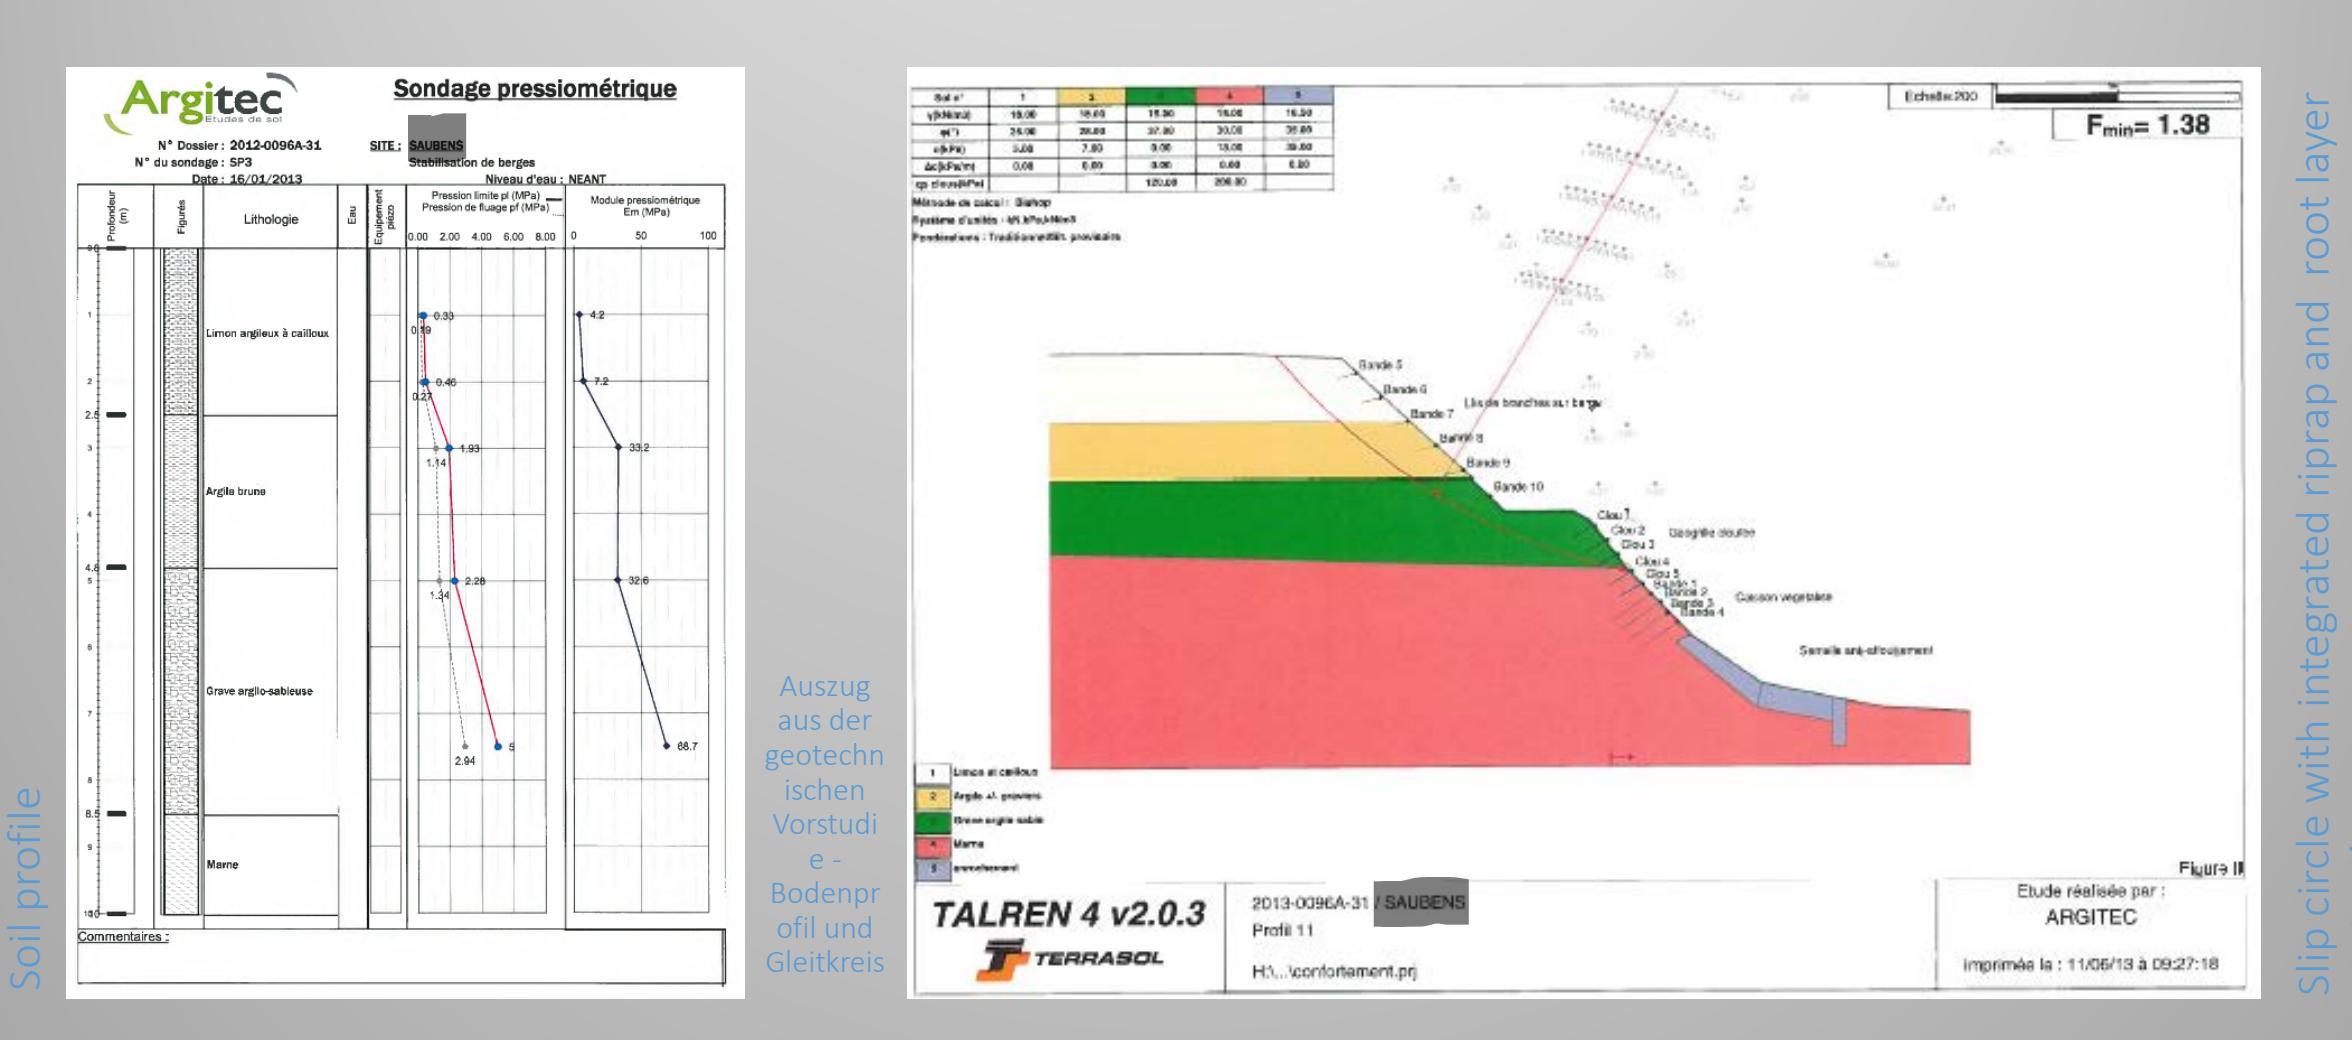
Design stage: Geotechnical assessment results based on a pre-design version of biological and mixed techniques intended in this design phase for protecting right river bank

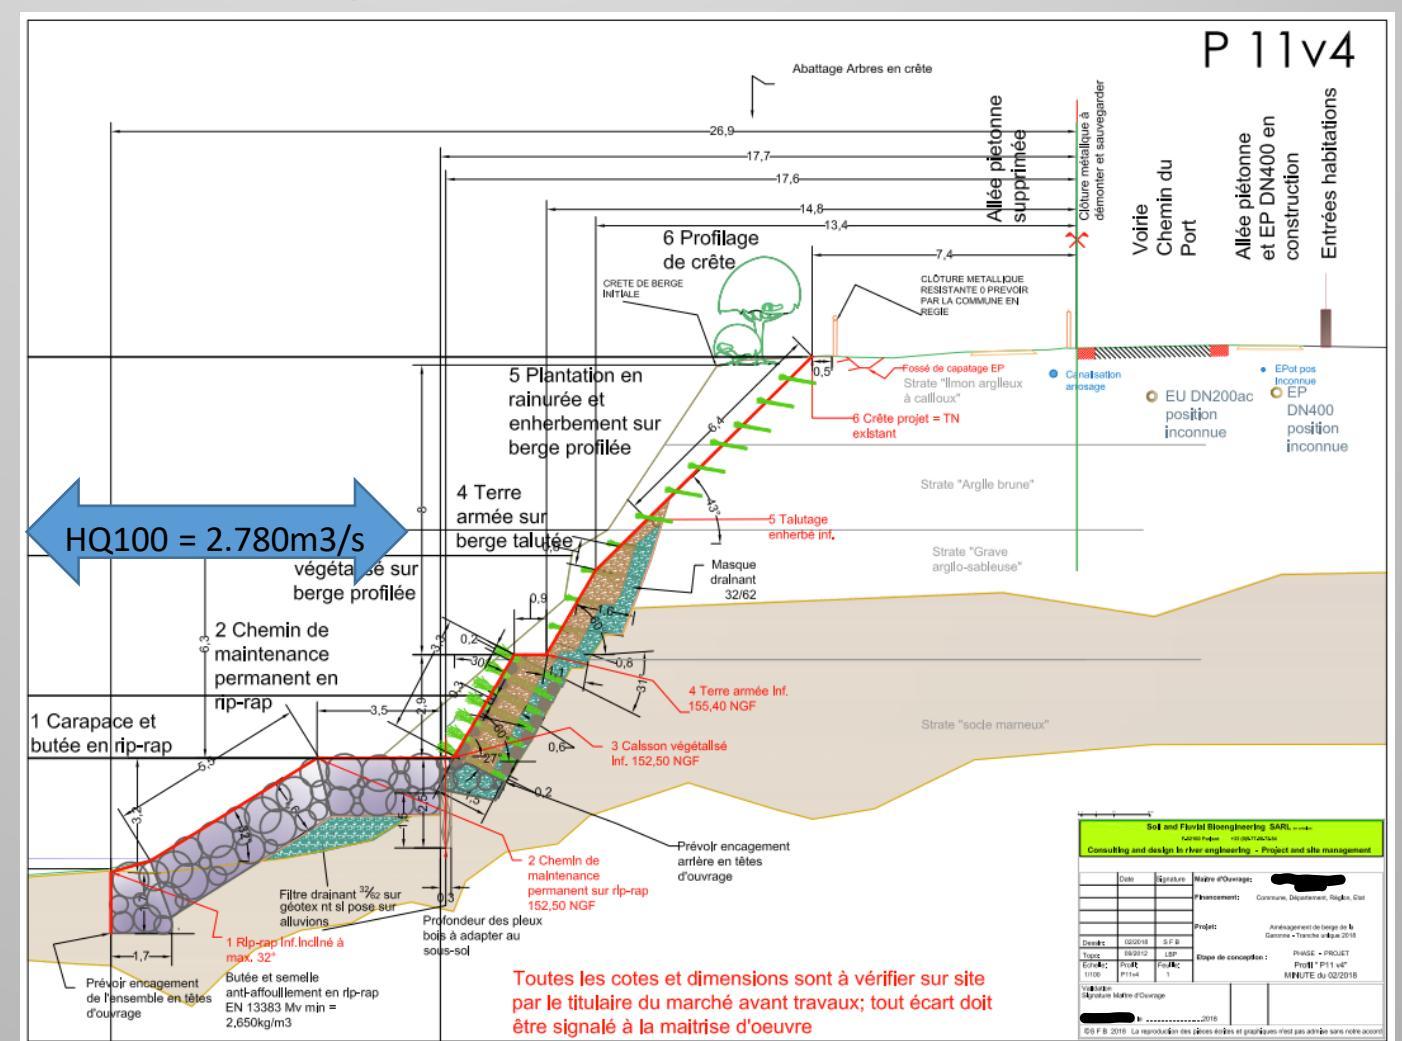
Design stage: Extract from the invitation to tender for public works – Finally selected execution profile

TOP bank: Multiple brush layer structures covered by 100% biodegradable coco geotextiles >>

UPPER: Dormant cuttings in 3D HMfree greened steel structure >>

MIDDLE: Greened Log Cribwall with integrated wedge filtering >>

BED: Machine-suitable maintenance strip >>blockstones according to EN 13383 Parts 1and2>>

BED: Rip-rap carapace blockstones according to EN 13383 Parts 1 and 2 >>

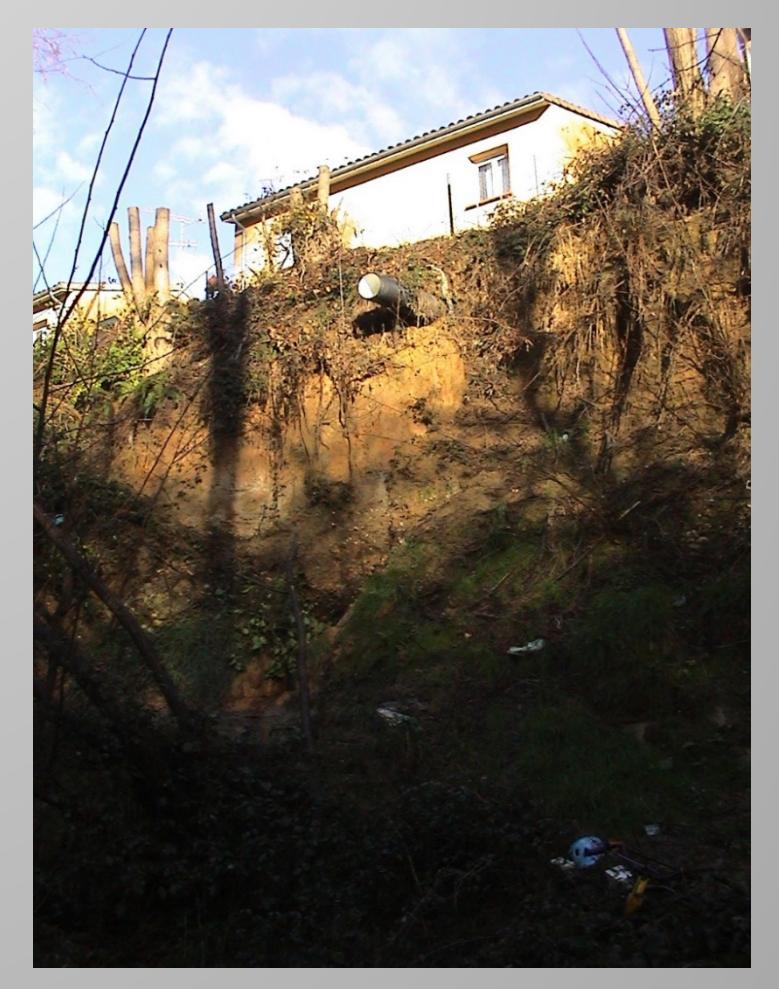
After clearing work we discovered broken sewers, huge building rubbish and a pretty nice [©] groundwater horizon

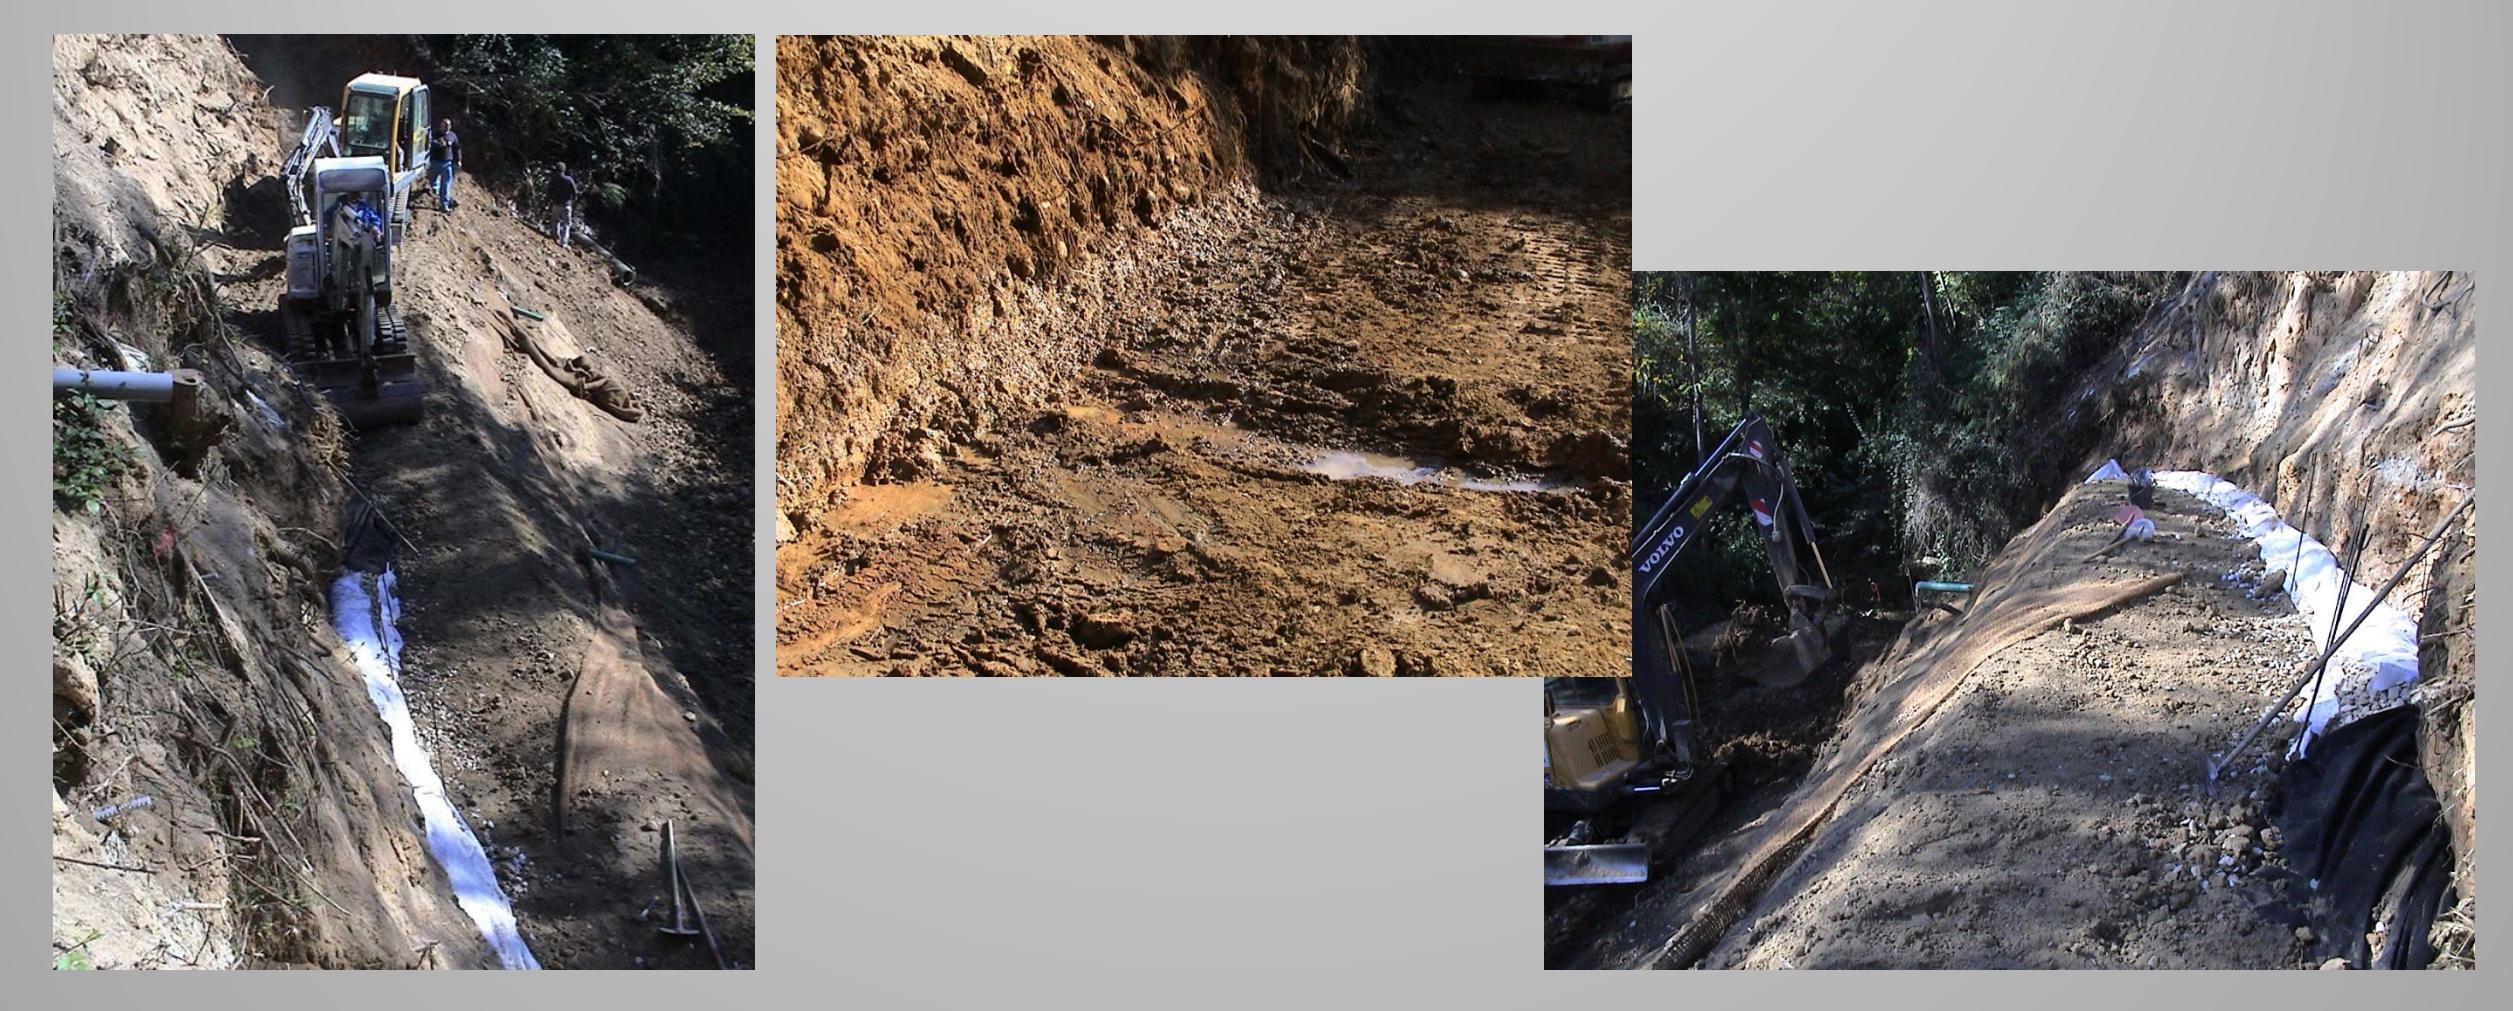
Catch and drainage of the groundwater discharges by means of drainage packings

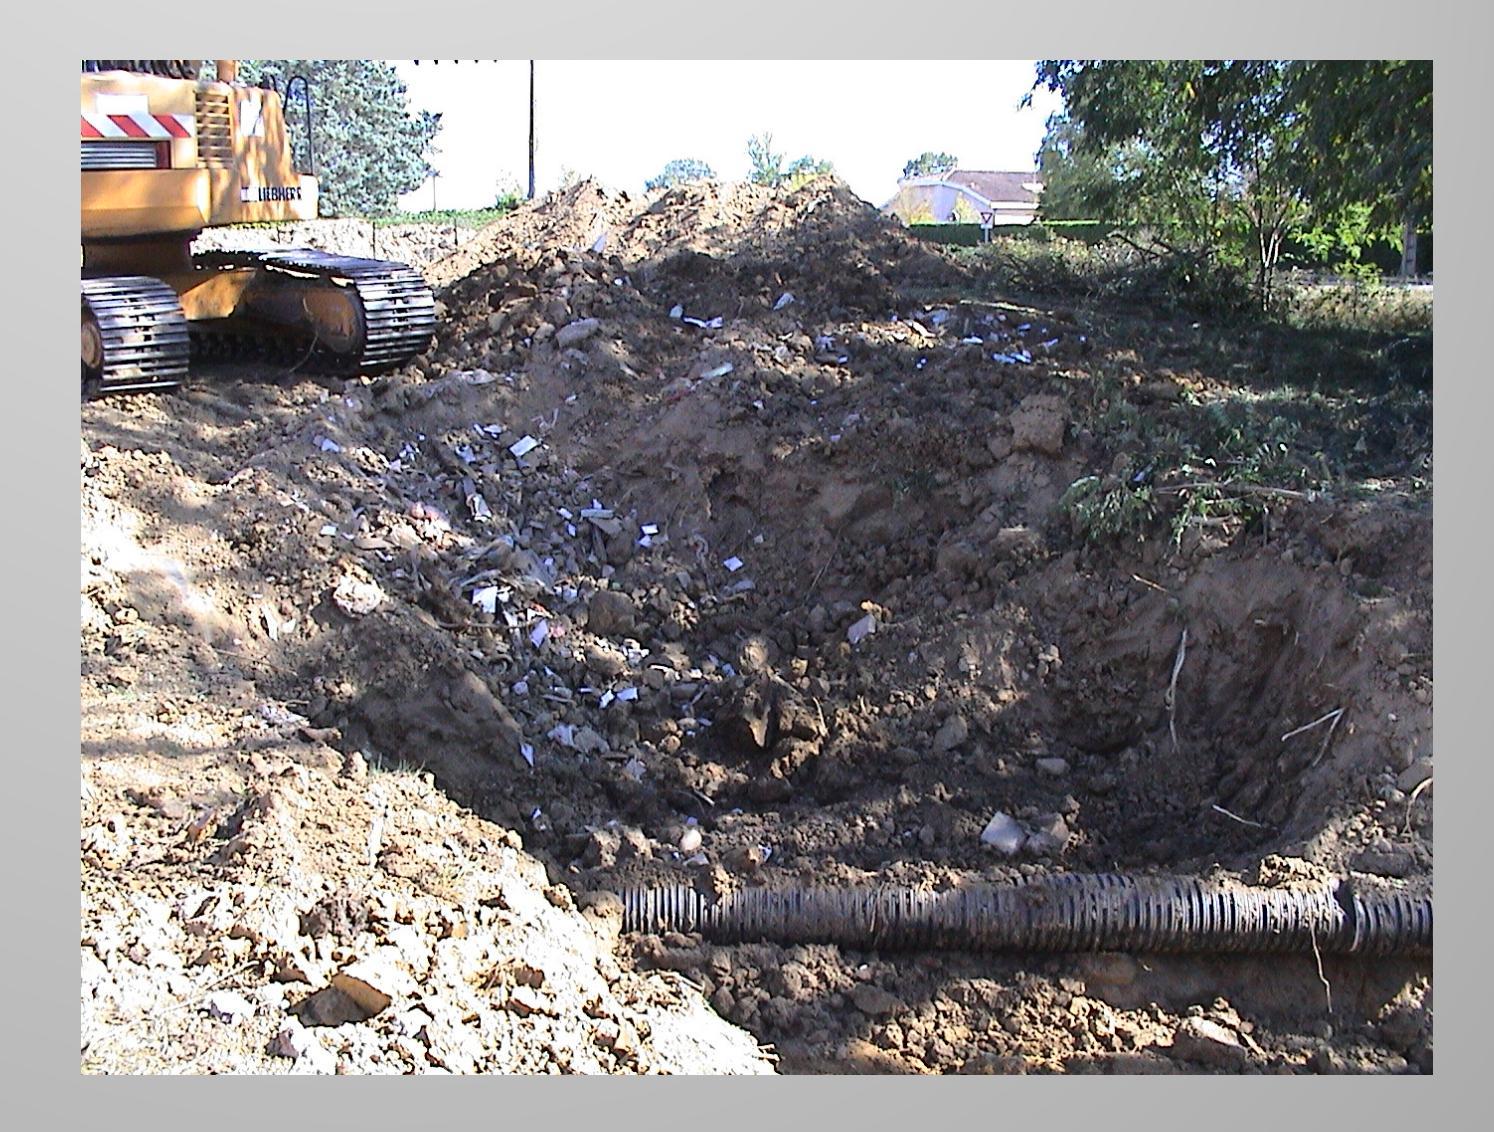
Sudden emergence of a 10 year old wild construction waste site with significant volume to be disposed of

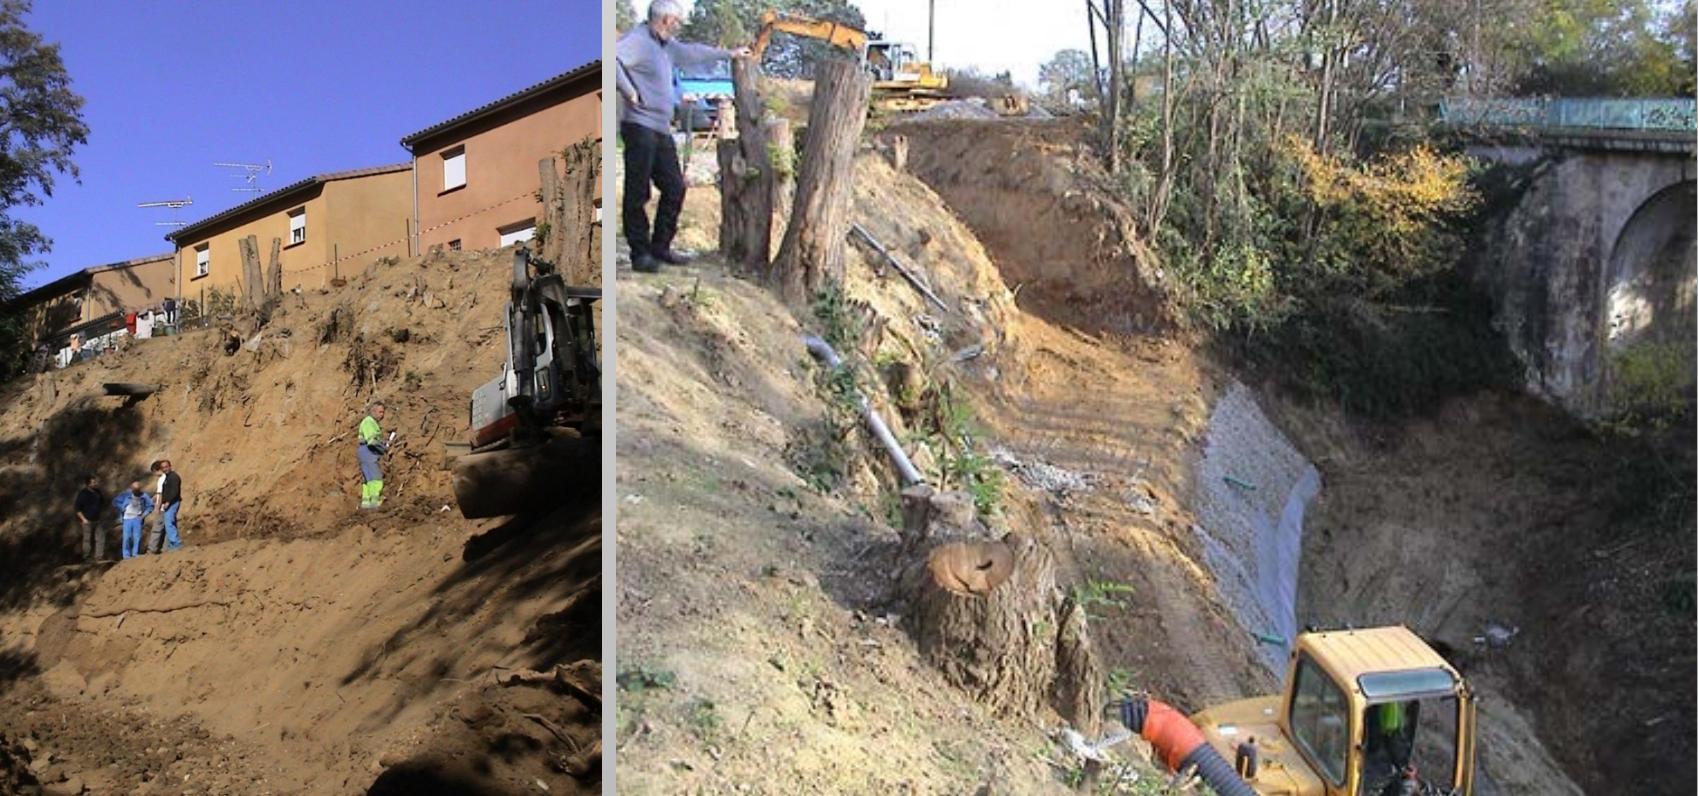
Earthworks giving hydraulic shape in order to obtain flood impact reduction

Implementation of anchored 4m high 3D steel structure onto lower bank in order to obtain flood impact reduction

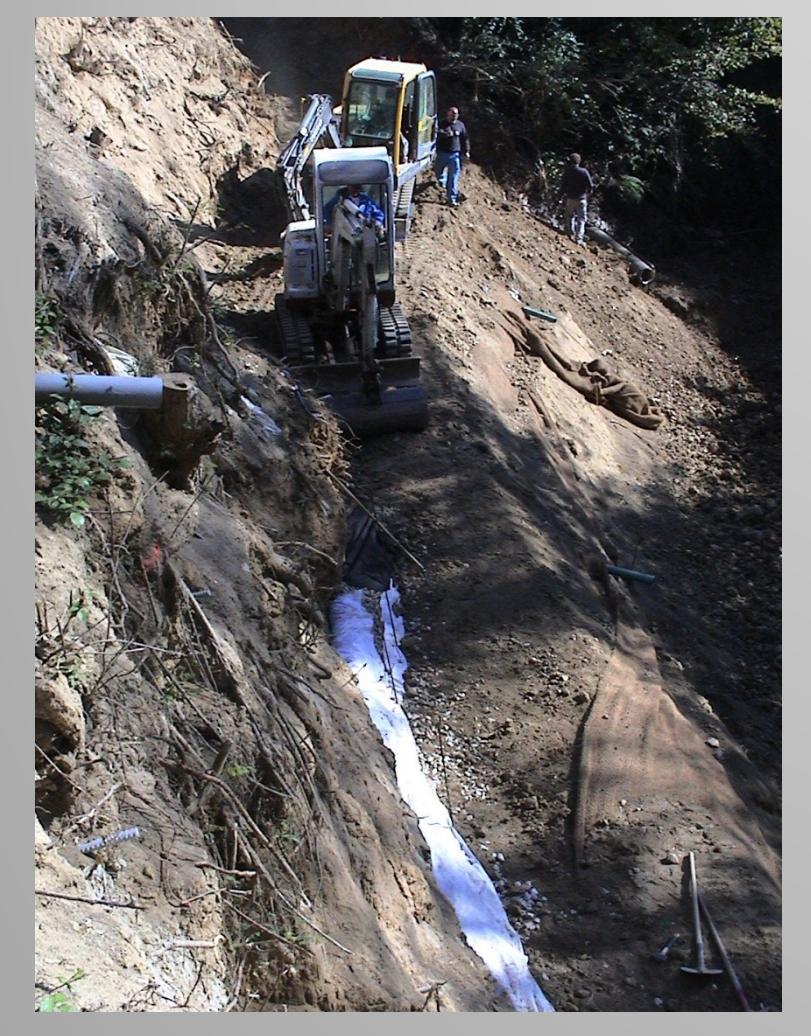
Groundwater capture on bedrock surface

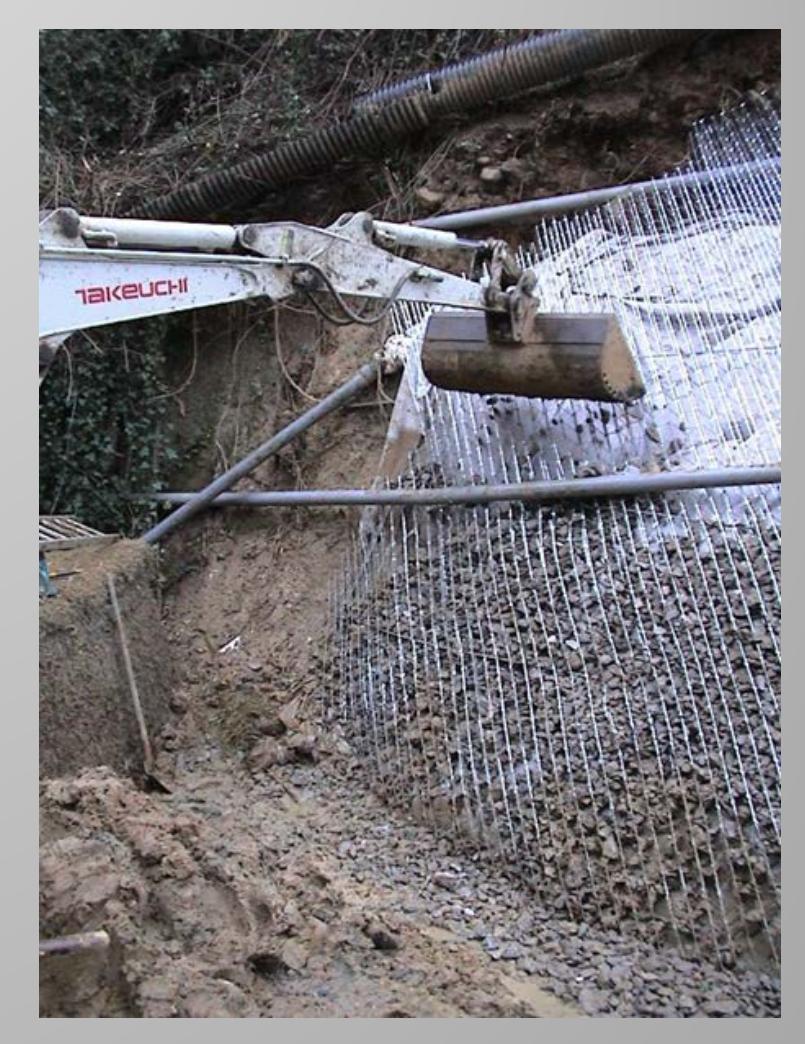
Before greening: Filling 3D steel structure with core grained gravel
