"NbS and combined techniques - Case studies of steep bank stabilizations in the Garonne water catchment area in France - Constructions in very close proximity to residential areas and infrastructures"

EGU General Assembly Vienna April 2023

Case study 1) 1999: Hers Vif River – 120m Rehabilitation work of River embankment Construction time 3 months – Pre-tax costs 75.000 € (64.500 £ 10/2016 rate)

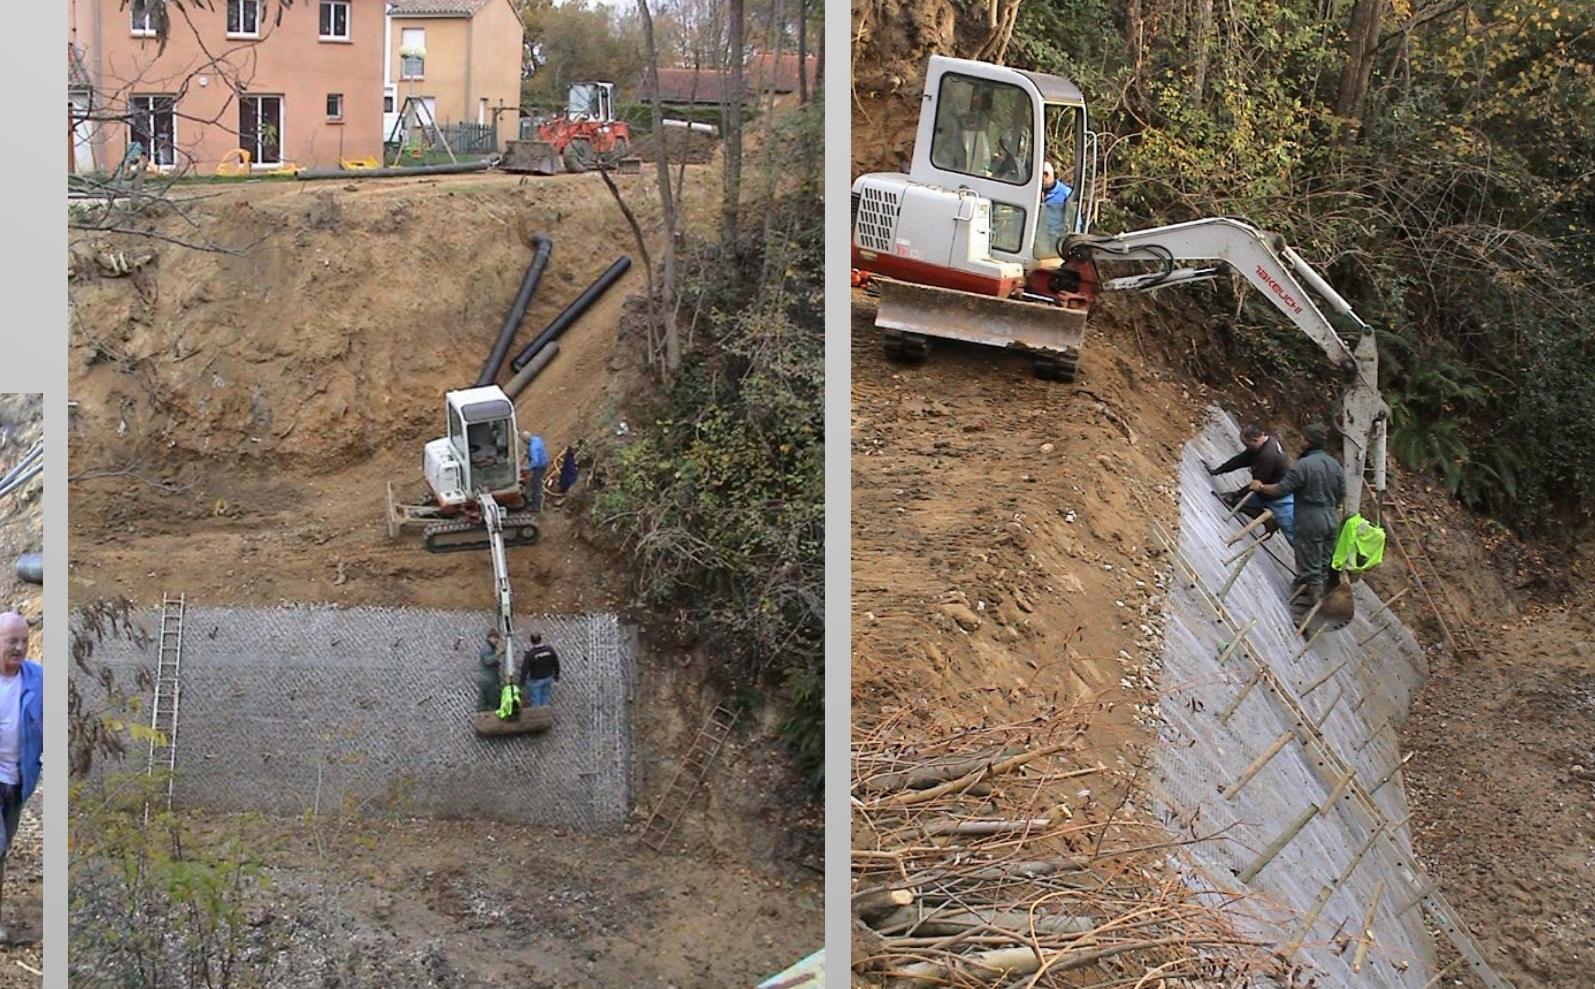
Pressing the willow stakes into remodelized lower bank

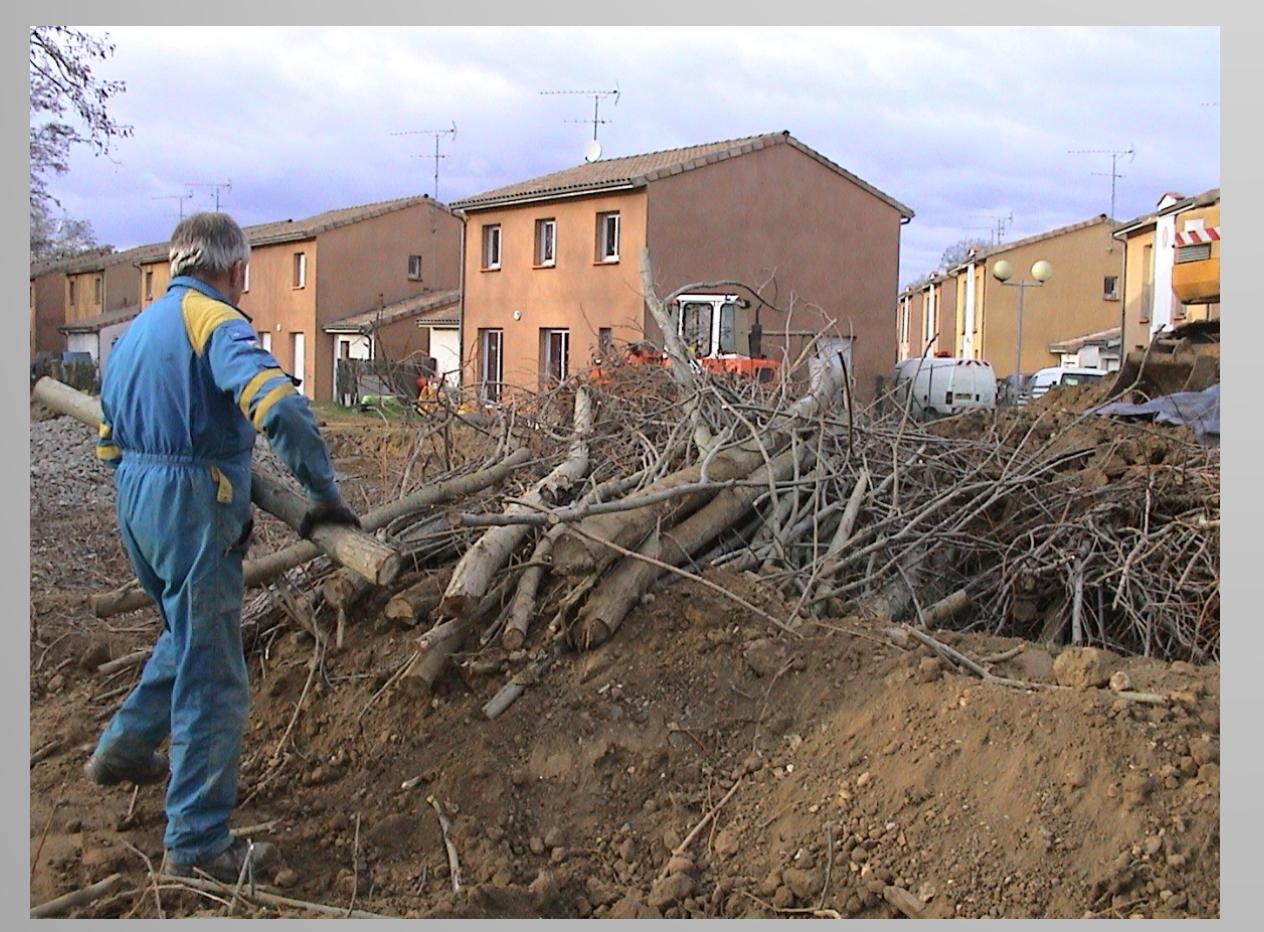
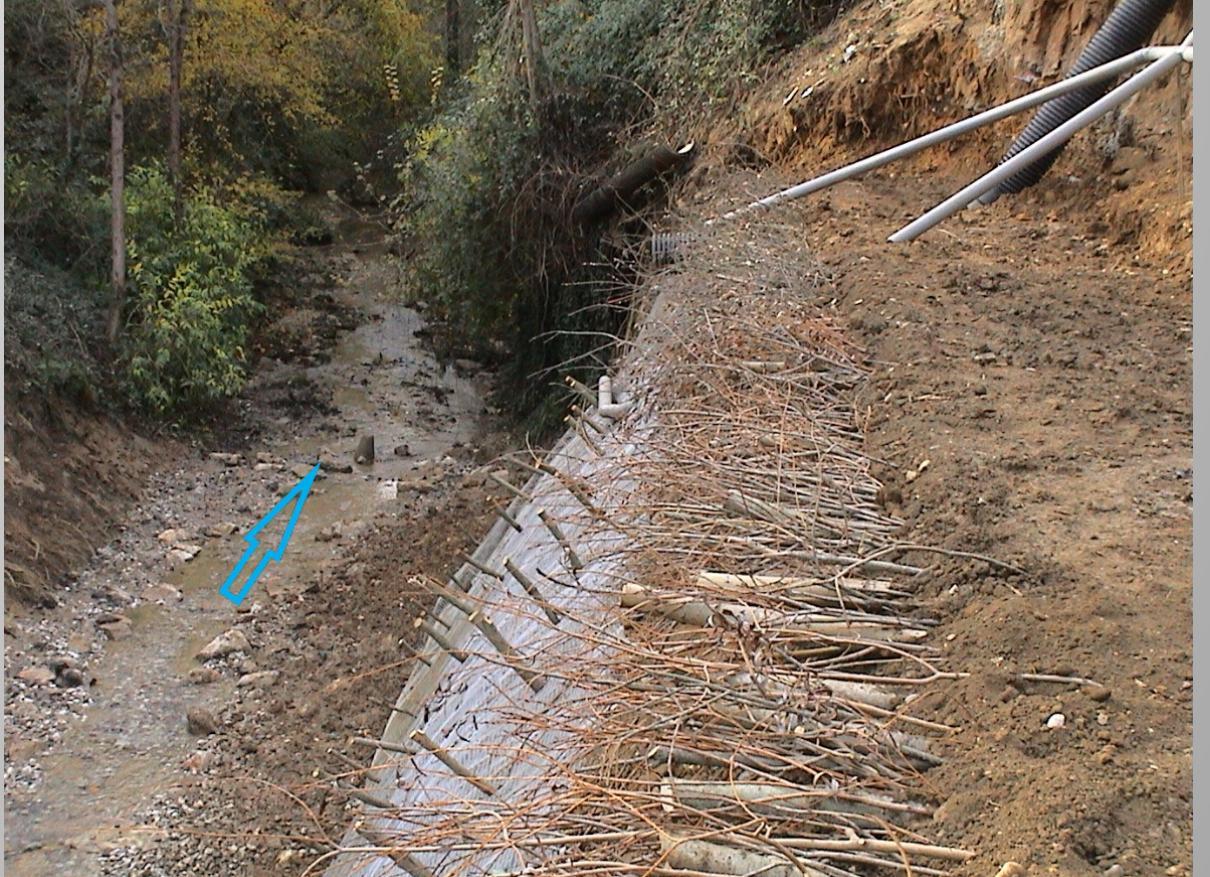
After filling 3D steel structure with gravel, followed the insertion of dormant cuttings in the 3D steel grid structure

Implementation of reconstruction work to center and top bank with log branch cuttings and dormant cuttings

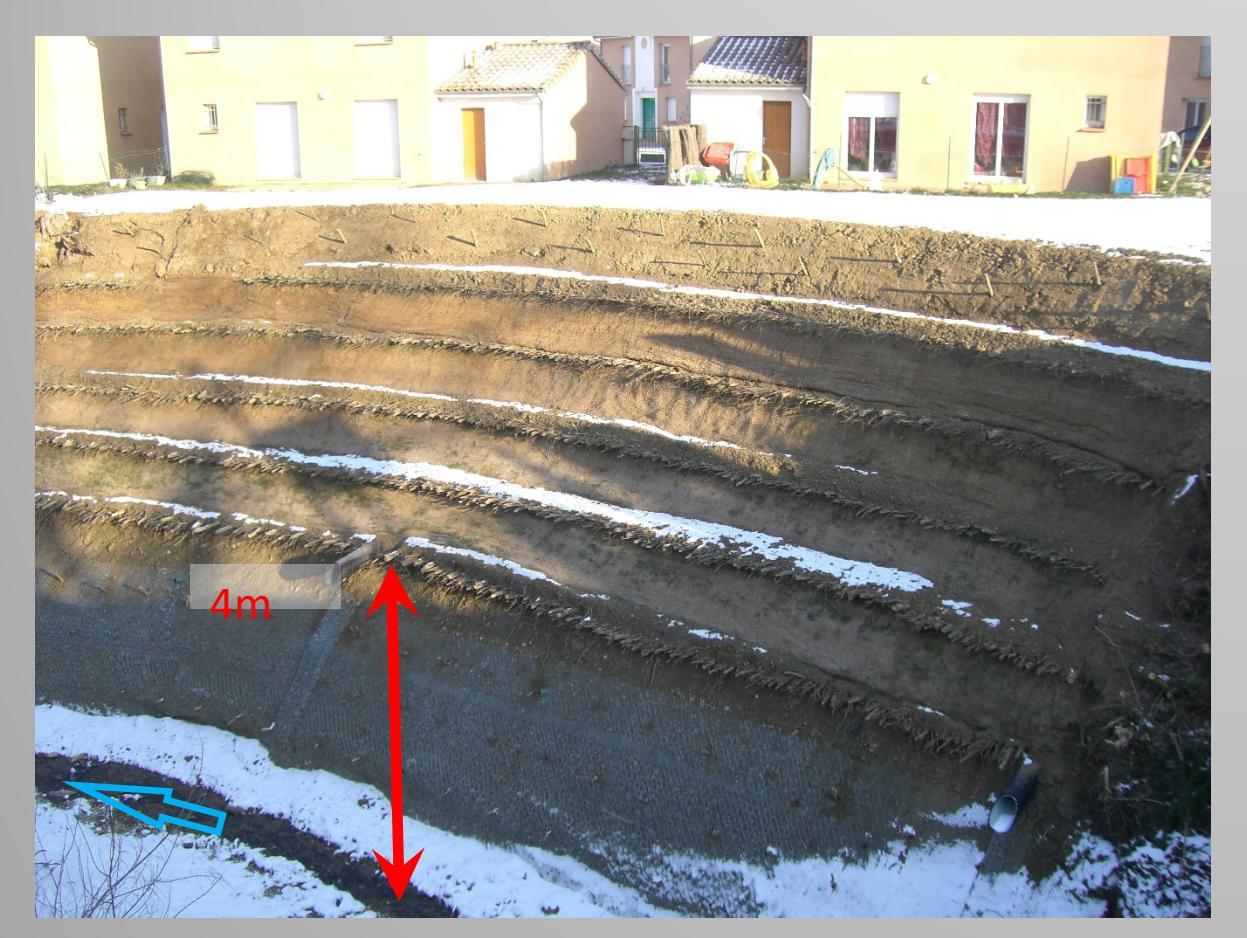
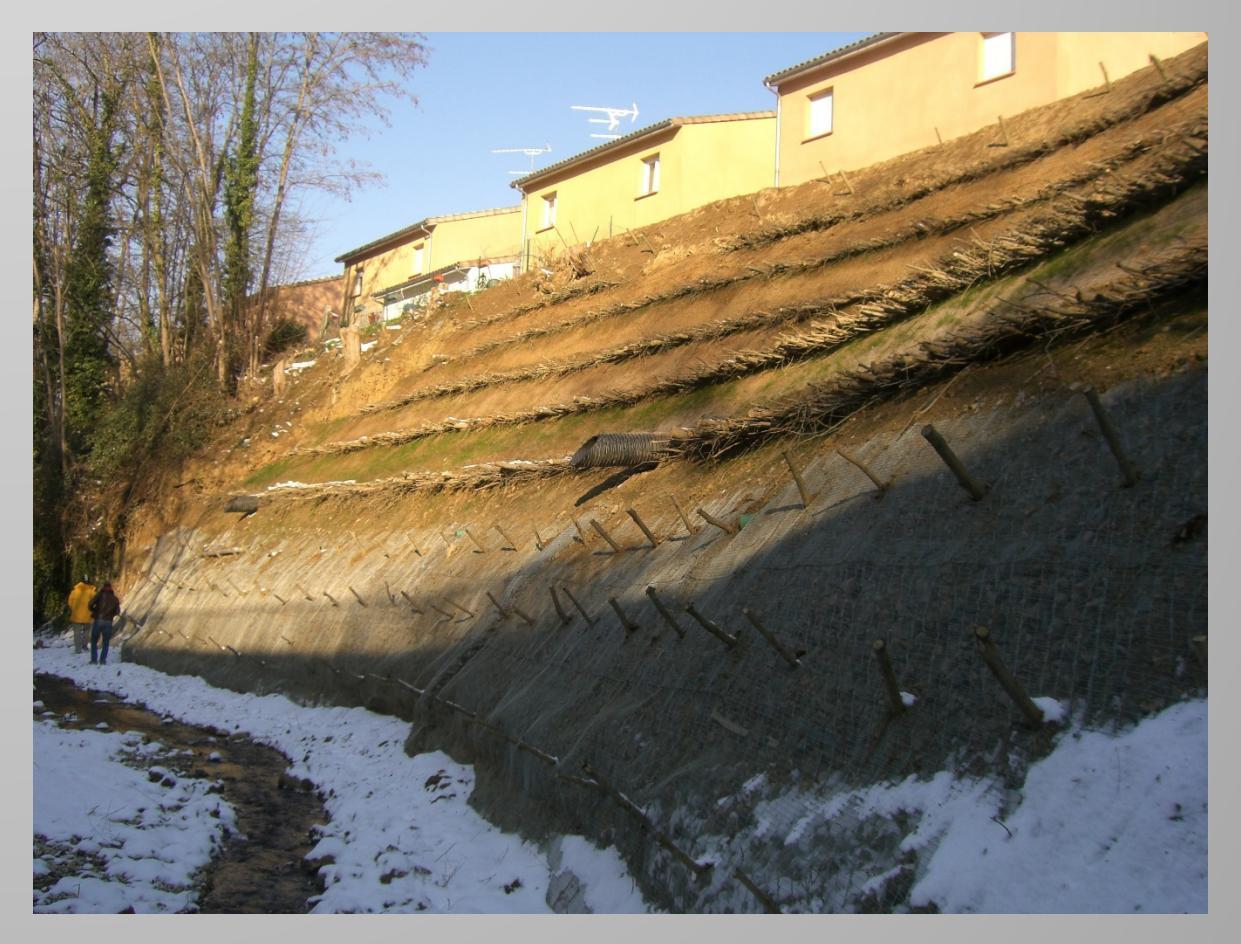
Pictures taken in January /February 2012: Above the 3D Krismer vegetated metallic grid structure is visible the reconstruction of the right riverbank completed by brush layers using locally harvested willow cuttings and willow set stakes.

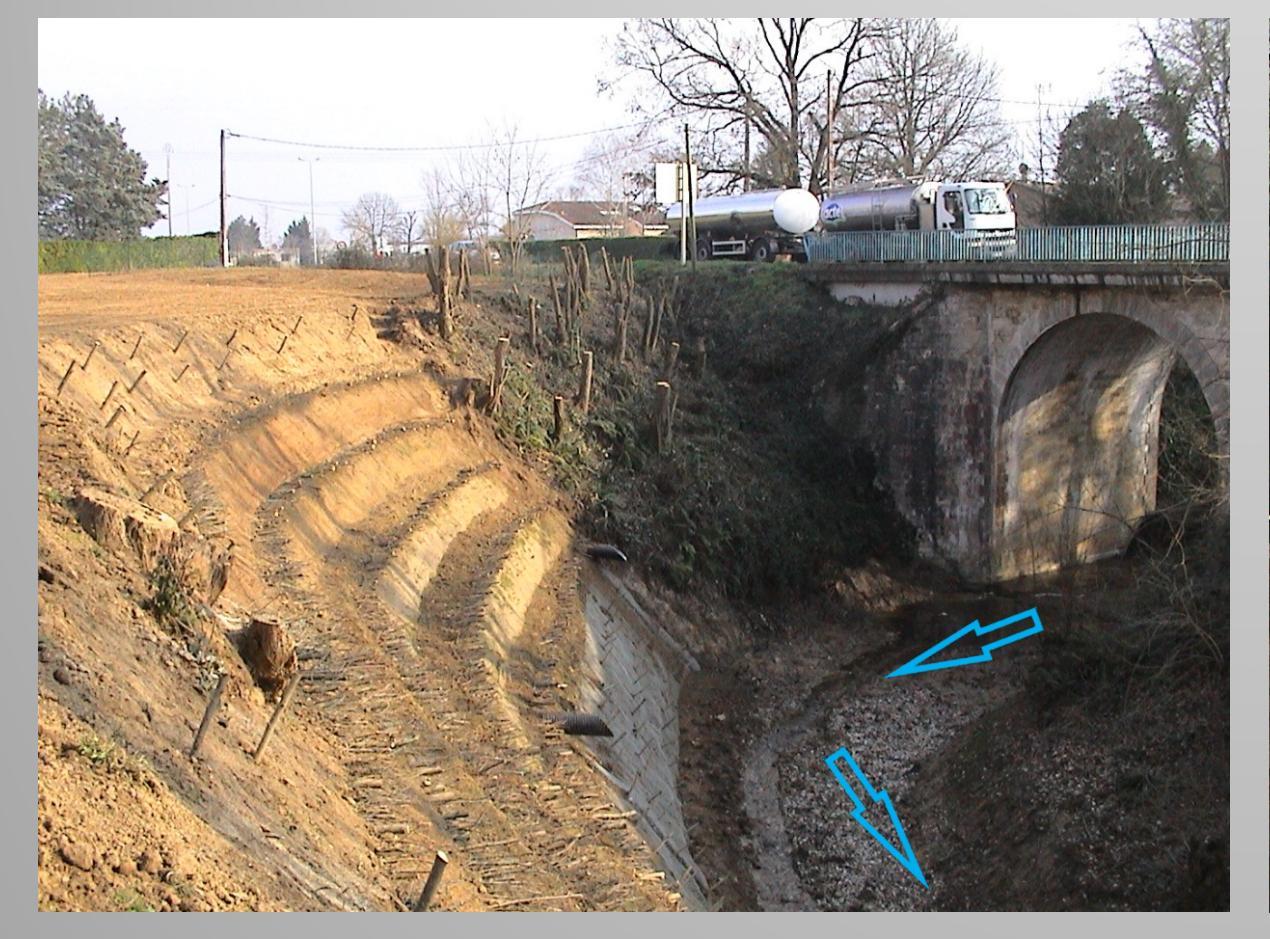
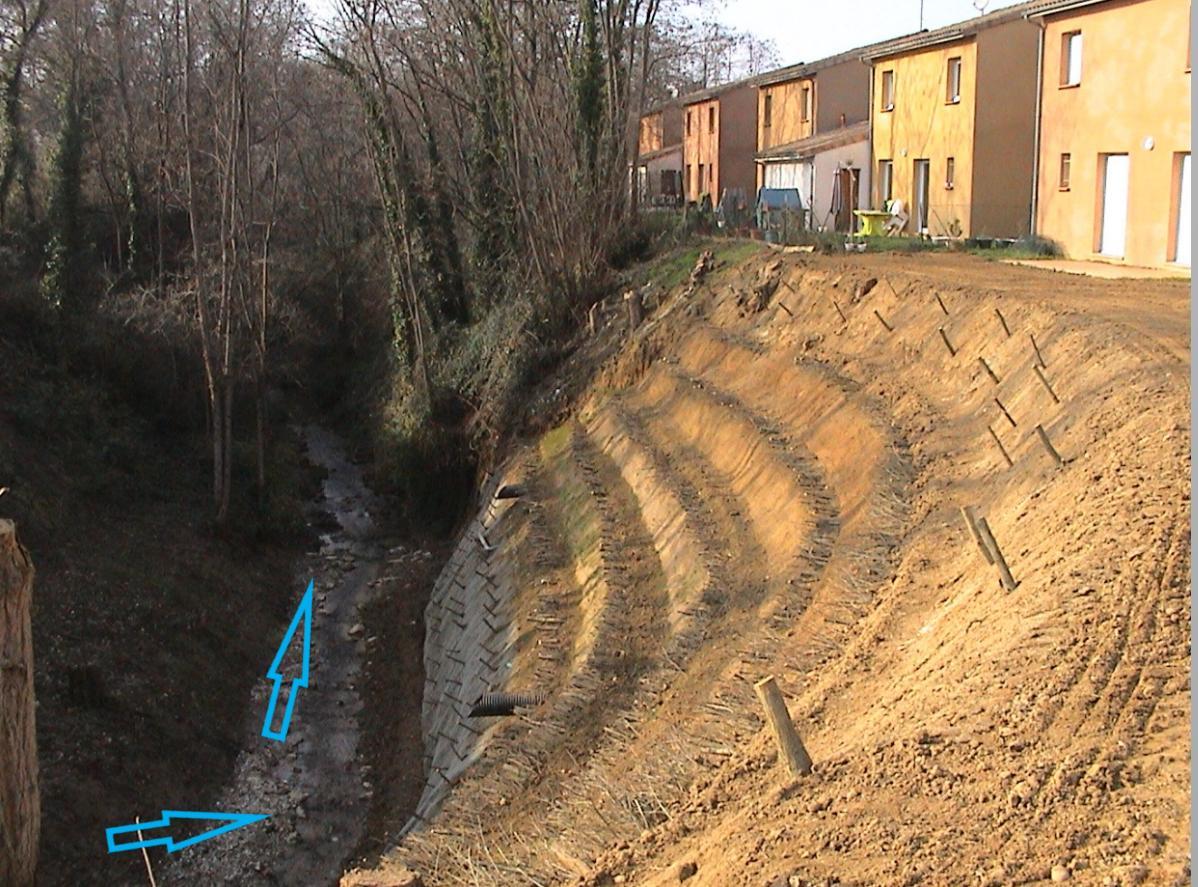
Completion date: Pictures taken March 2012

Picture to upstream right riverbank

Same position but picture to downstream right riverbank

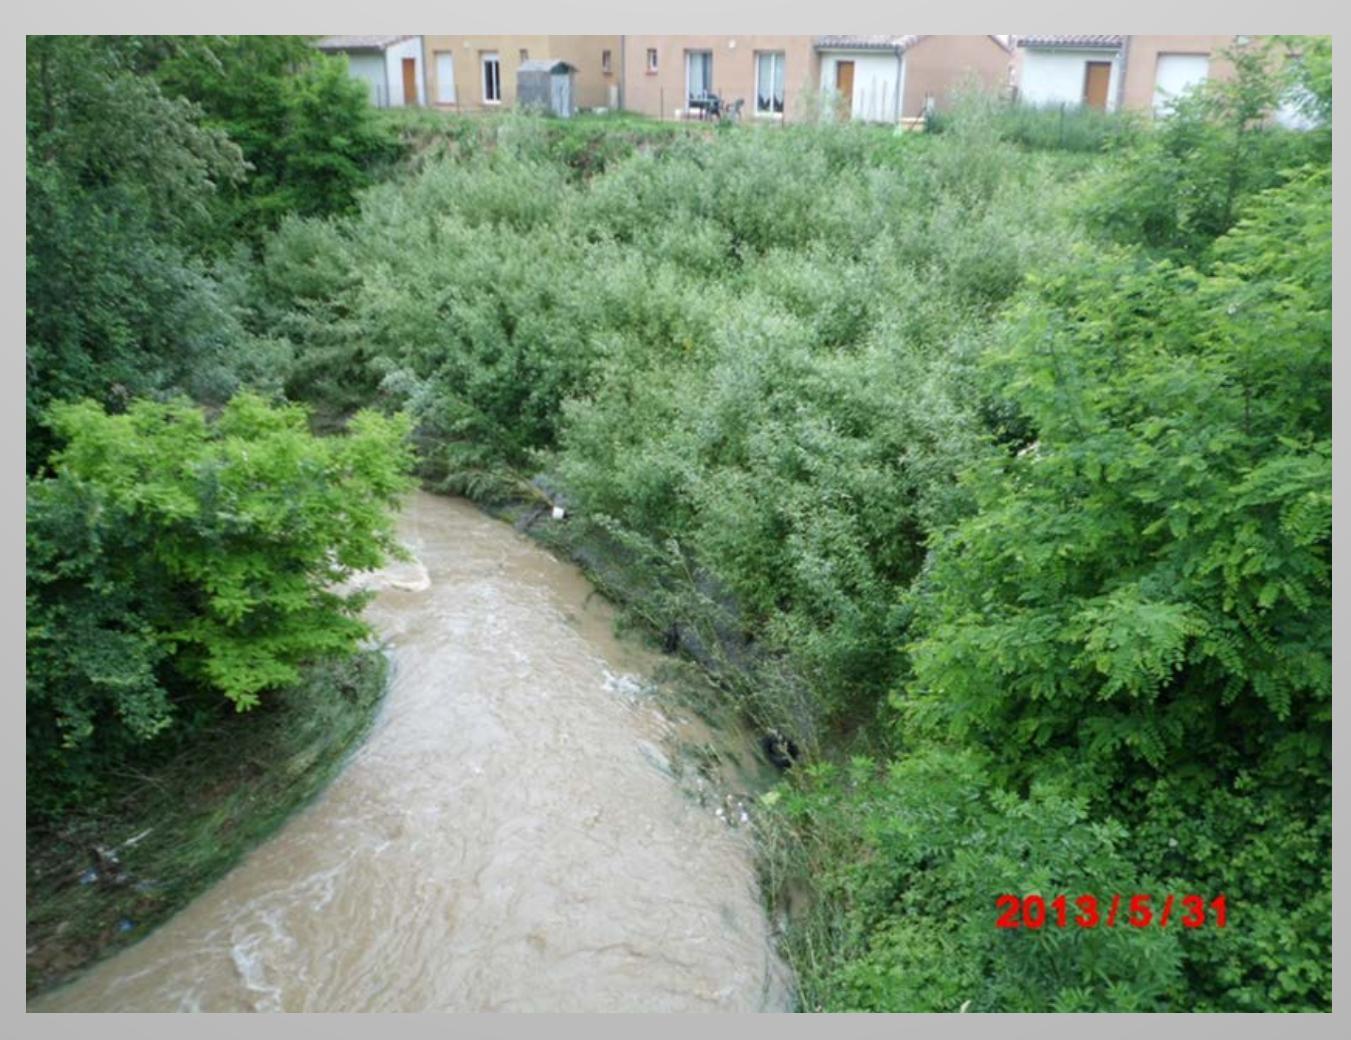
Lifetime monitoring: Shrub stratum condition during a small 1.50m high flood one year after completion date in 2013

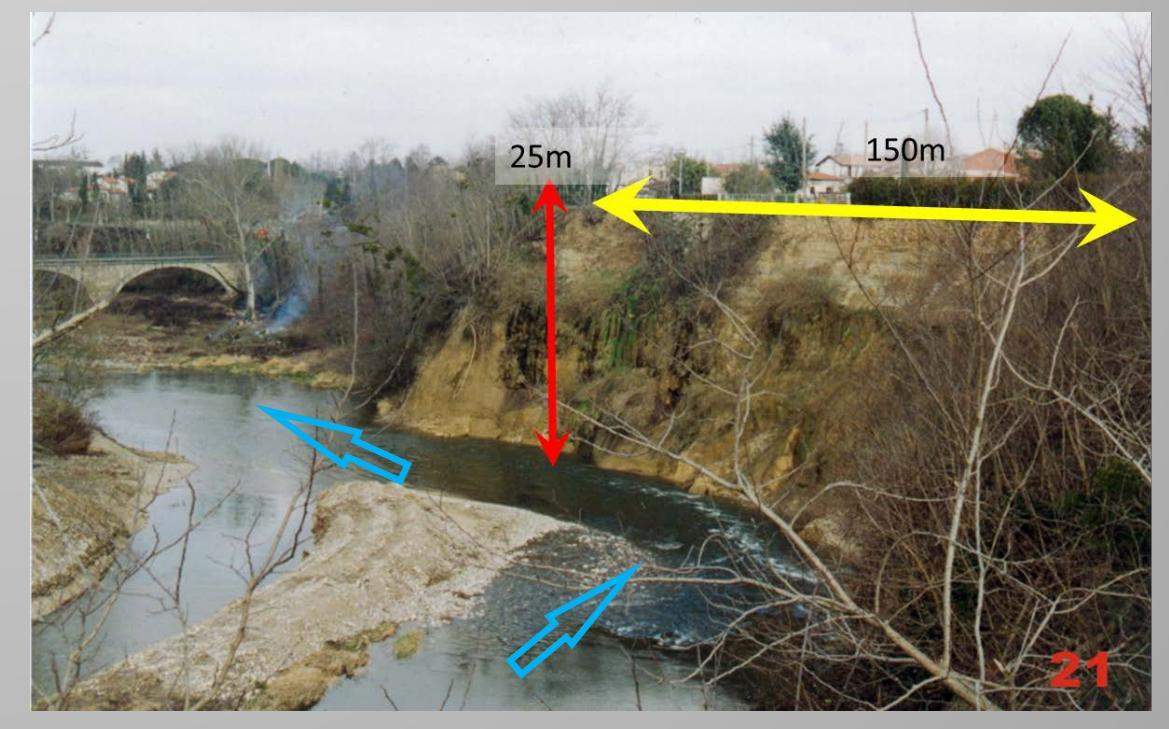
View to breaking steep wall due to riverbed shifting in immediate vicinity of houses and acces road in the year 2000

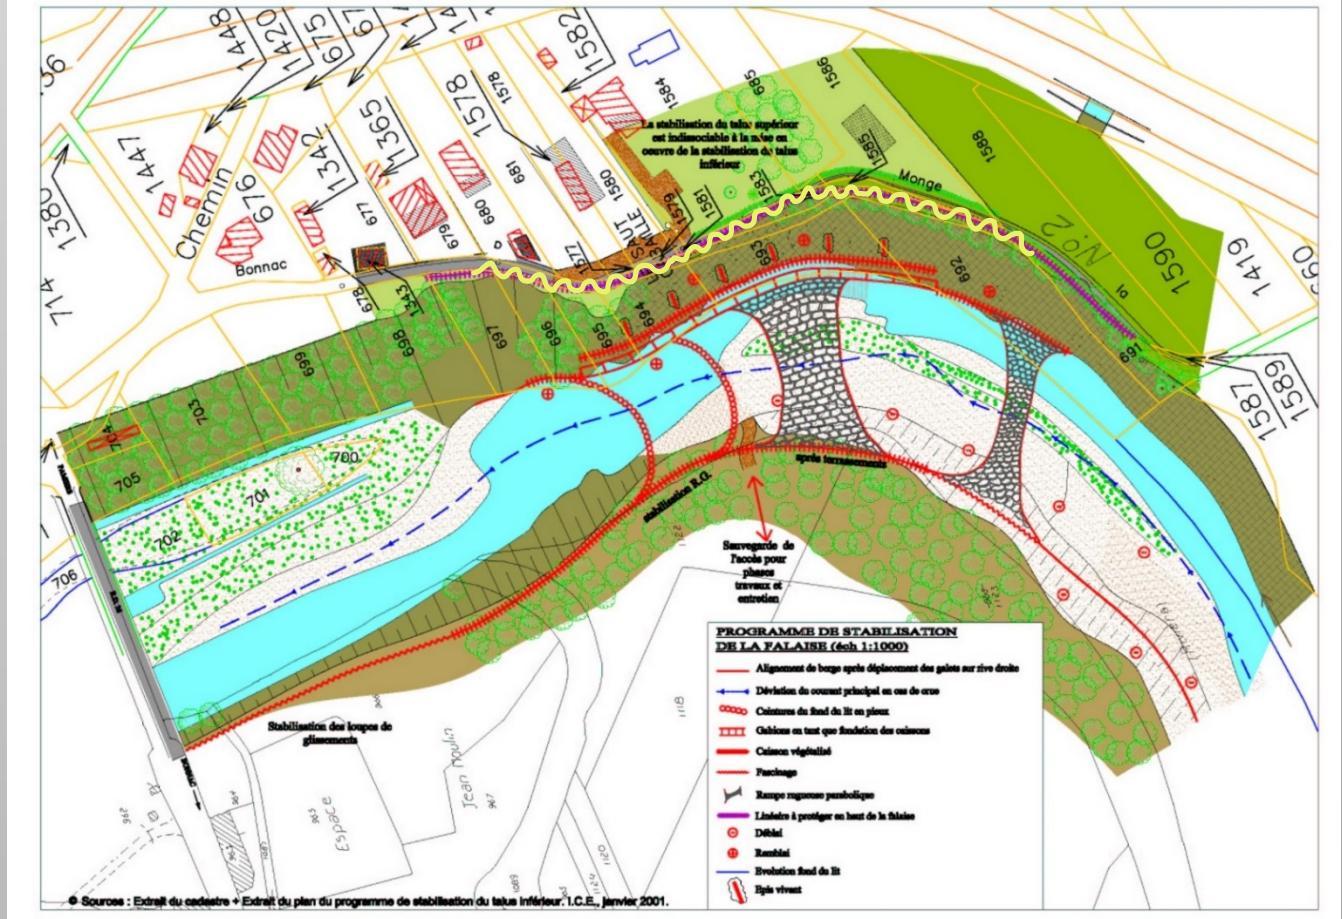
Longitudinal works on left and right bank: Scouring protection by vegetatif reinforced timber Krainer wall on gabion foundation, brush layers, willow piles, chemically untreated

Transversal works: 3D rough blockstone ramp, timber ram belts

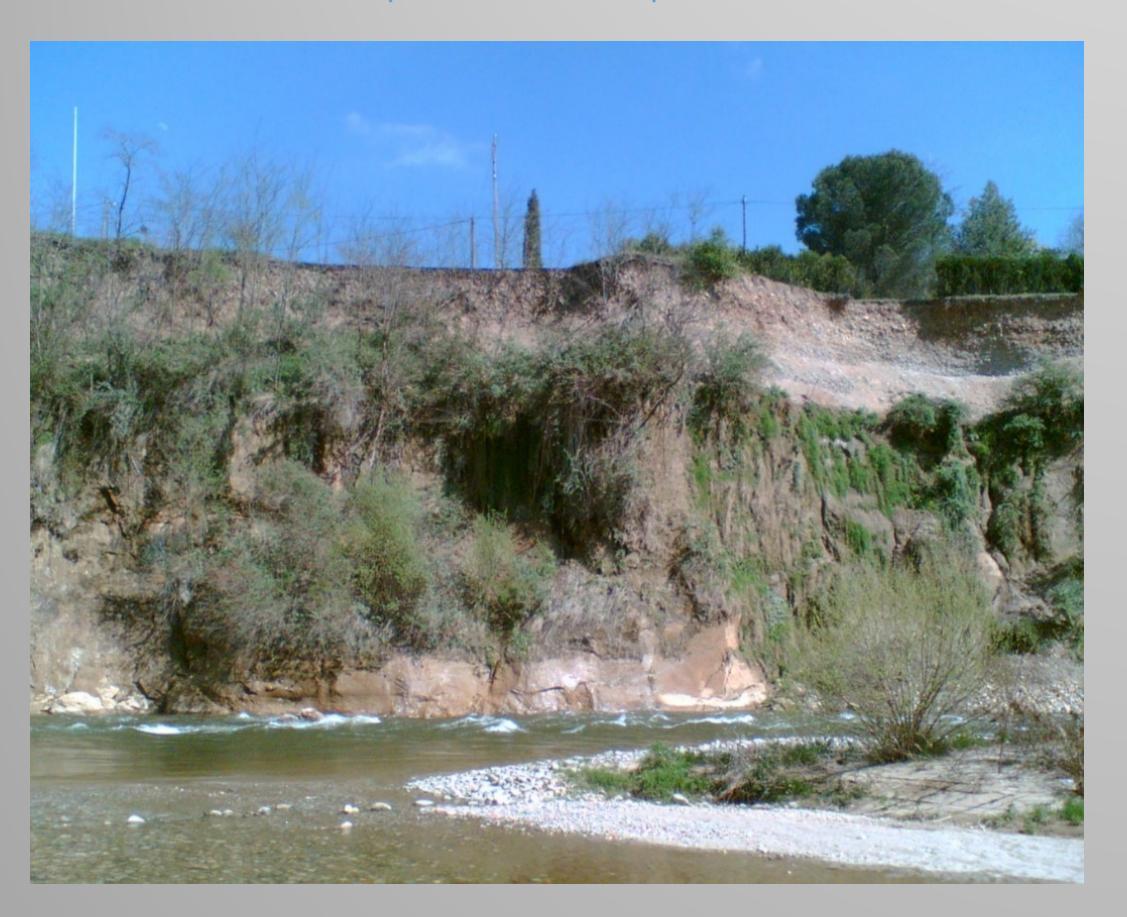
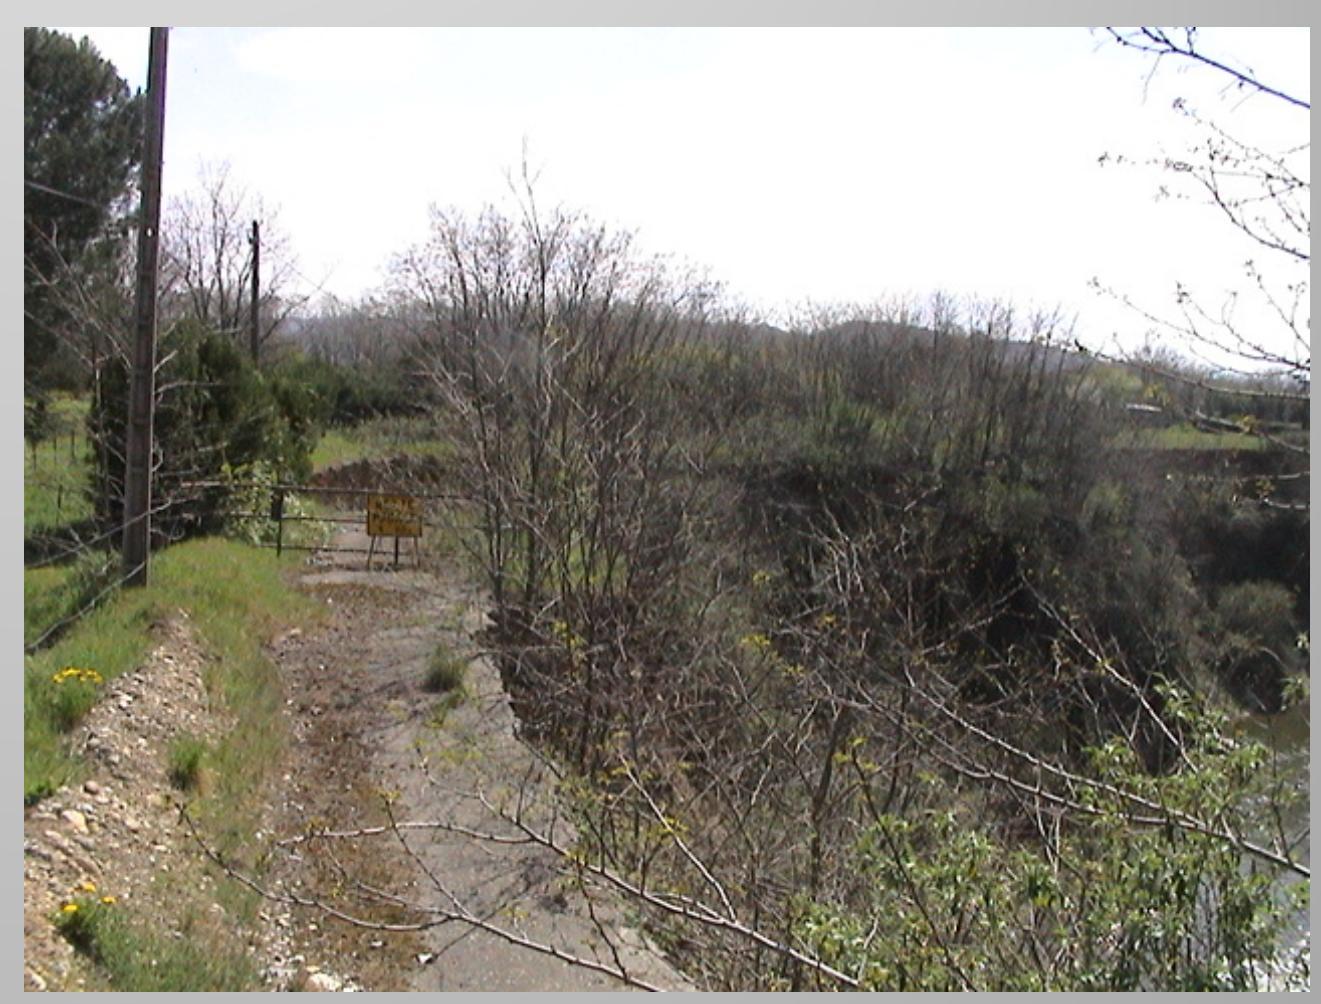
Pictures left and right: View to pathology of the access road on top of the escarpment in 2006.

Collapsed cliff edge in 2006

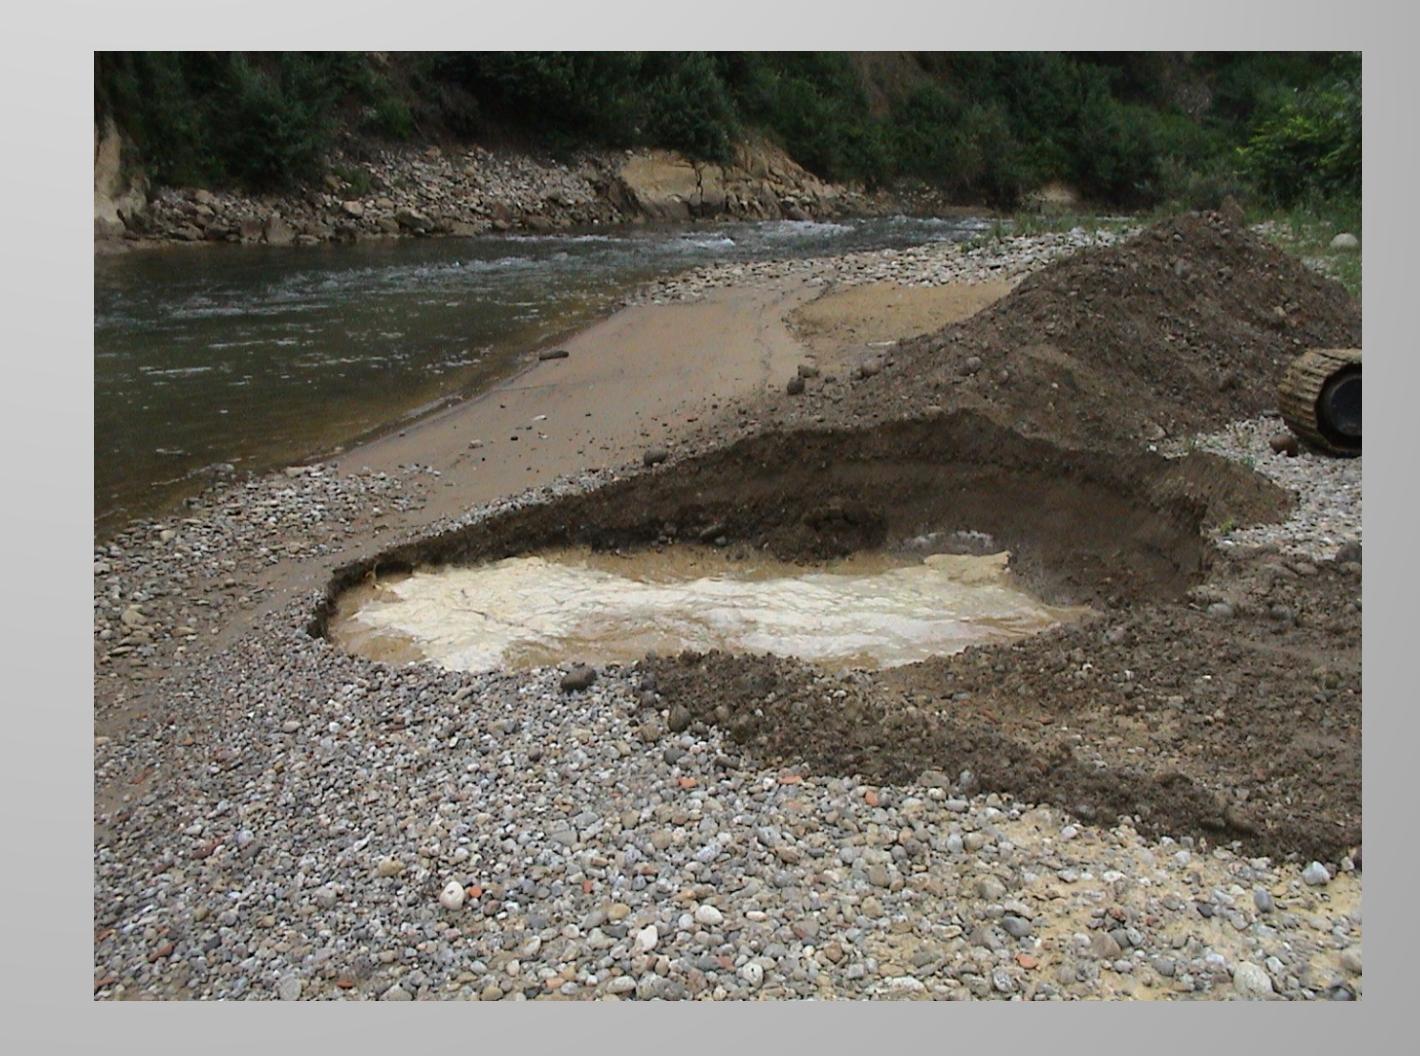
Our ongoing river bed survey in 06/2006 to obtain alluvium and subsoil parameters

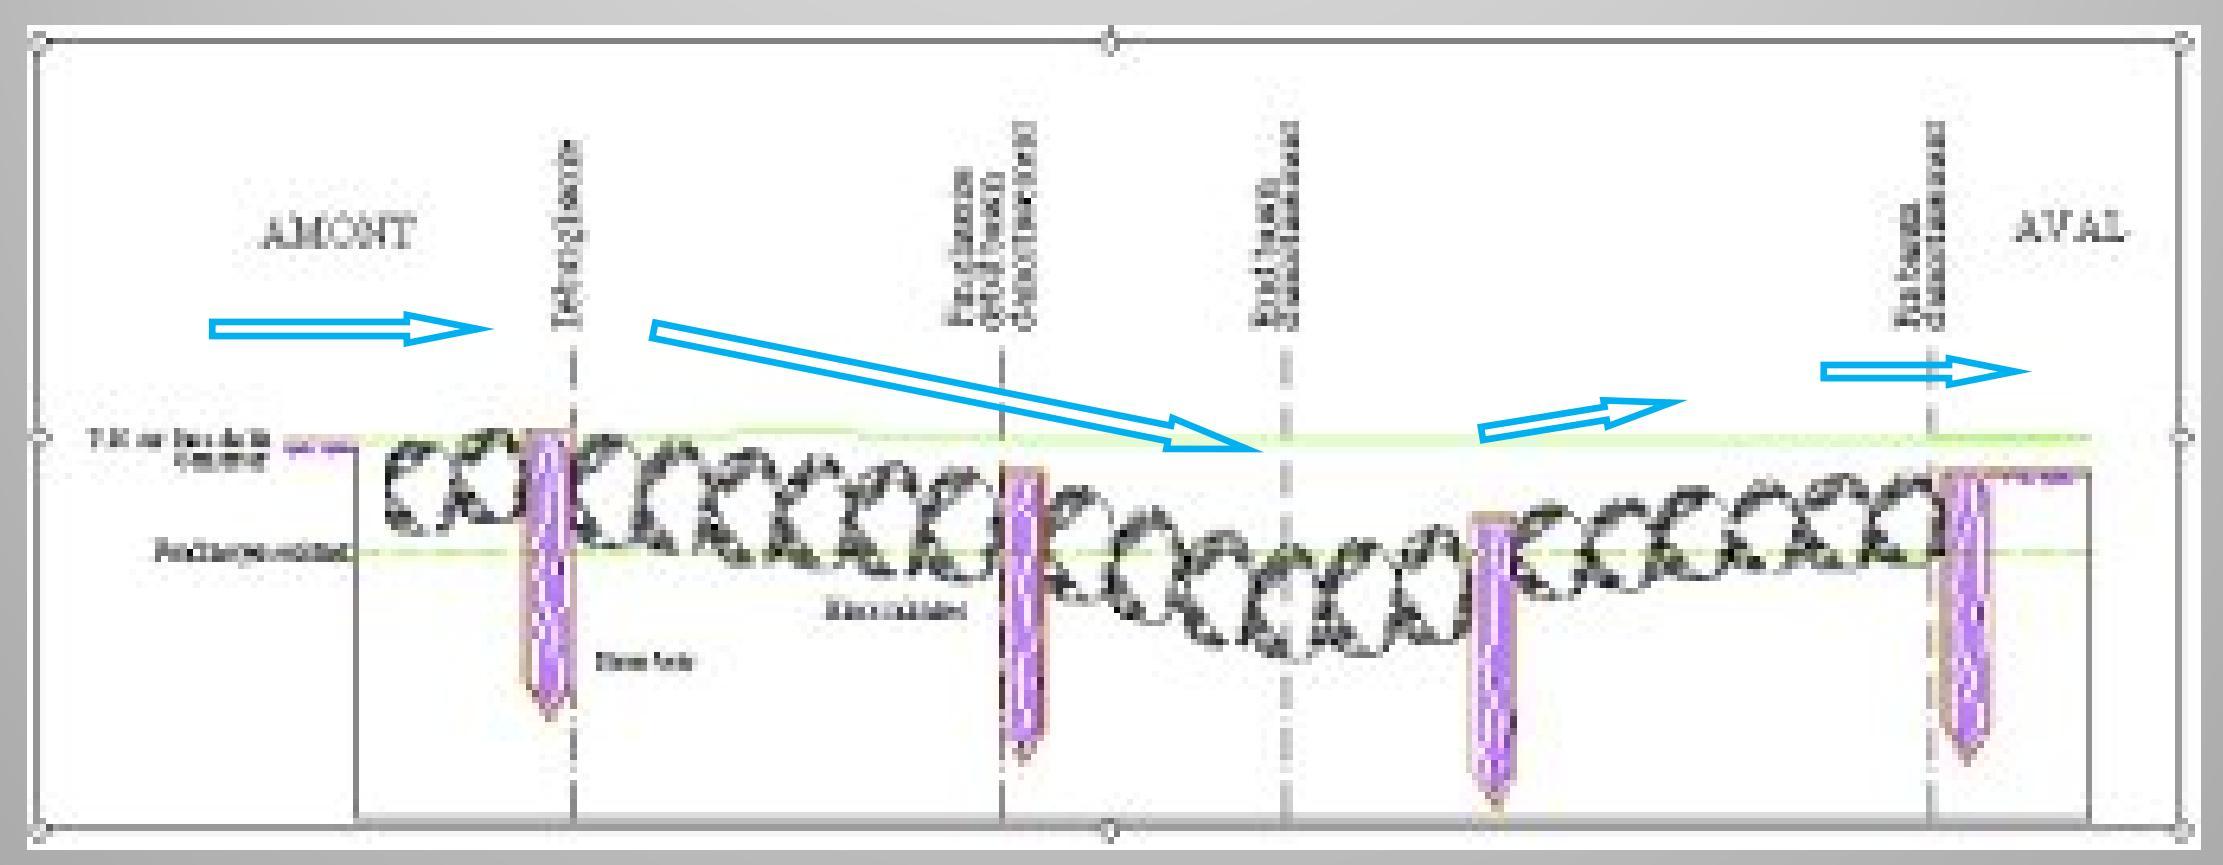
Design principle of the hydraulic blockstone Rough Ramp shown by longitudinal profile – Hydraulic assessment was made during preliminary-studies stage

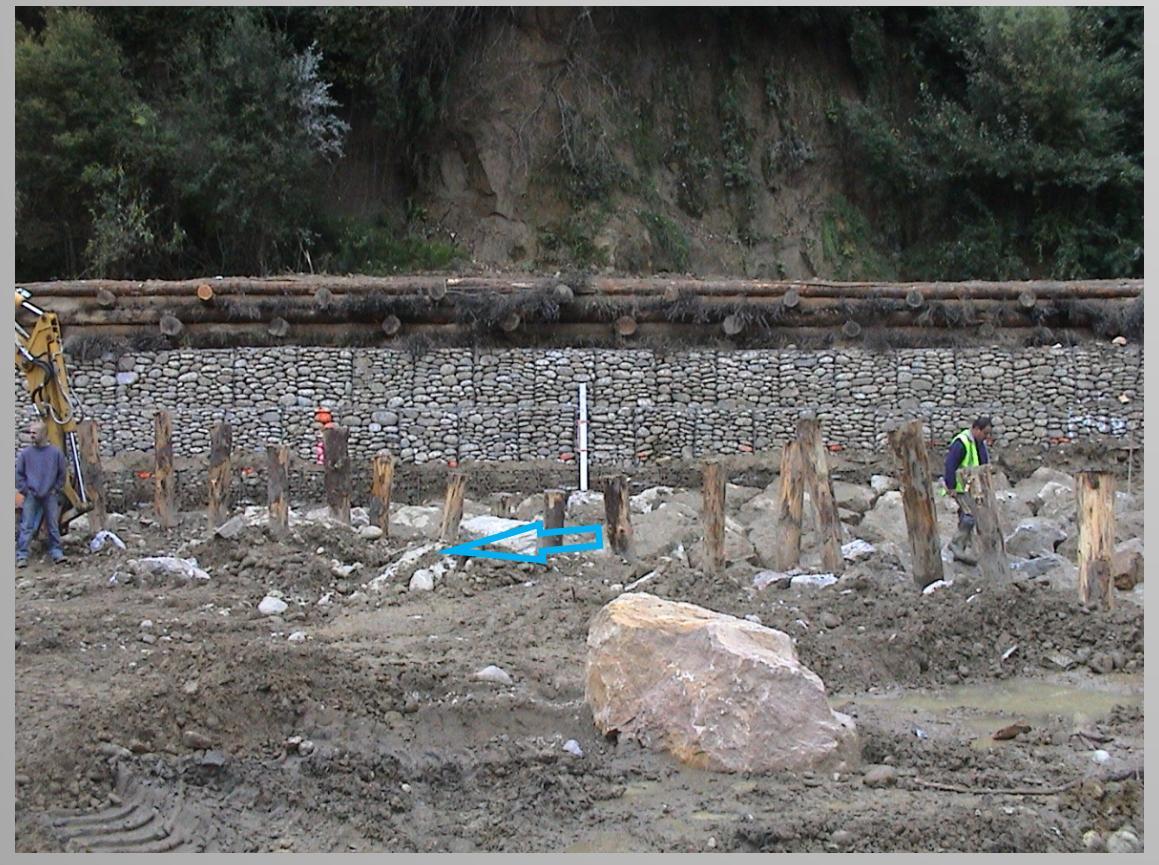
Background of right rviver bank : Greened Log Cribwall called « Krainerwand » construction work is ongoing

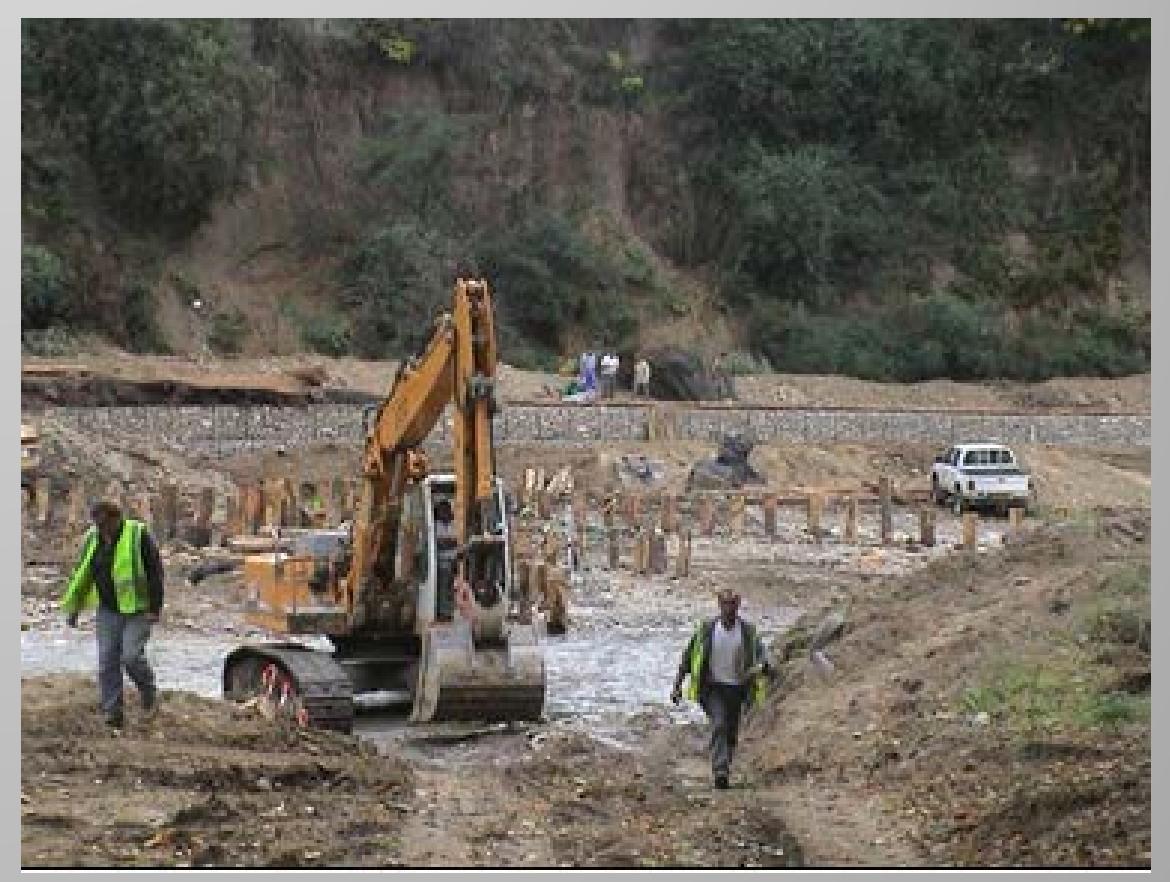
Foreground of right rviver bank :Hydraulic rough ramp construction work by timber pile driving is ongoing Ariège runoff is shifted to left river bank !

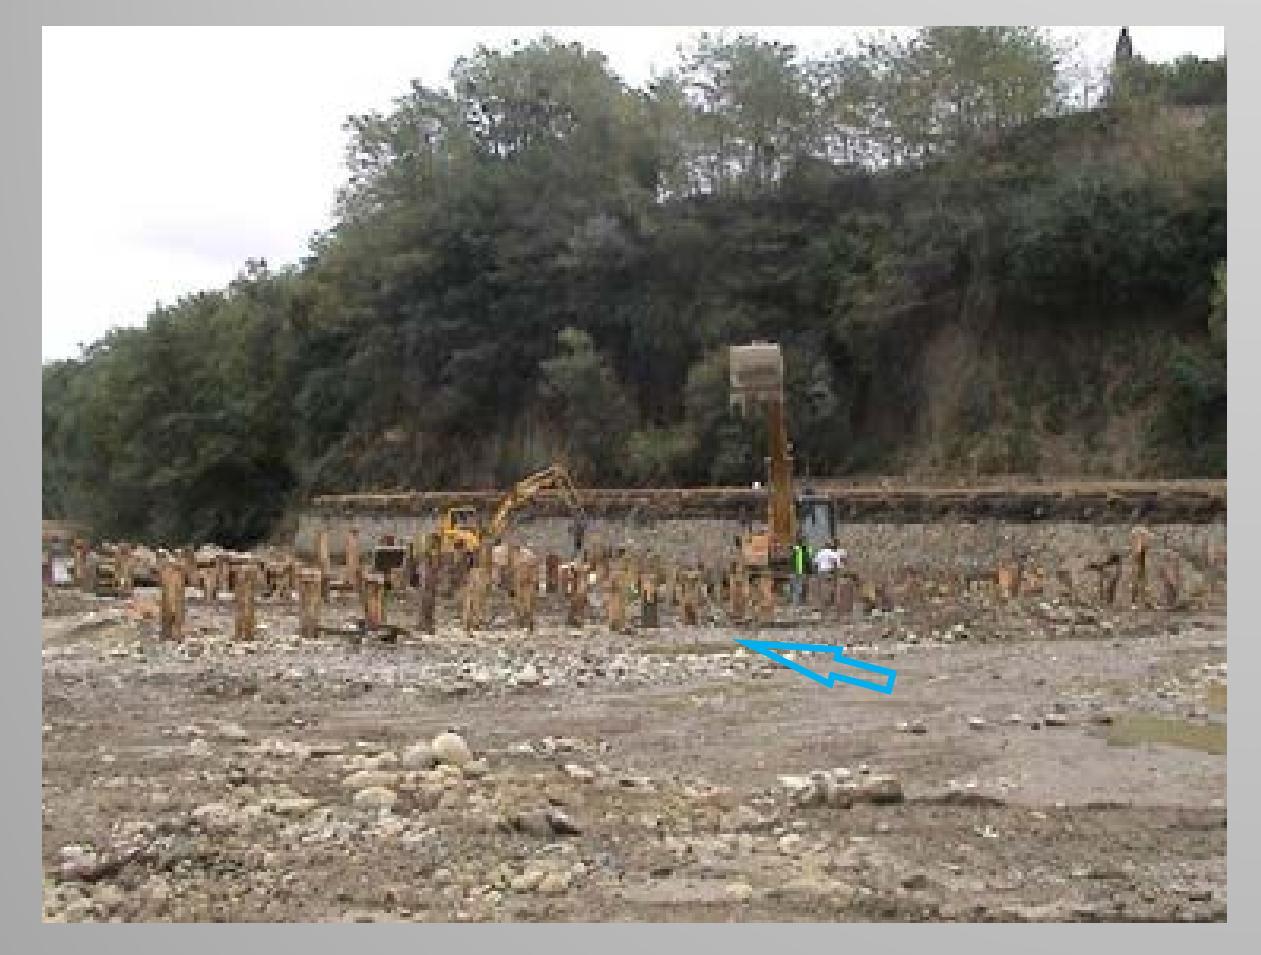
Work progresses in minor river bed from right bank to left bank

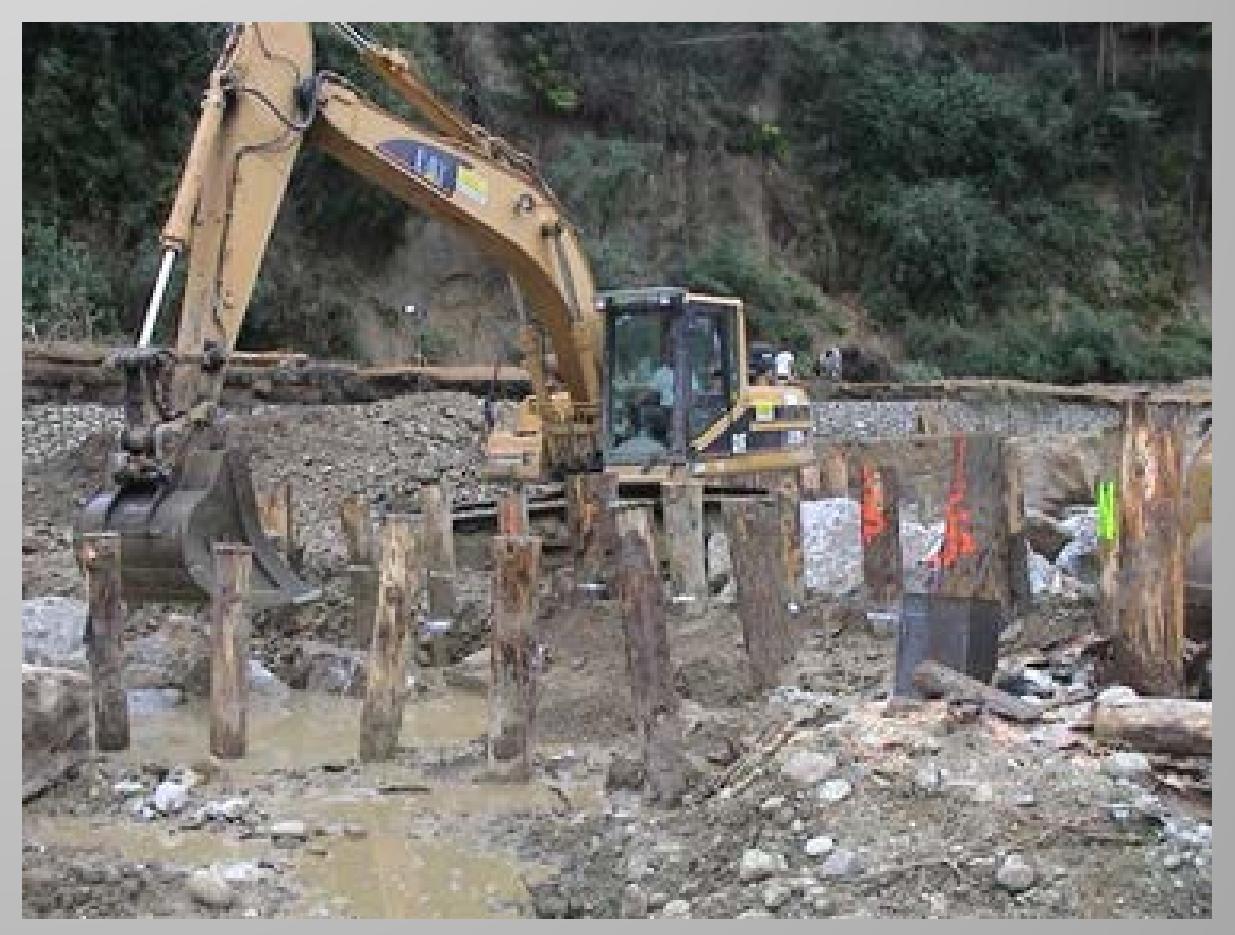
Pile setting is required for reinforcing RipRap blockstones
