"NbS and combined techniques - Case studies of steep bank stabilizations in the Garonne water catchment area in France - Constructions in very close proximity to residential areas and infrastructures"

EGU General Assembly Vienna April 2023

Case study 1) 1999: Hers Vif River – 120m Rehabilitation work of River embankment Construction time 3 months – Pre-tax costs 75.000 € (64.500 £ 10/2016 rate)

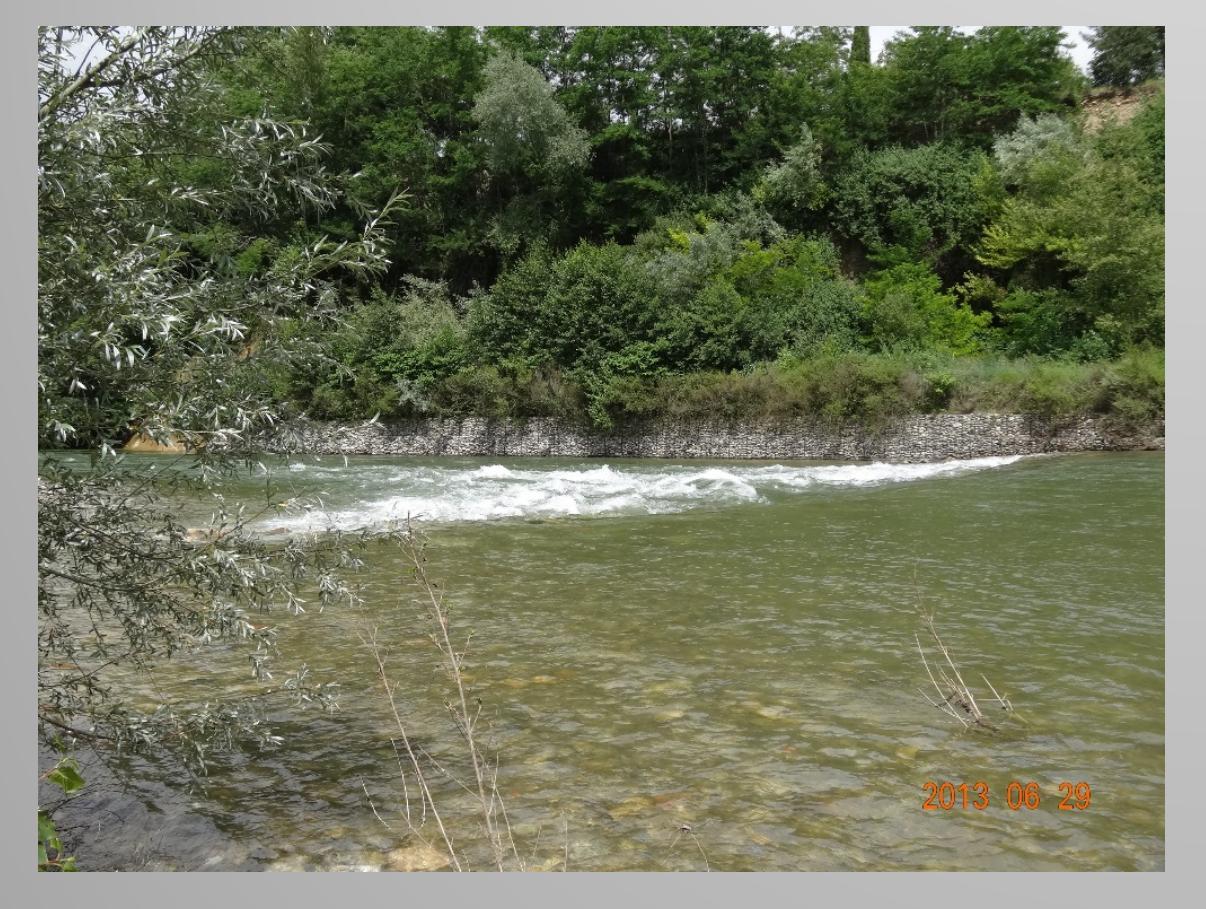
Gabions, timber cribwall and hydraulic rough ramp designed with a bypass for canoes/kayak sporting

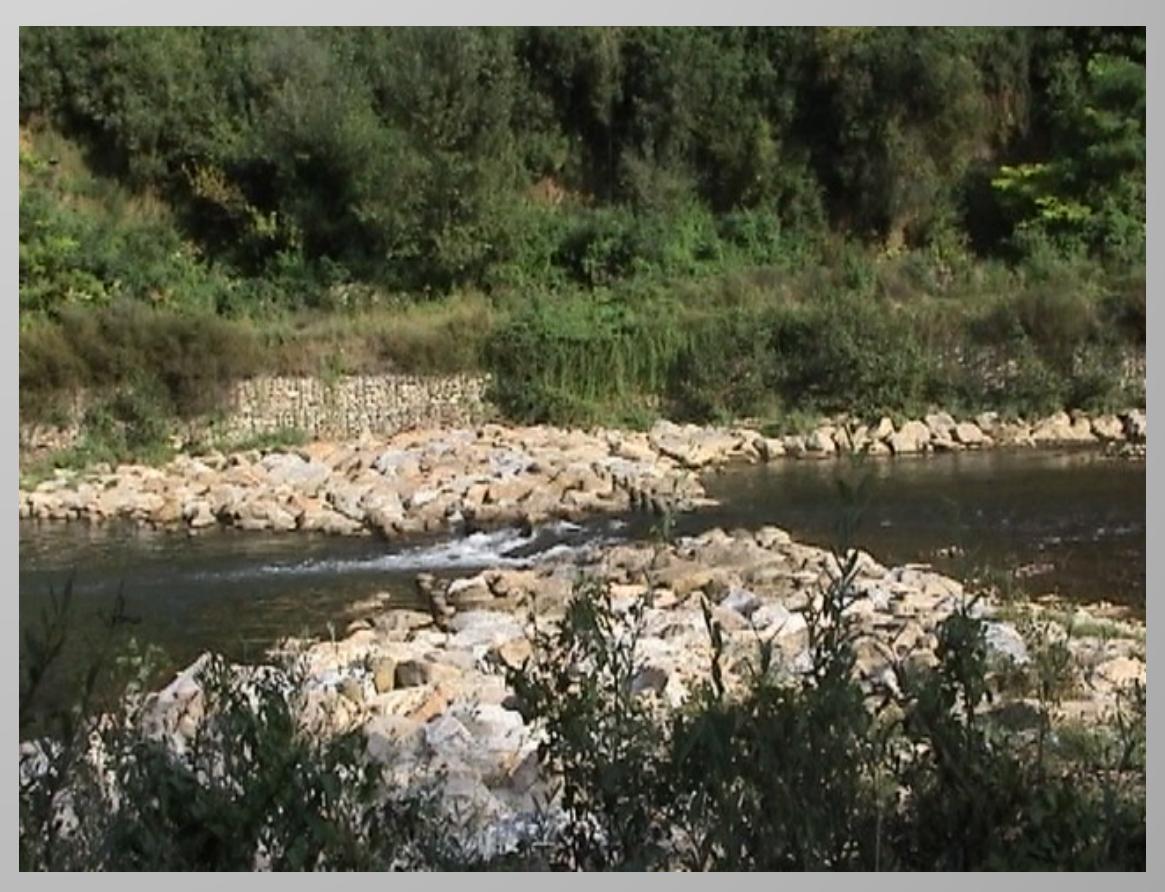
Transversestream picture taken in October/November during low runoff

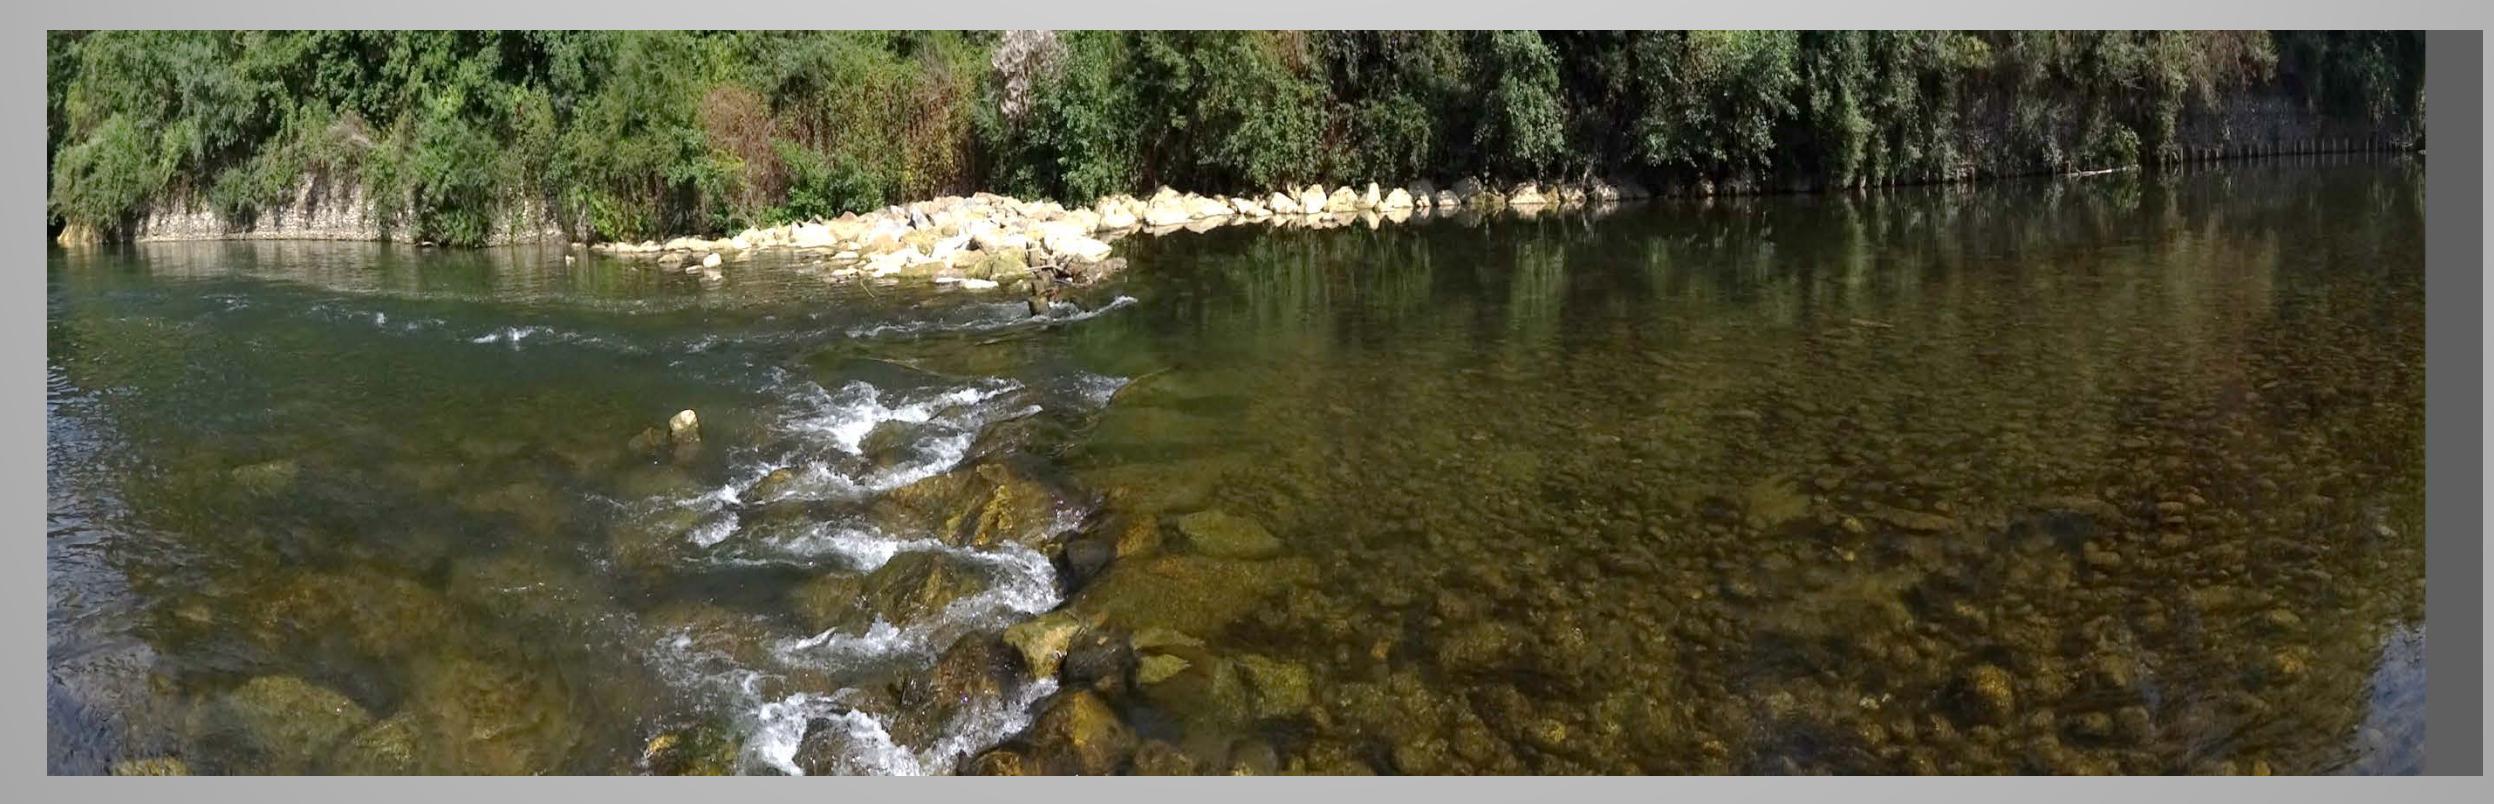
Here panoramic view of the rough ramp in September 2016. The intended raising of the underwater river bottom by about 40cm in the upstream can be seen well from the gravel granulation

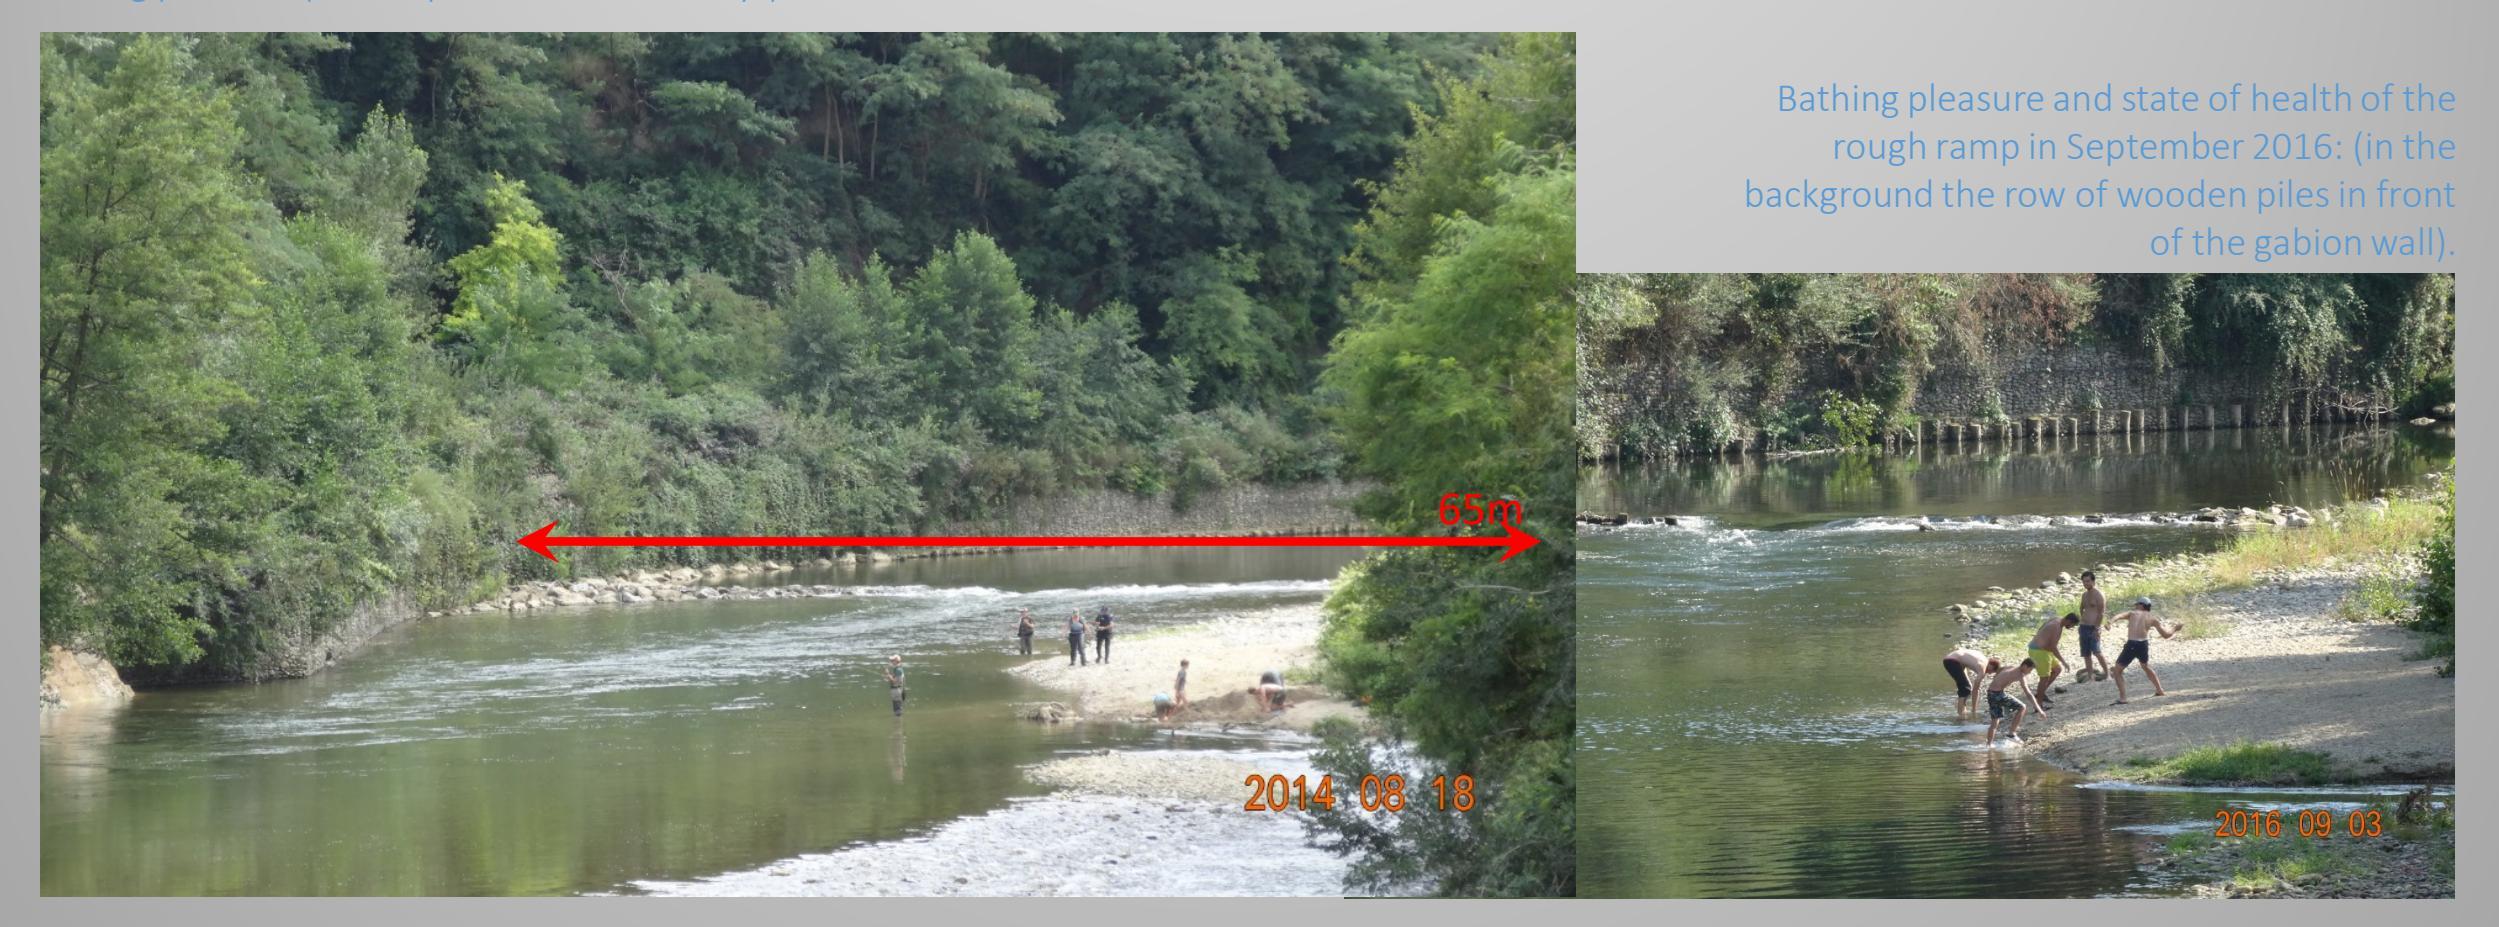
State of health of the 65m wide hydraulic rough ramp in August 2014: Fishing pleasure (>>free permanent O2 entry!)

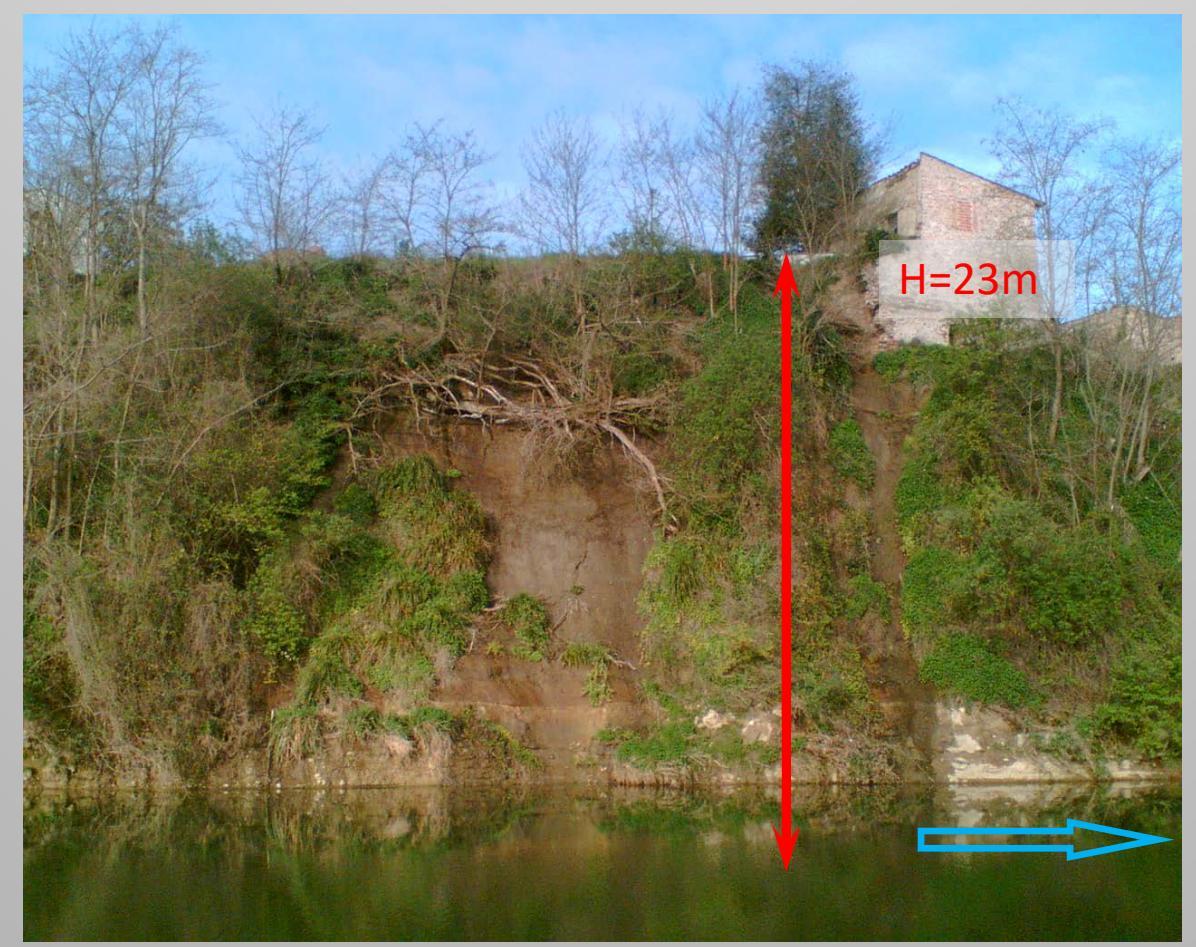
Condition of limestone cliff site in 2006: several detached areas and others with potential for collapse

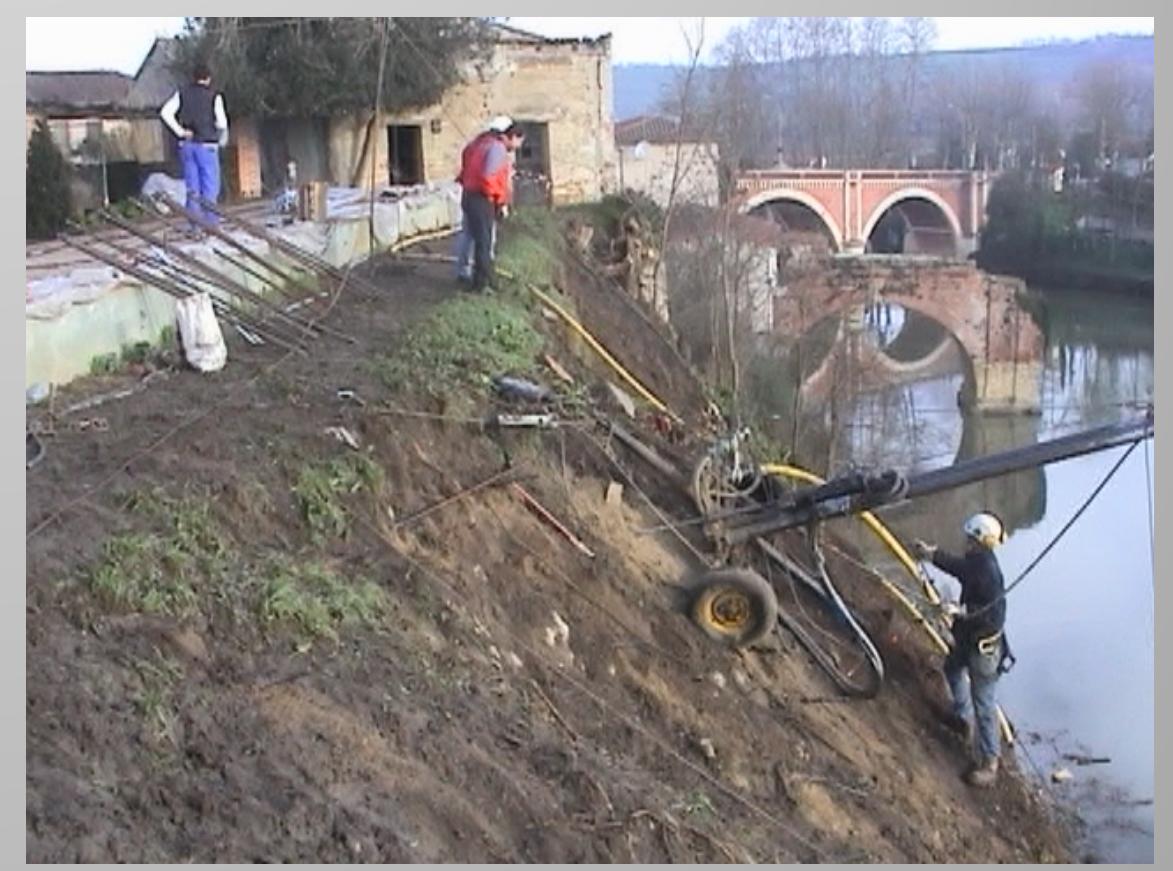
Ground anchor preparation for reinforcing upper cliff

Implementation of 7-m-long ground anchors by drilling and concrete injection

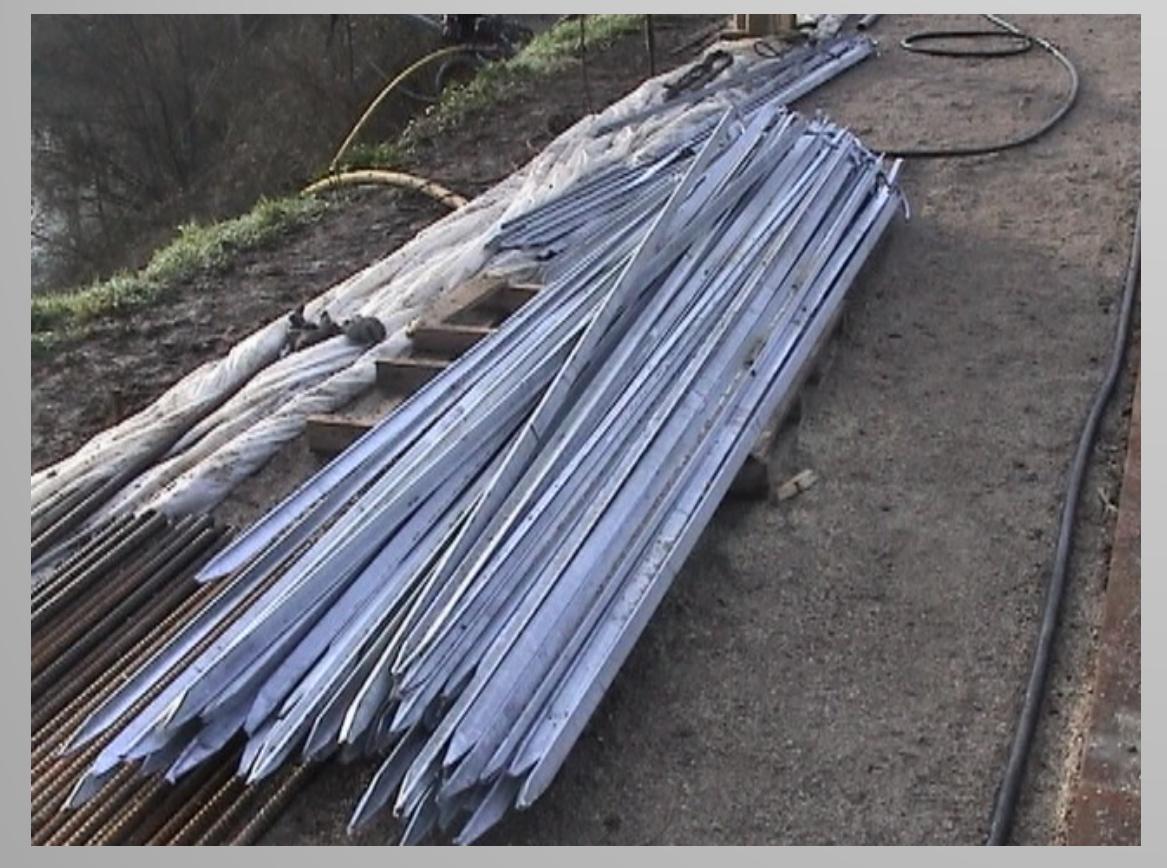
Anchors for tightly placing the 3D steel structure onto the purged steep slope, sizing in accordance to geotechnical survey results

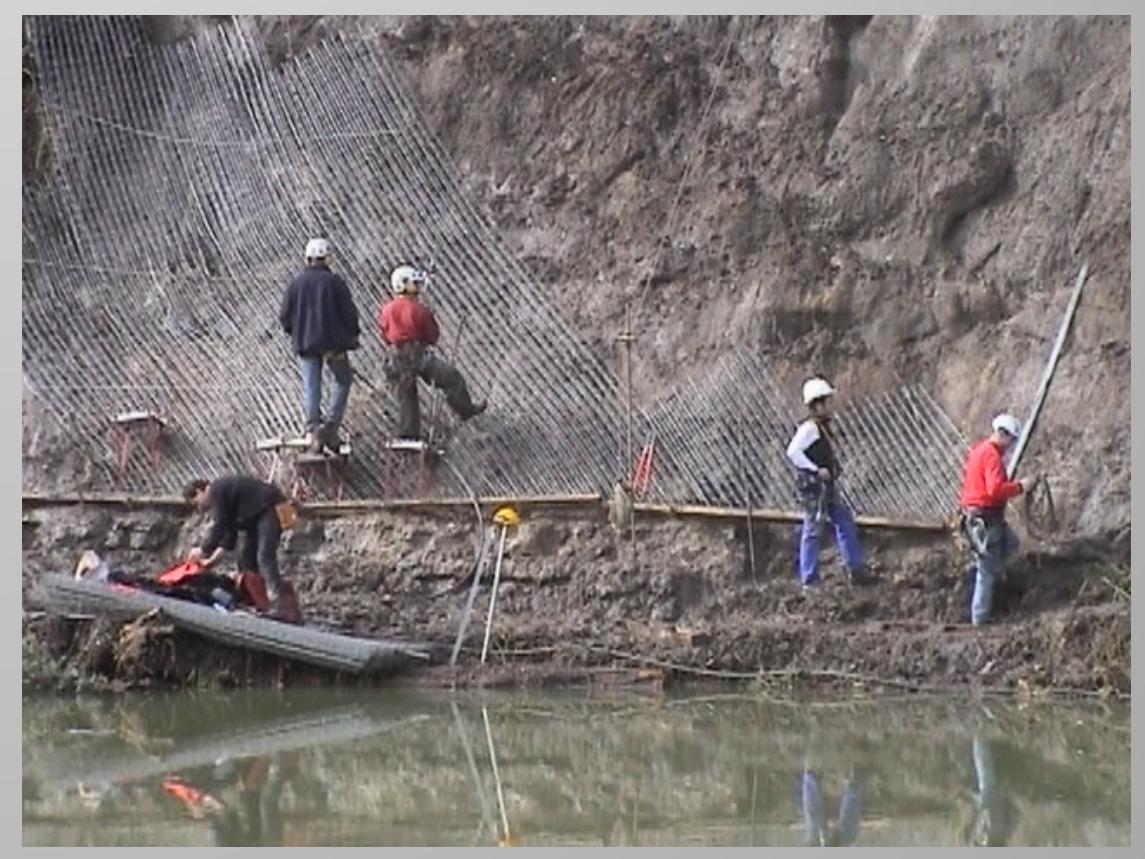
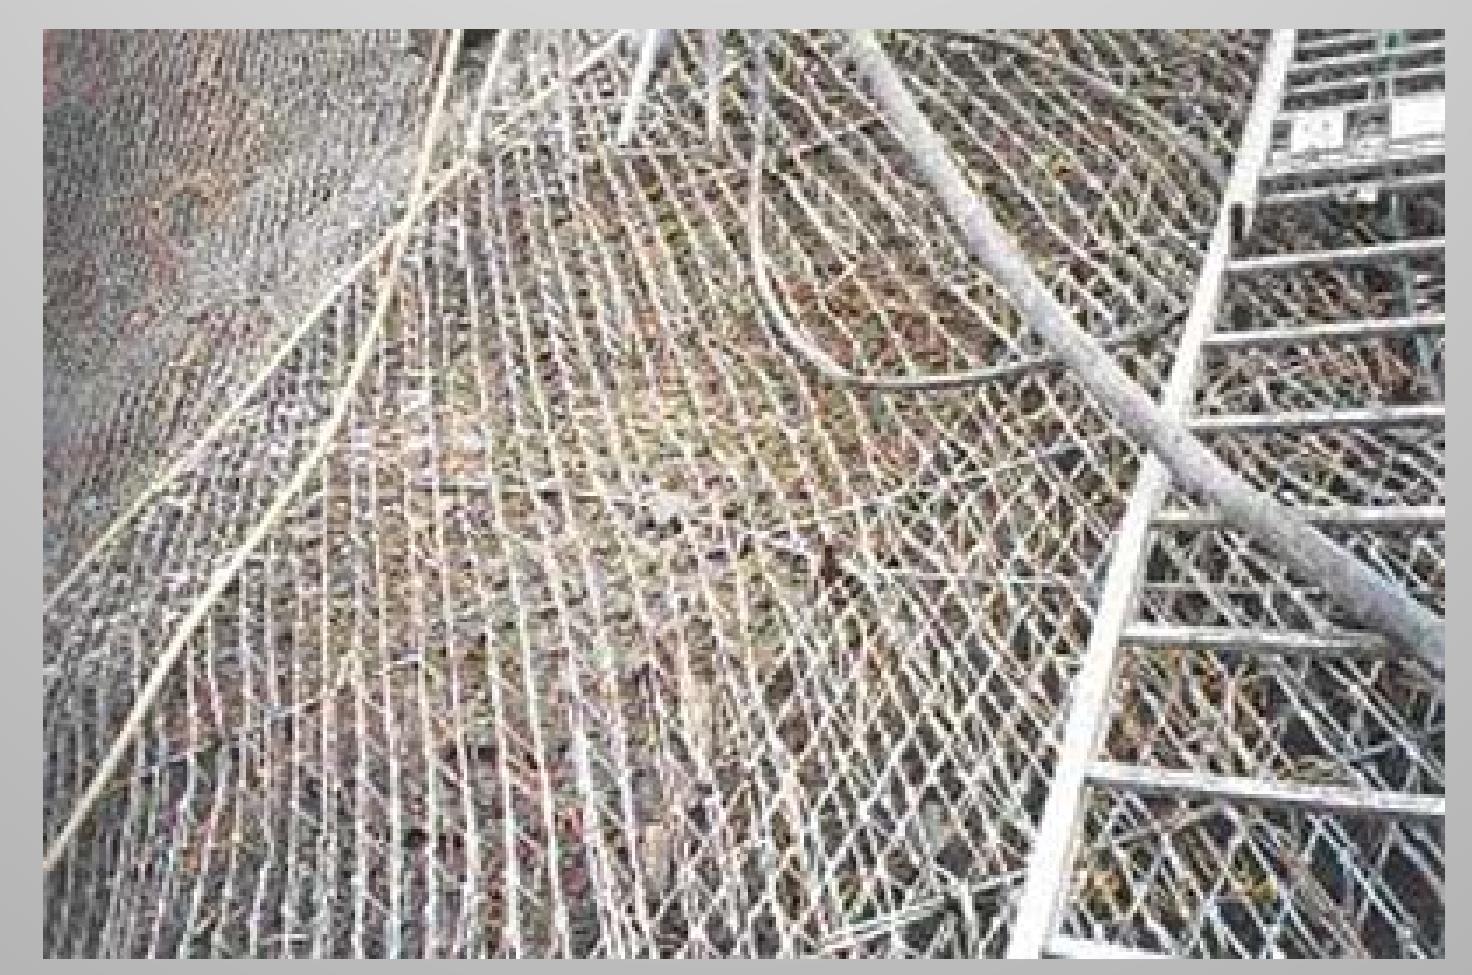
Implementing 3D KRISMER steel structure panels

Detail of embedded 3D KRISMER steel structure panel: fixing system by steel cables, themselve held by anchors

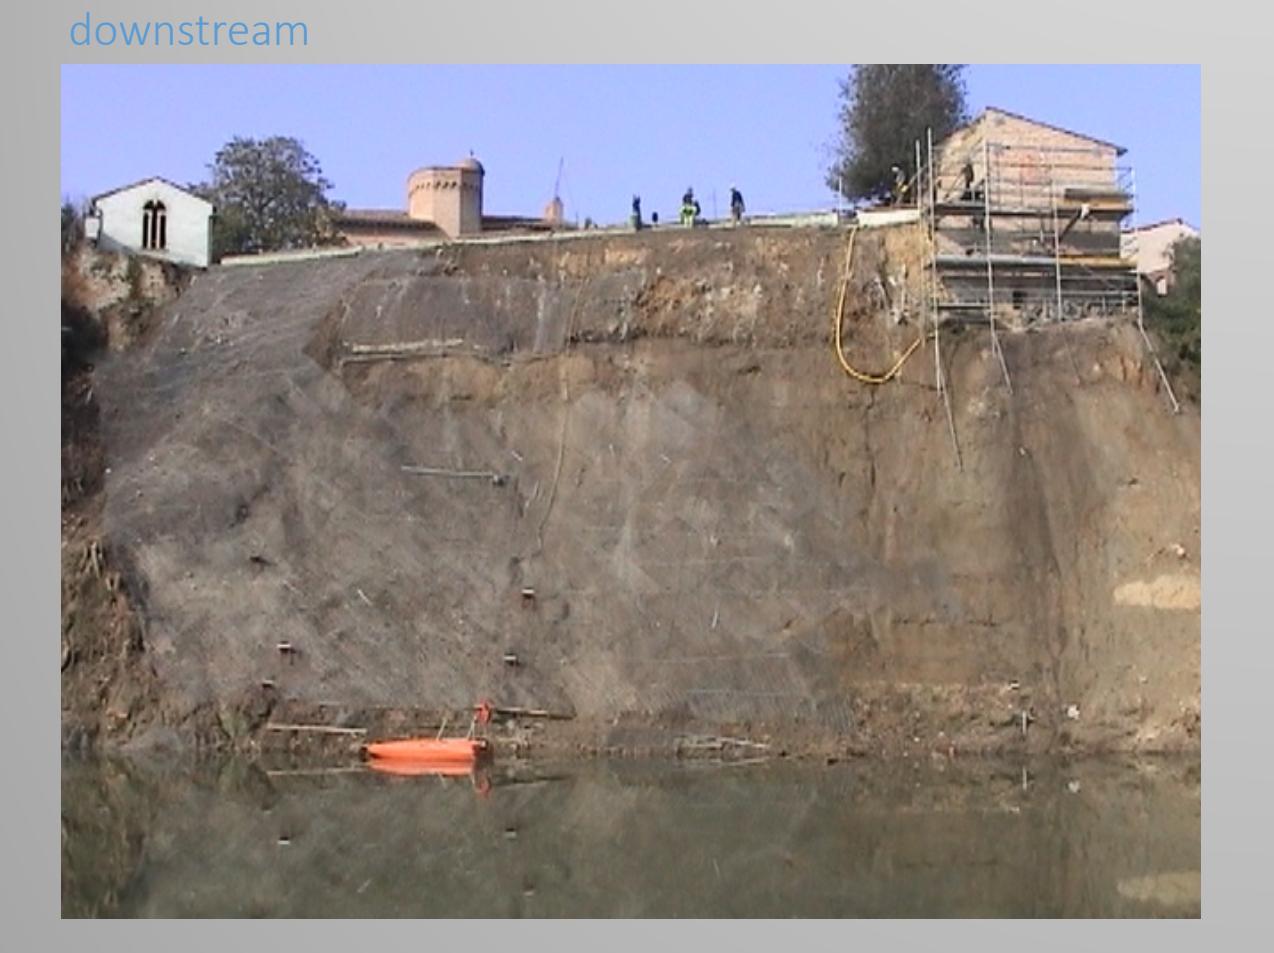
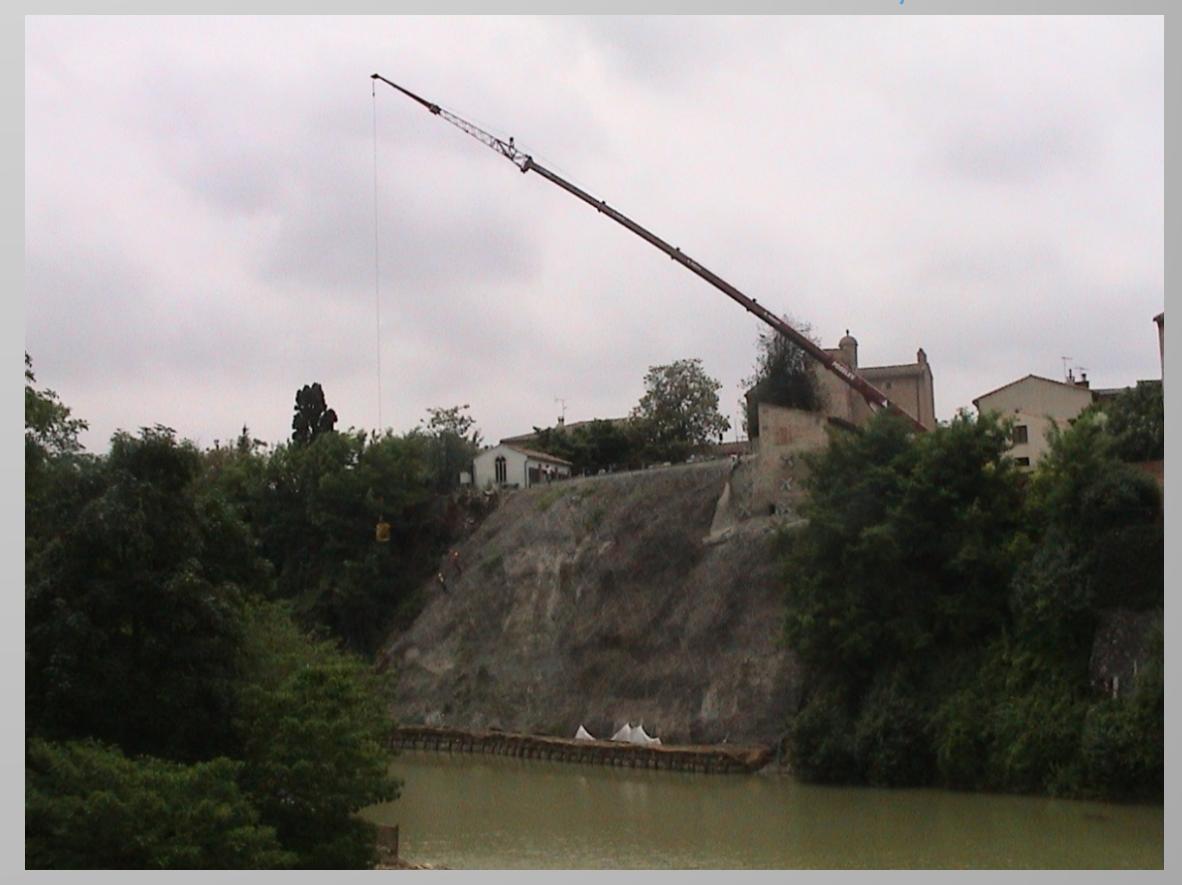
Installing steel structure in progress from upstream to

Filling the 3D steel structure with ballast using a mobile hydraulic crane

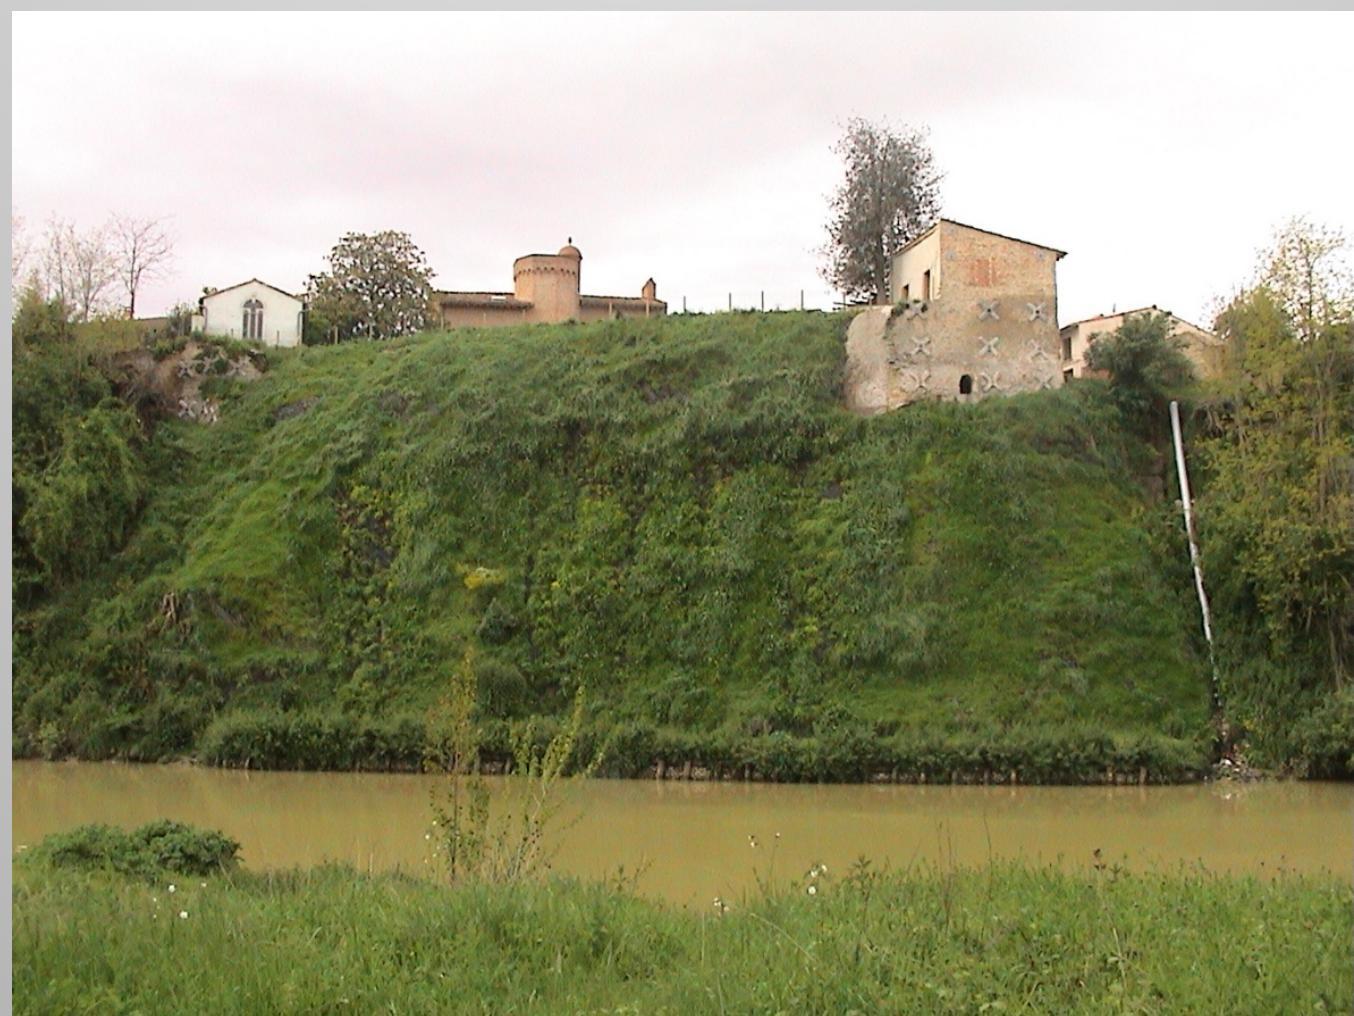
Cliff condition one year later after completion date (picture taken in April 2008)

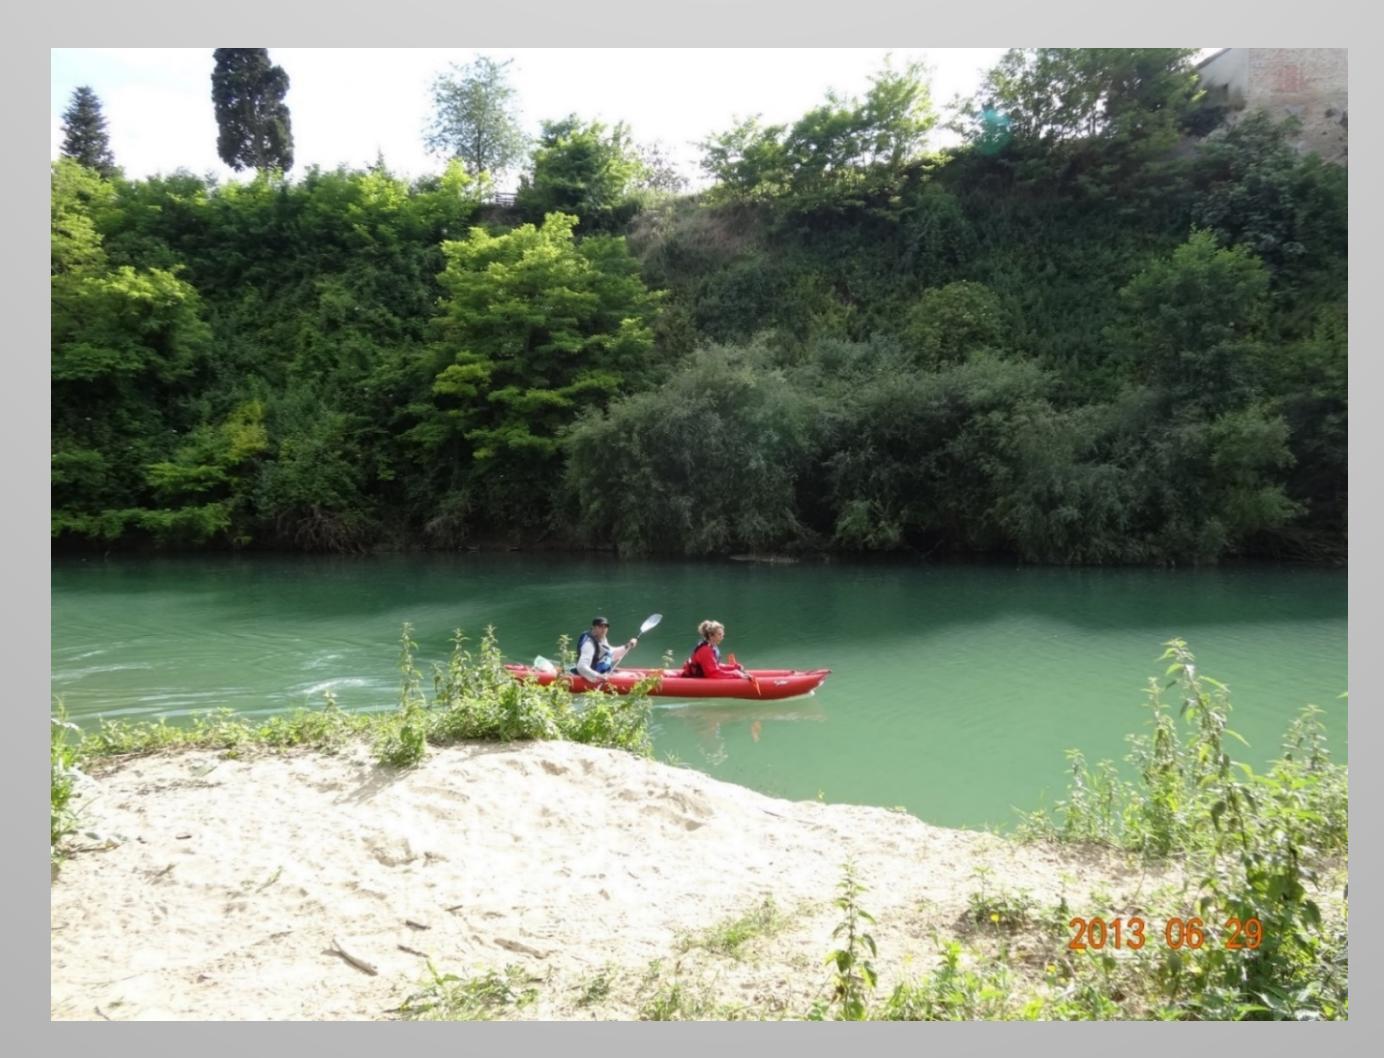
<<Growing vegetated log crib wall onto gabion wall

Cliff condition **5 years later after completion date** (picture taken in June 2013)
