# **Spatial diversity and time variability of erosion and accumulation processes on the unconsolidated cliffs of the Wolin Island (Southern Baltic - Pomeranian Bay)**

**Marcin Winowski, Zbigniew Zwoliński, Andrzej Kostrzewski  
Institute of Geoecology and Geoinformation, Adam Mickiewicz University**

Quantification of the  
sediment budget of  
unconsolidated cliffs of the  
Wolin Island in the years  
2013-2019

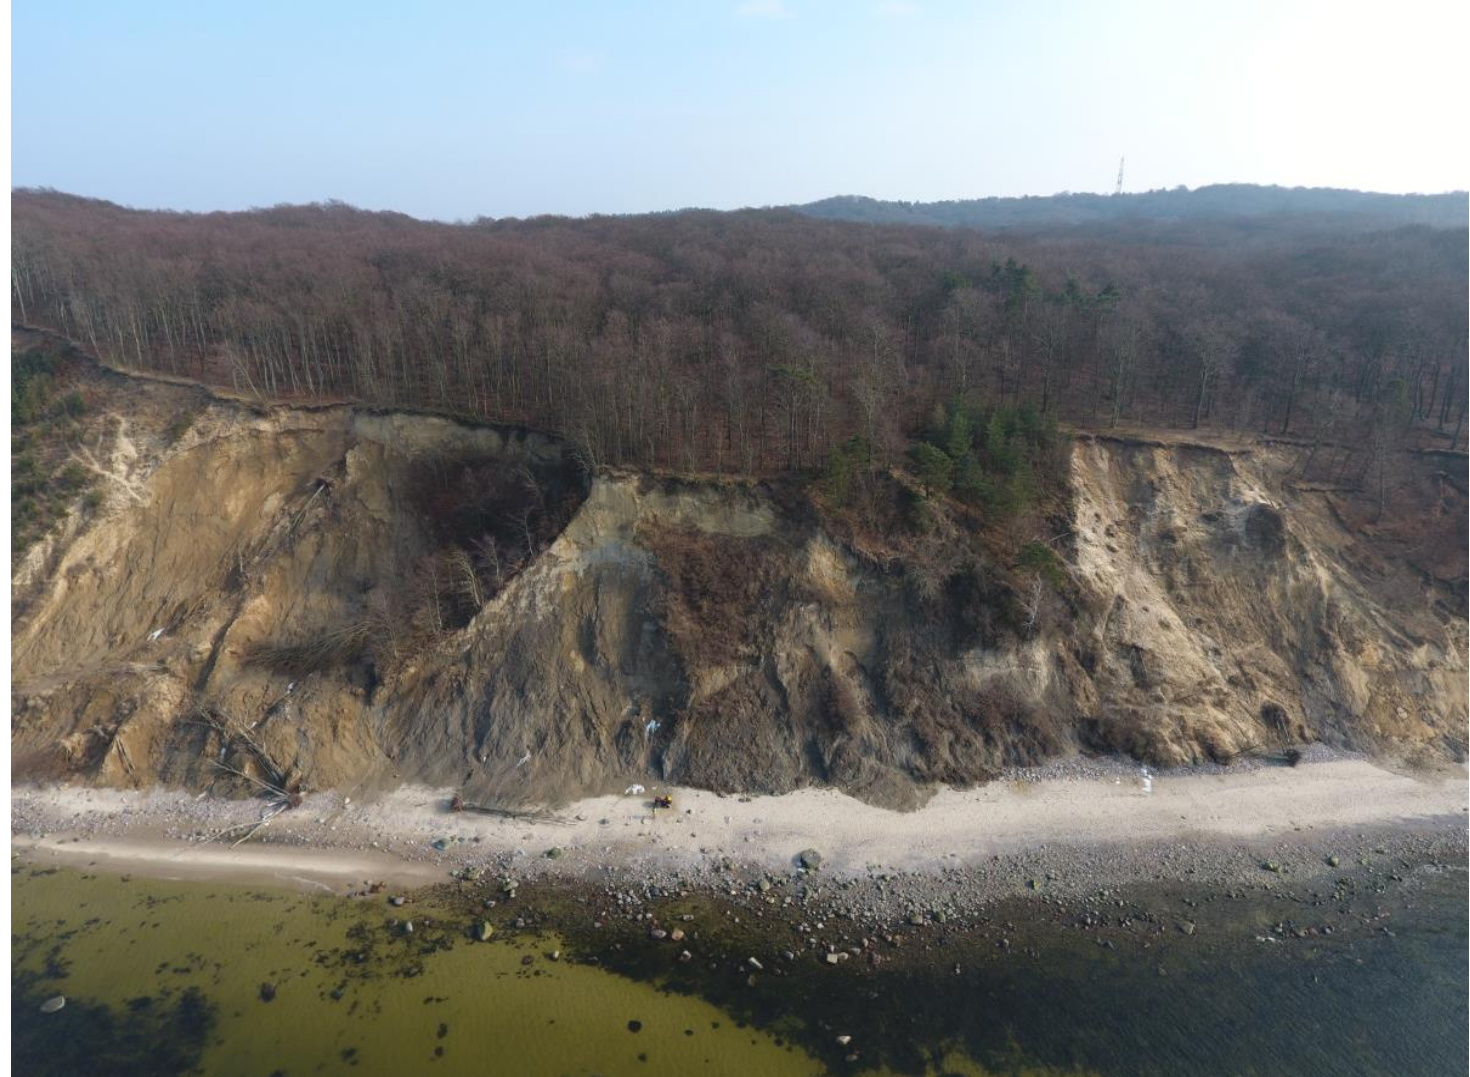
Moraine cliffs (Wolin Island, Poland)

- Slope  $< 80^\circ$ ,
- Resistance:
  - ✓  $\tau_{fu}$  - 100-150 kPa,
  - ✓  $\rho$  - 2,0-2,3 g/cm<sup>3</sup>,
  - ✓  $W_p$  - 10-14%,
  - ✓  $W_L$  - 14-23%.
- Low recession rate
  - ✓ 0,10 – 0,18 m/a
  - ✓ Long response time
- Weathering (30-40 cm):
  - ✓ Mechanical,
  - ✓ Chemical,
  - ✓ Biological.
- Clay flaking– susceptibility to fall

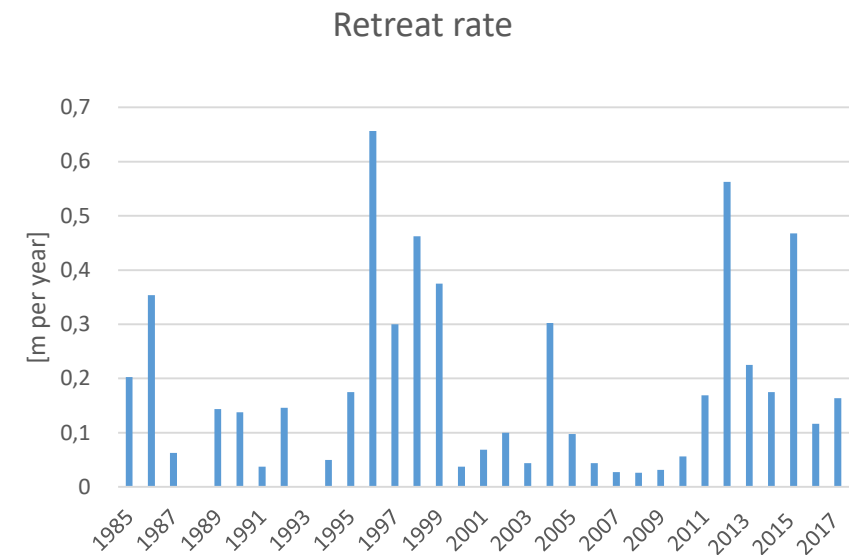
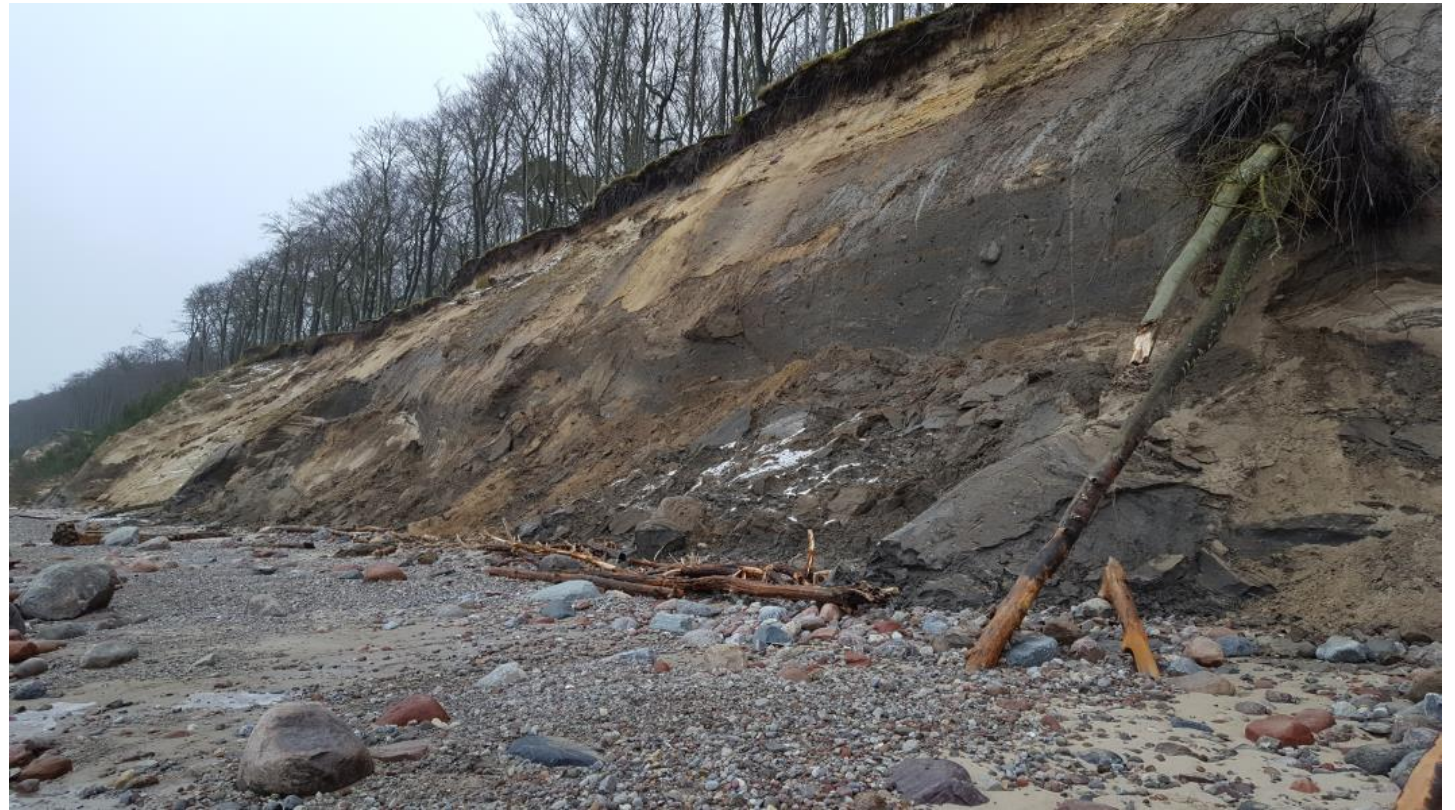
## Clay cliffs

- Slope  $<40^\circ$ ,
- Low resistance:
  - ✓  $\tau_{fu}$  - 40-80 kPa,
  - ✓  $\rho$  – 1,7-1,8 g/cm<sup>3</sup>,
  - ✓  $I_D$  – 0,2-0,6
- Short response time,
- High recession rate
  - ✓ 0,30-0,35 m/a

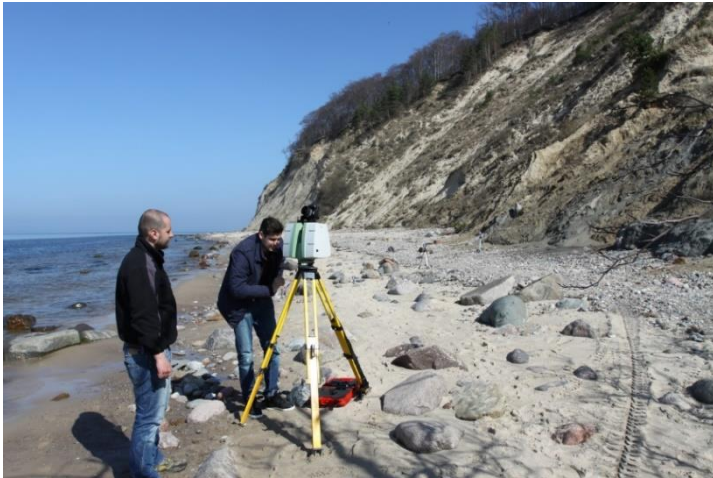
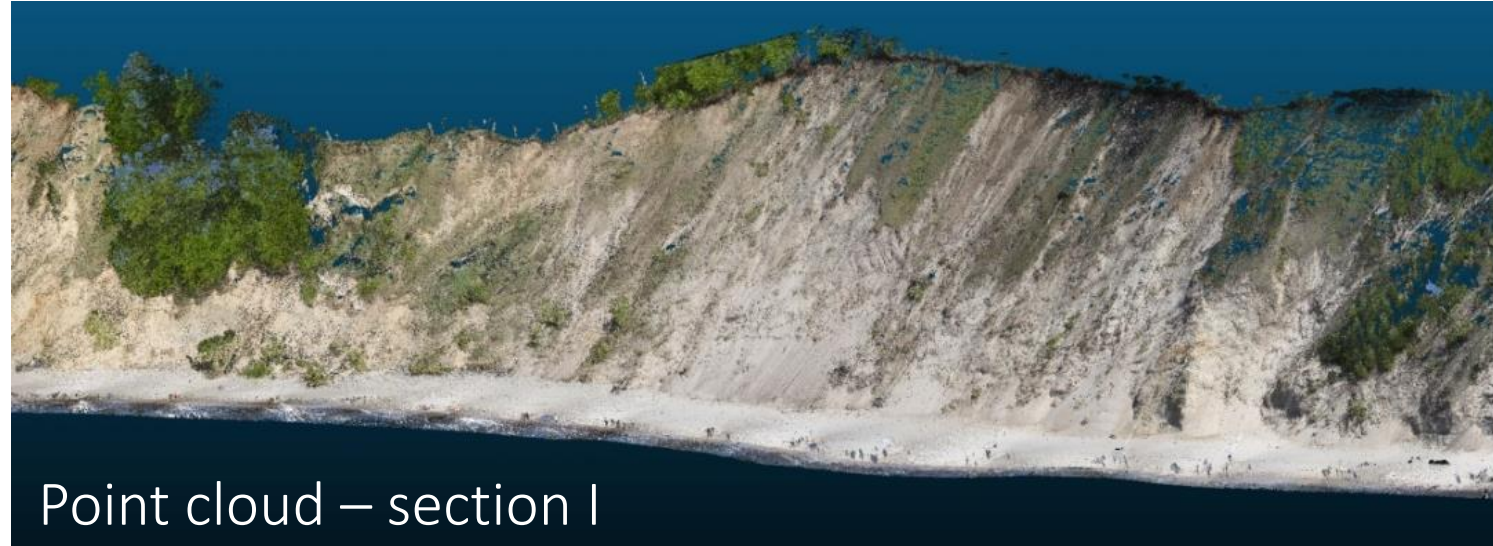
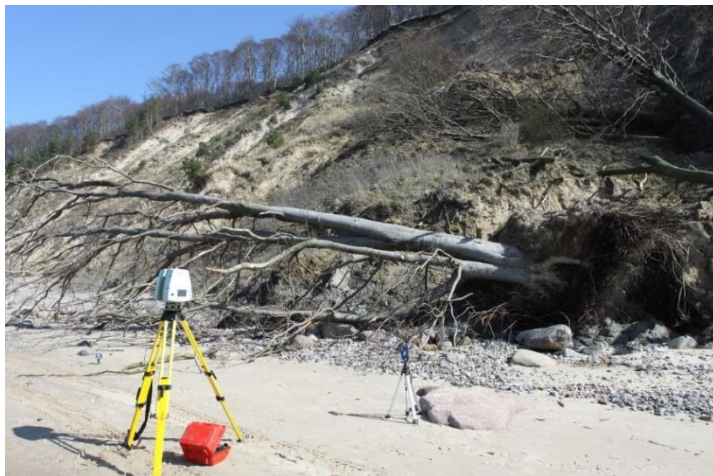
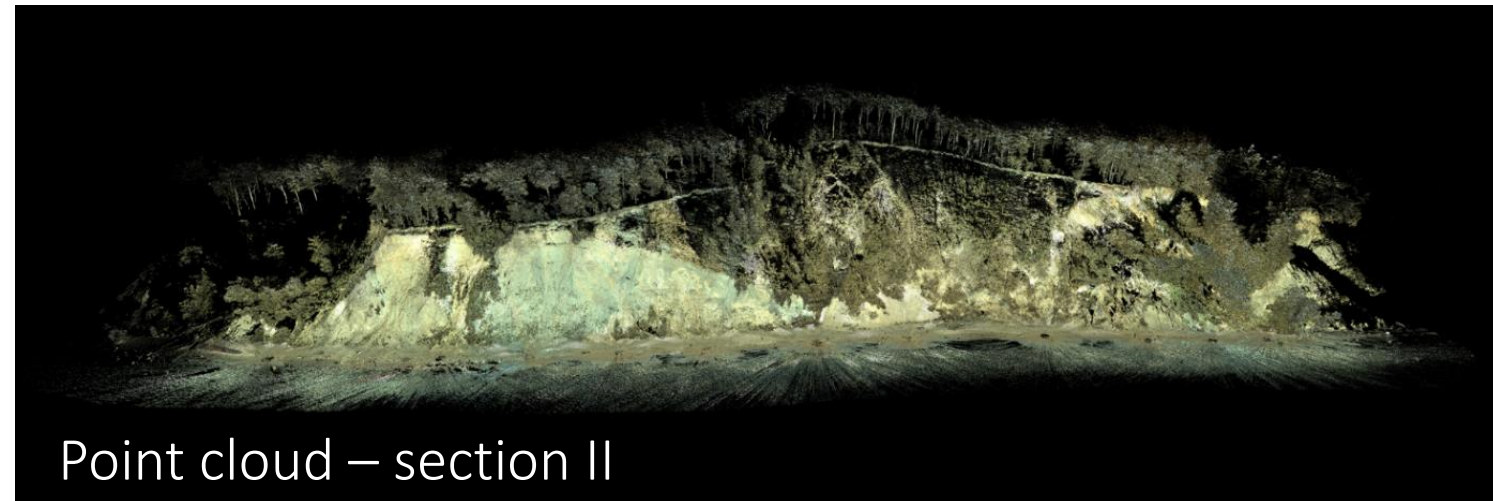
## Field survey: Terrestrial Laser Scanning (TLS) (Geocartis sp. z o.o.)

Leica ScanStation c10

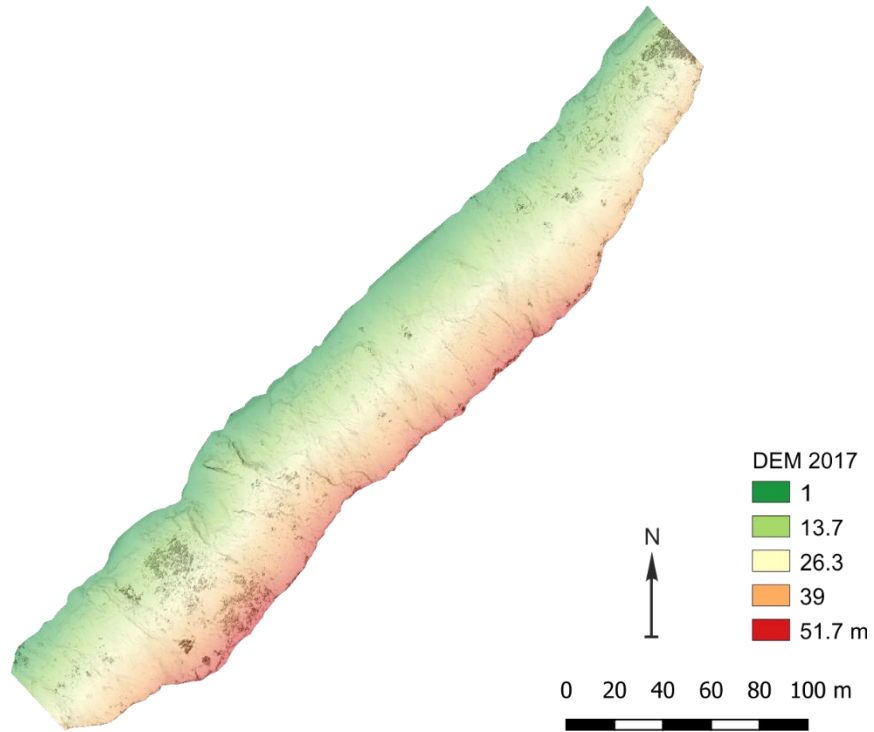
Digital Elevation Model

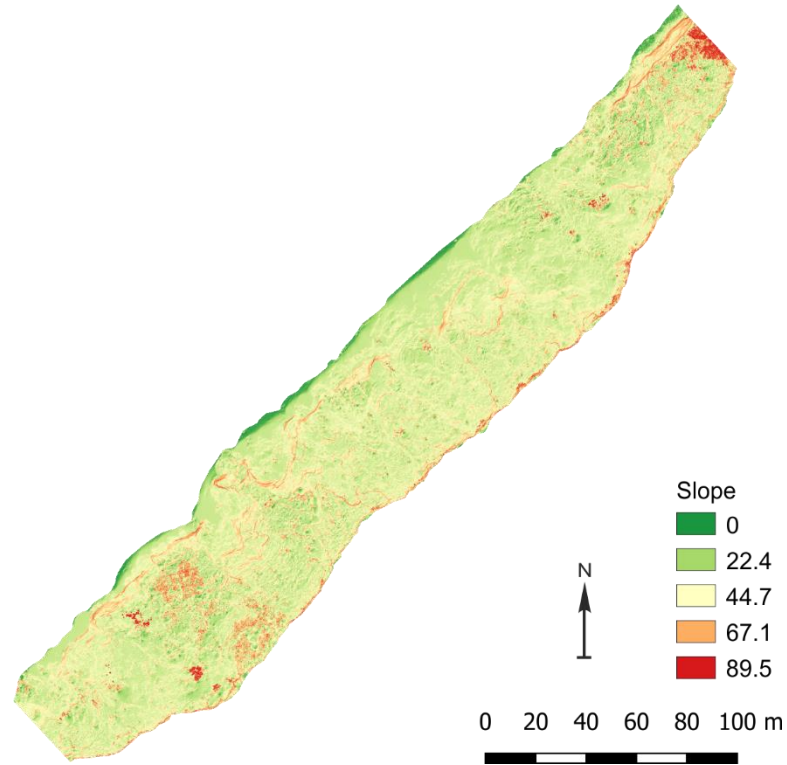
Slope model

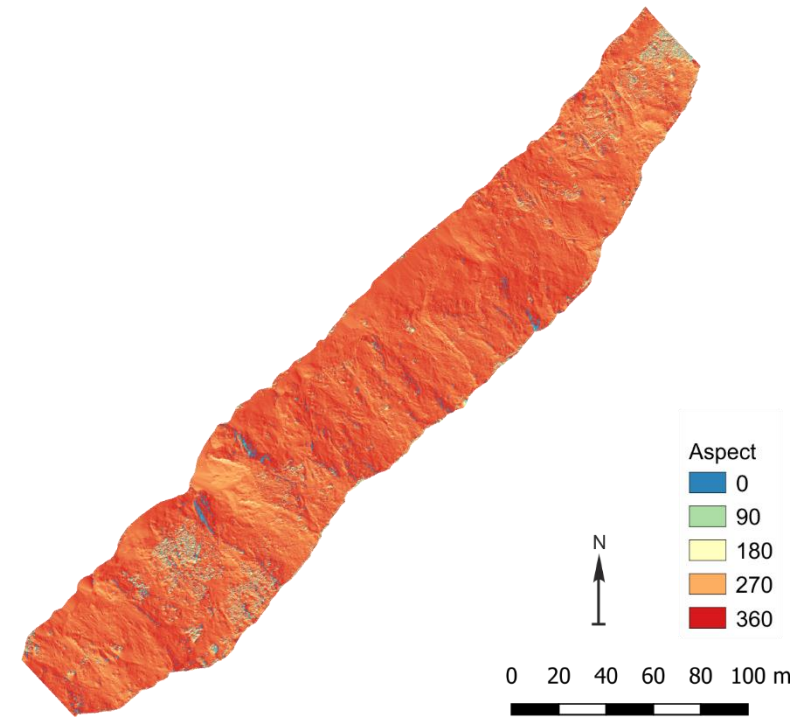
Aspect model

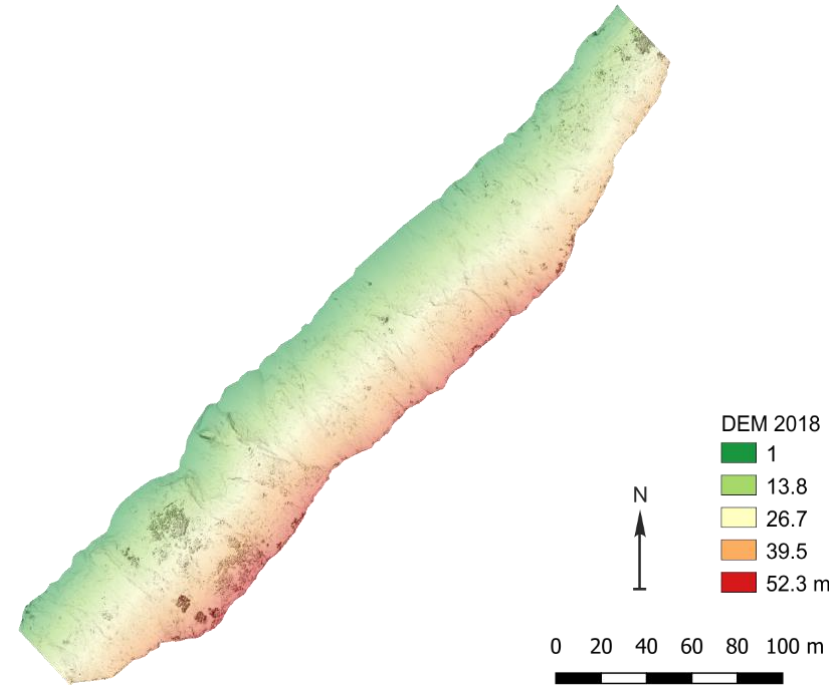
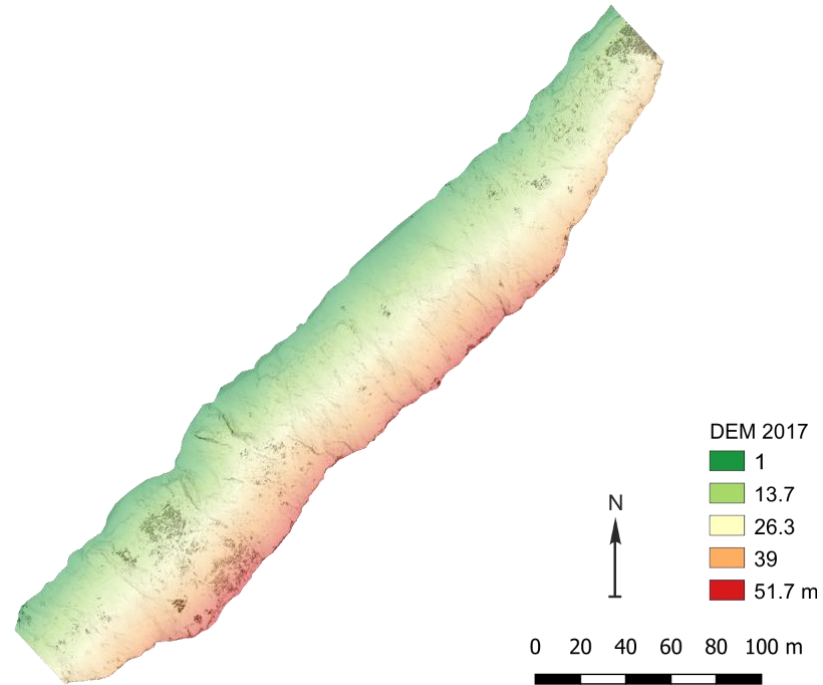
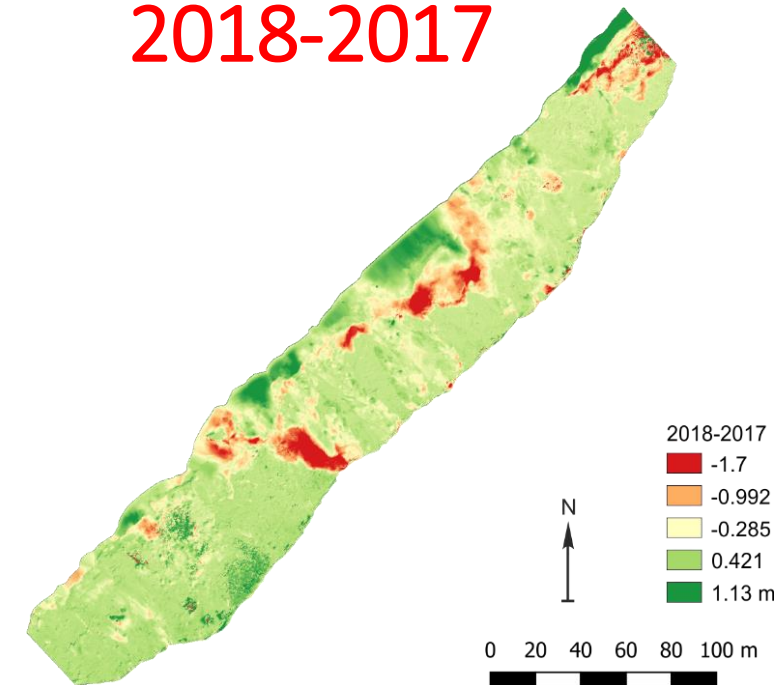
DEM 2018

DEM 2017

Differential elevation  
map (DoD)  
2018-2017

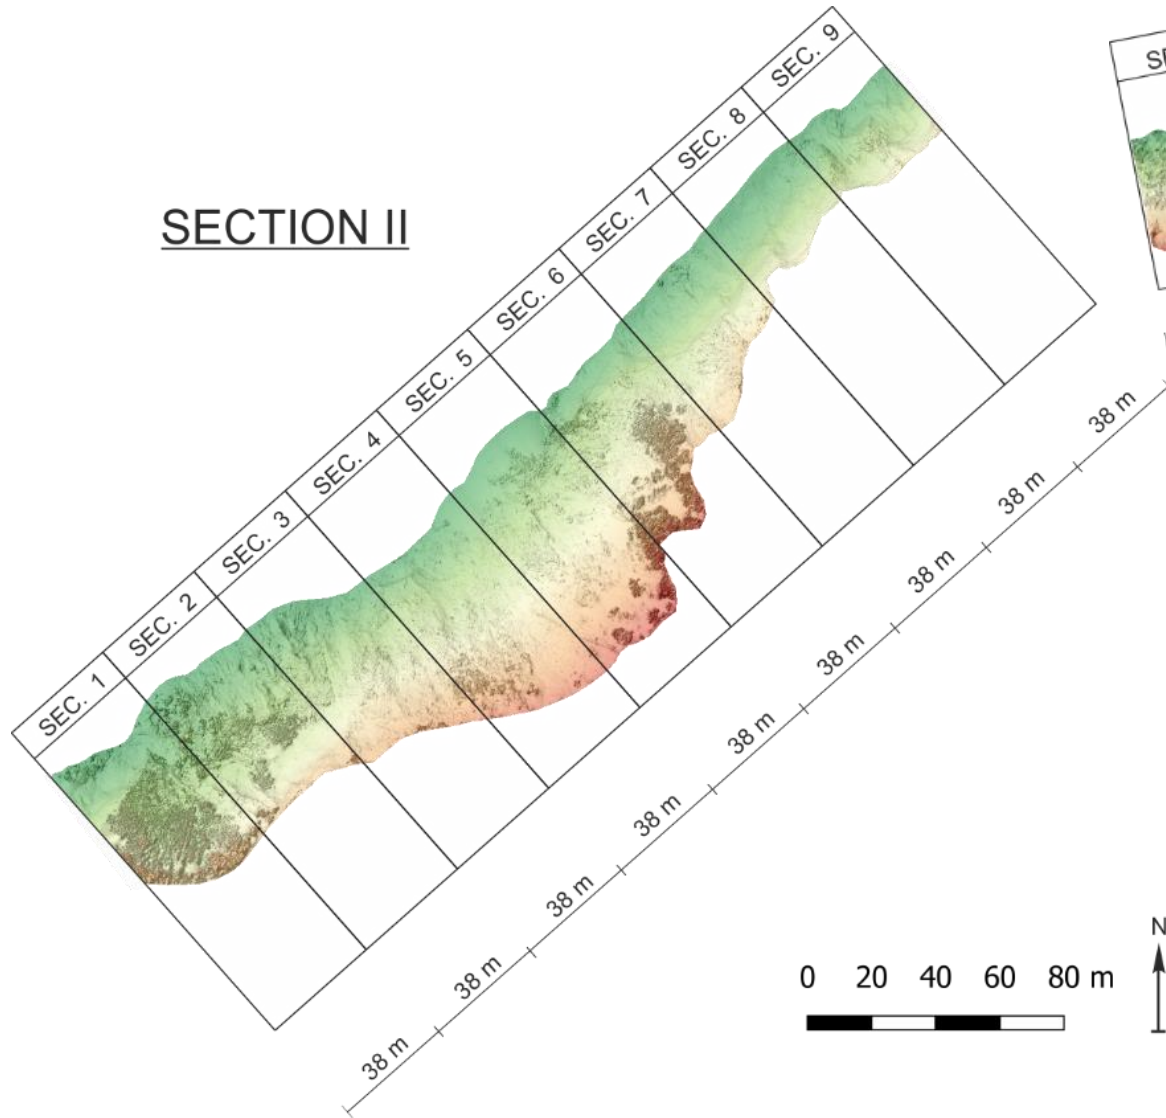
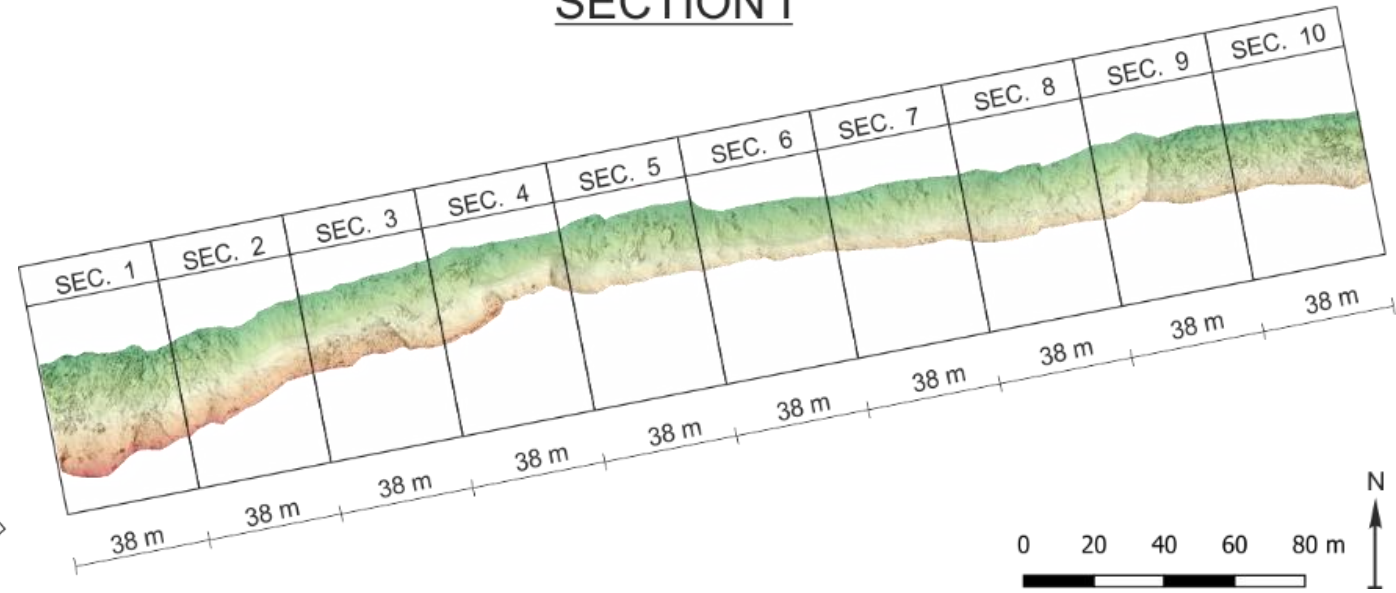
- Sections divided into equal sectors (38 m),
- Section I - 10 sectors
- Section II - 9 sectors
- **Possibility of spatial analysis of erosion and accumulation processes.**

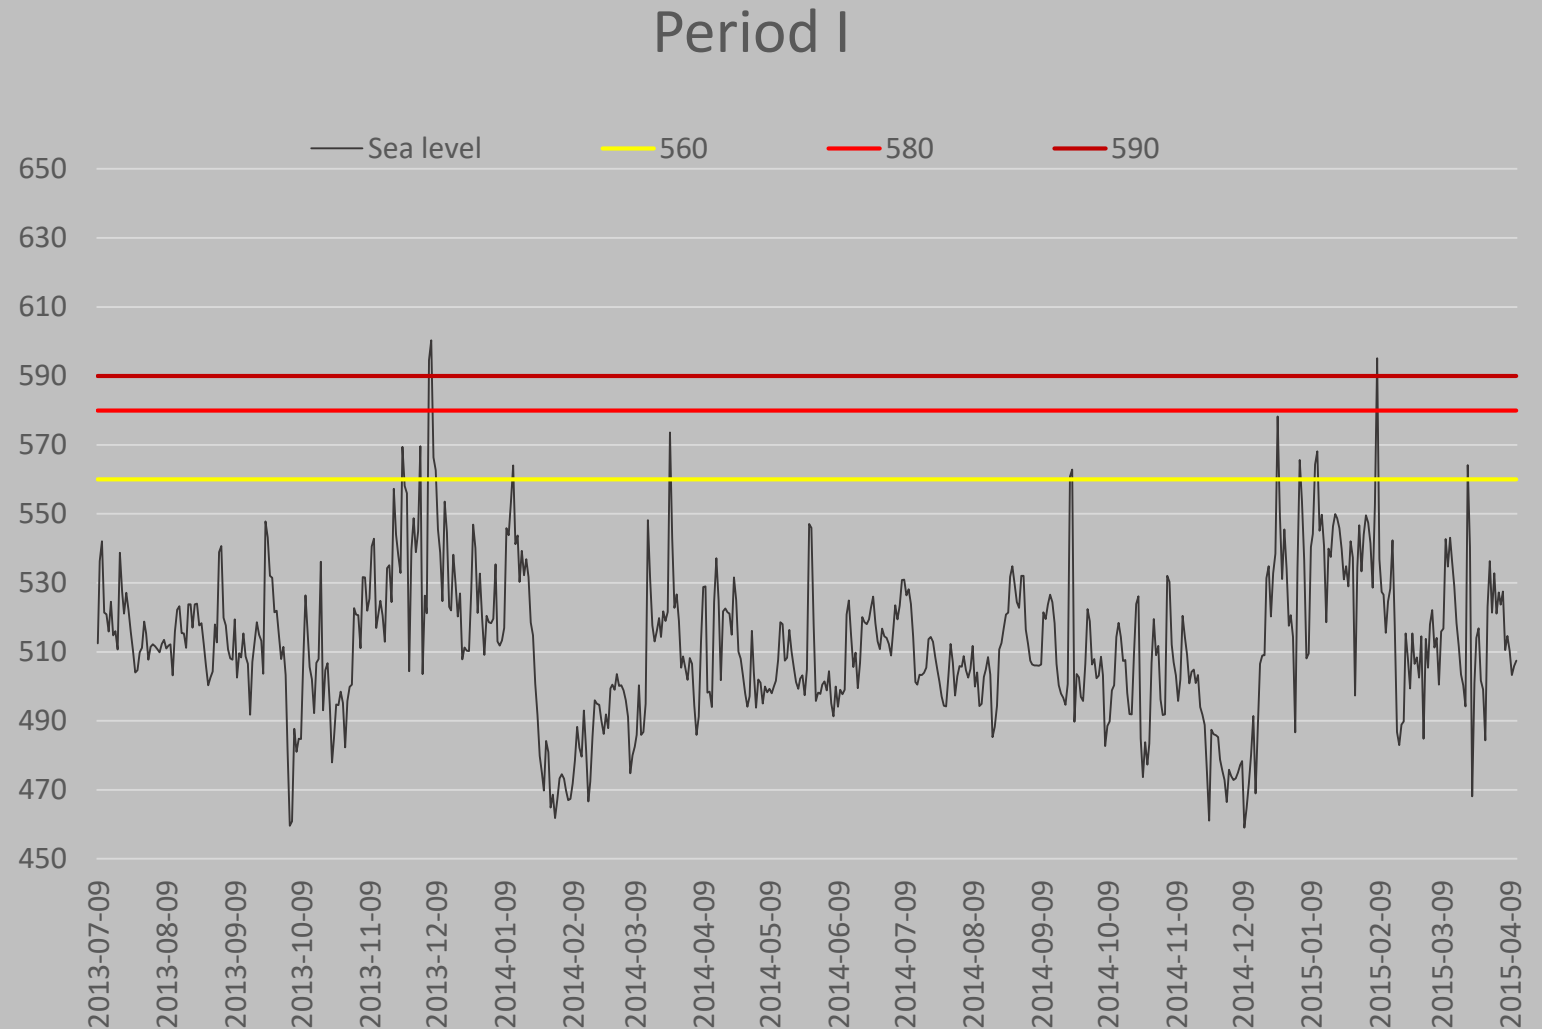
Period I (07.2013 – 04.2015) – 643 days:

## 2 storm surges

Max sea level – 600 cm,

Max. height of significant wave – 3,44 m

- 560-580 cm – 82 h,
- 580-590 cm – 15 h,
- > 590 cm – 16 h.

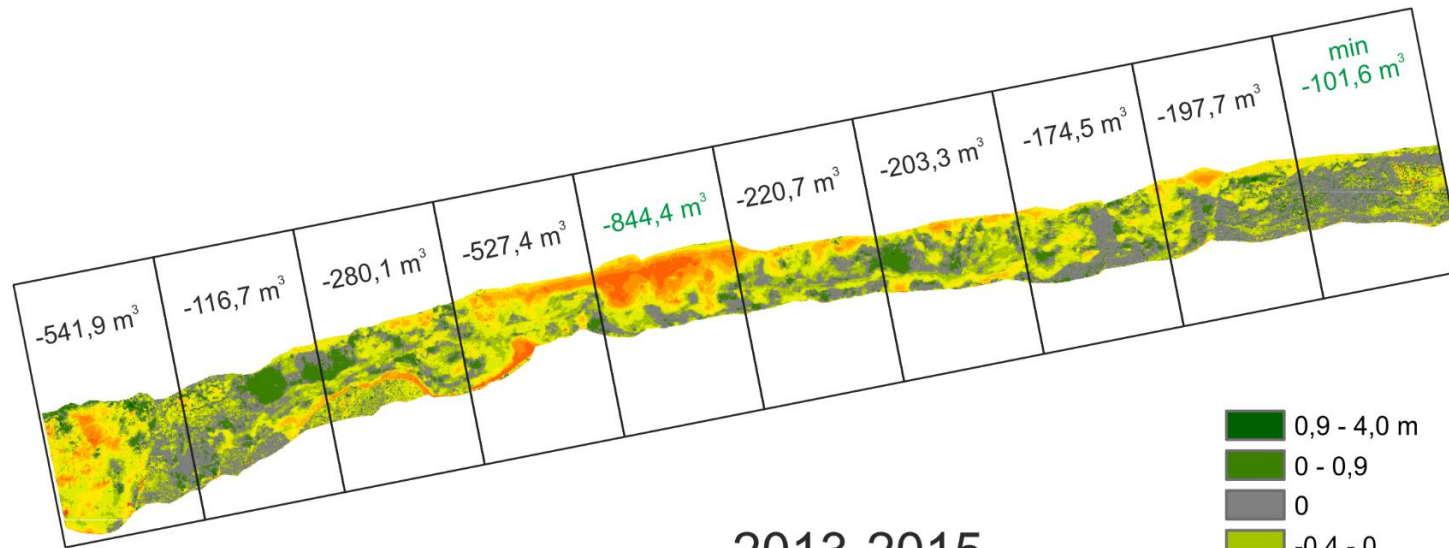
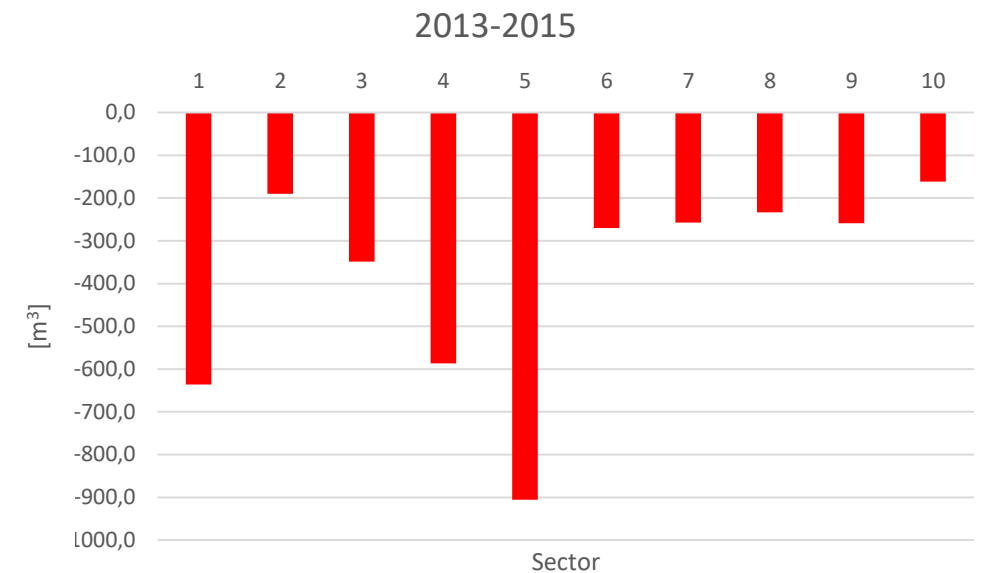
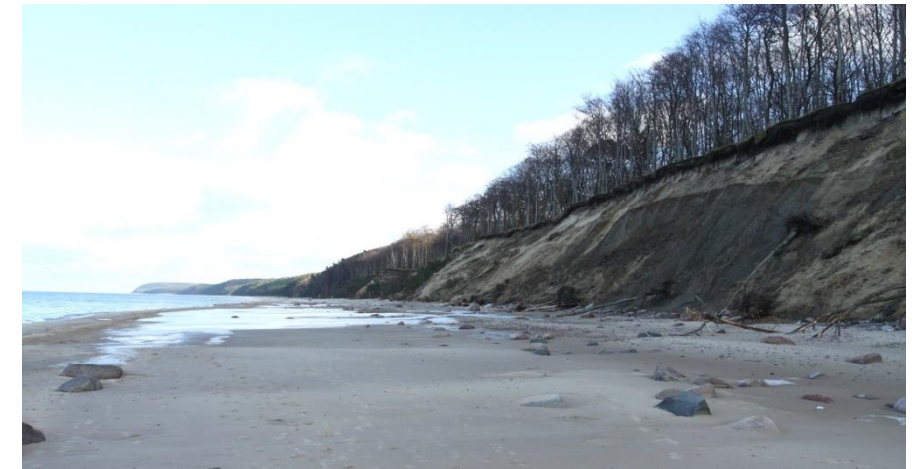
(Period I) - 07.2013 – 04.2015 - 643 days

Total = - 3208,3 m³

Total sediment budget – **-3208,3 m³**,

- Max erosion - middle part of section
- Min erosion – eastern part of section

✓ **-8,44 m³/m**,

✓ **-0,40 m³/m²**

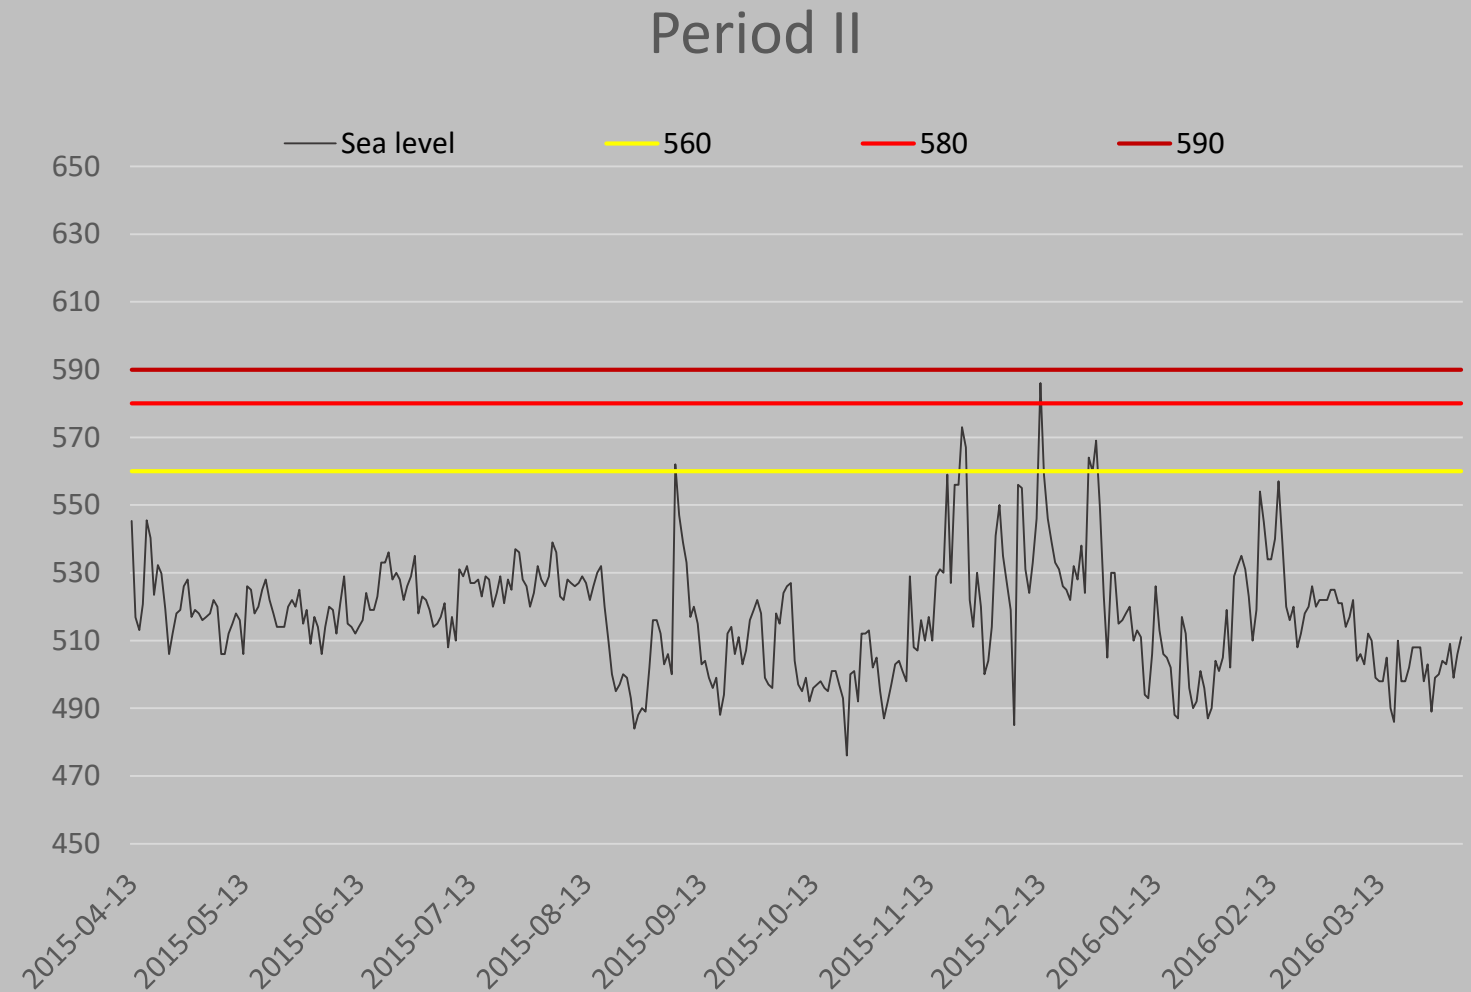
Period II (04.2015 – 04.2016) – 358 days:

1 storm surge

Max sea level – 586 cm,

Max. height of significant wave – 1,3 m

- 560-580 cm – 53 h,
- 580-590 cm – 2 h,
- > 590 cm – 0 h.

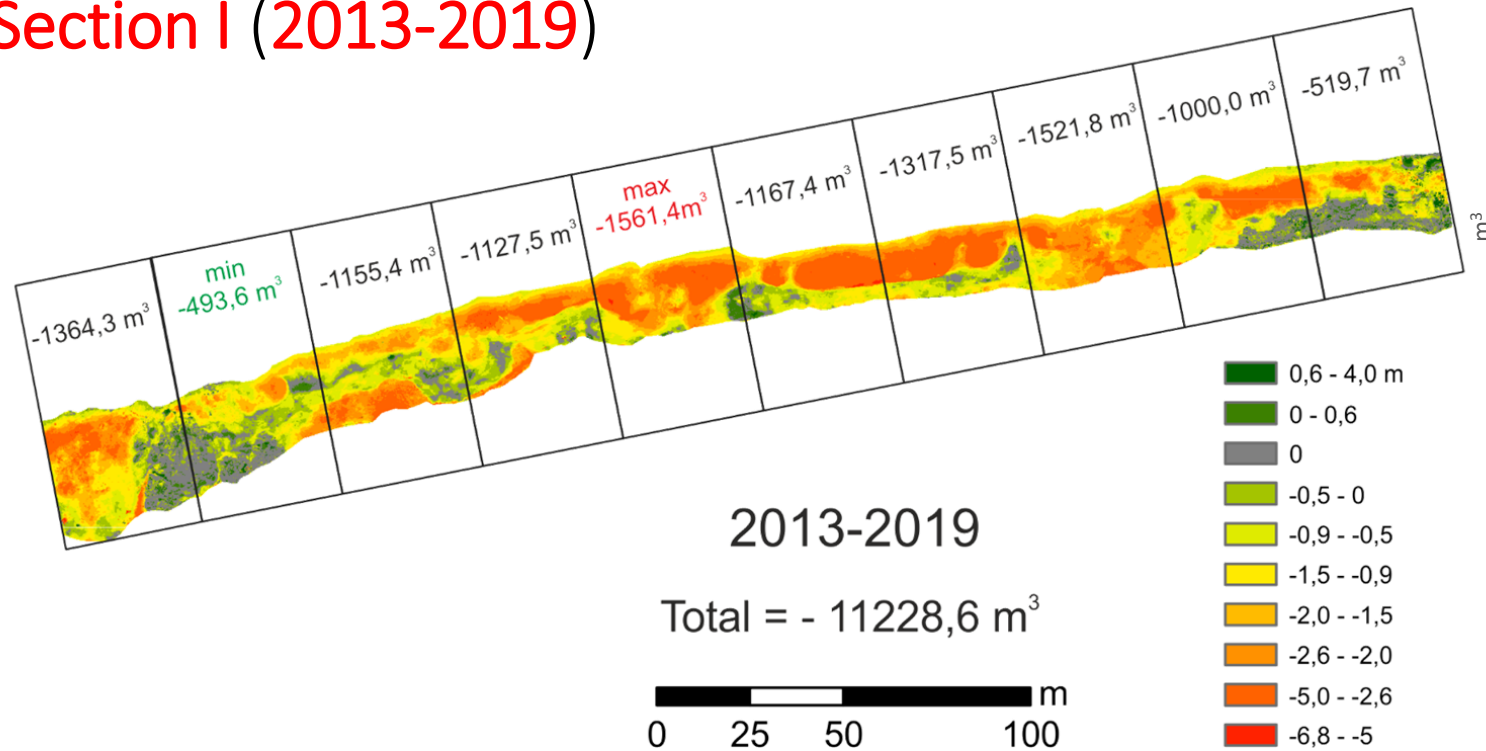
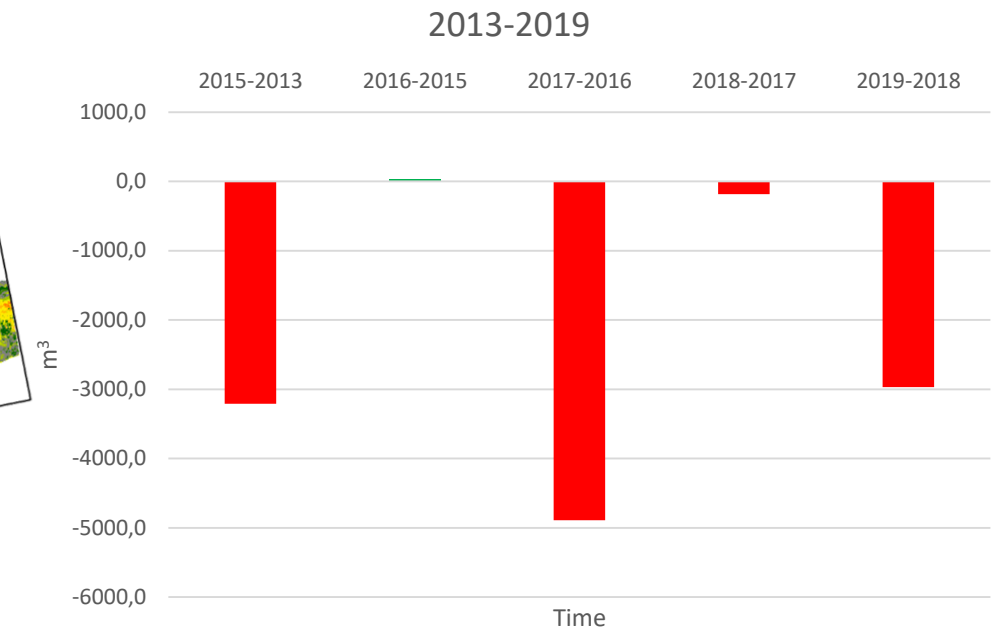
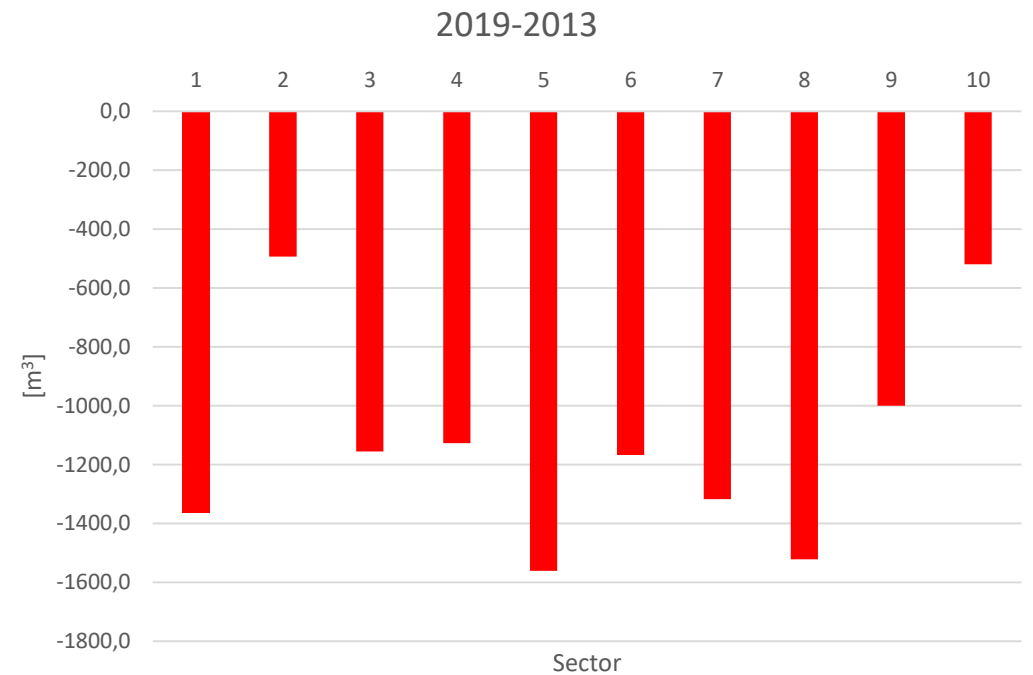
Total sediment budget – **11228,6 m³**,

- Max erosion in 2016-2017 (III period) - - 4892,8 m³
- Min erosion in 2015-2016 (II period) - + 27,9 m³
- Evenly distributed erosion with 2 exceptions (2 and 10 sector)

- ✓ **-29,55 m³/m;**    **-4,90 m³/m/yr**
- ✓ **-1,46 m³/m²;**    **-0,24 m³/m²/yr**

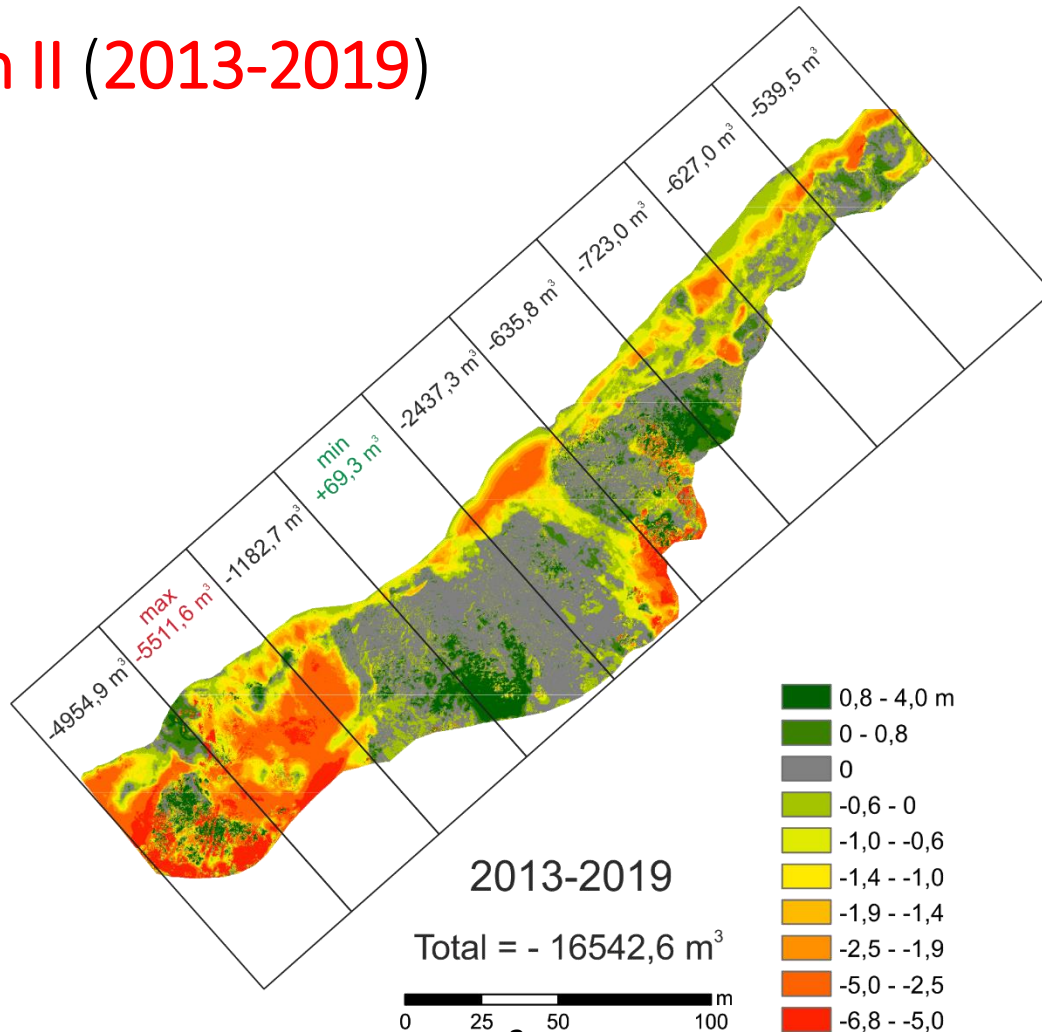
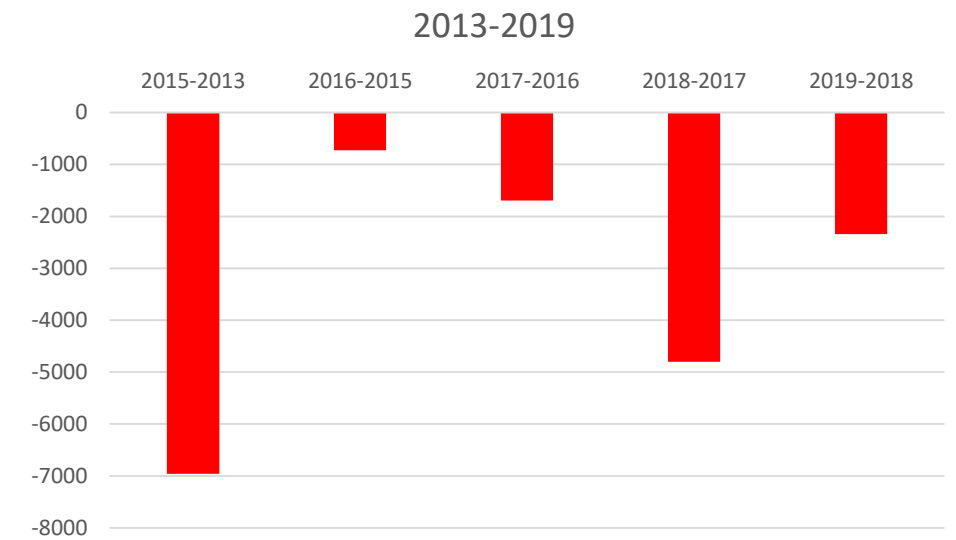
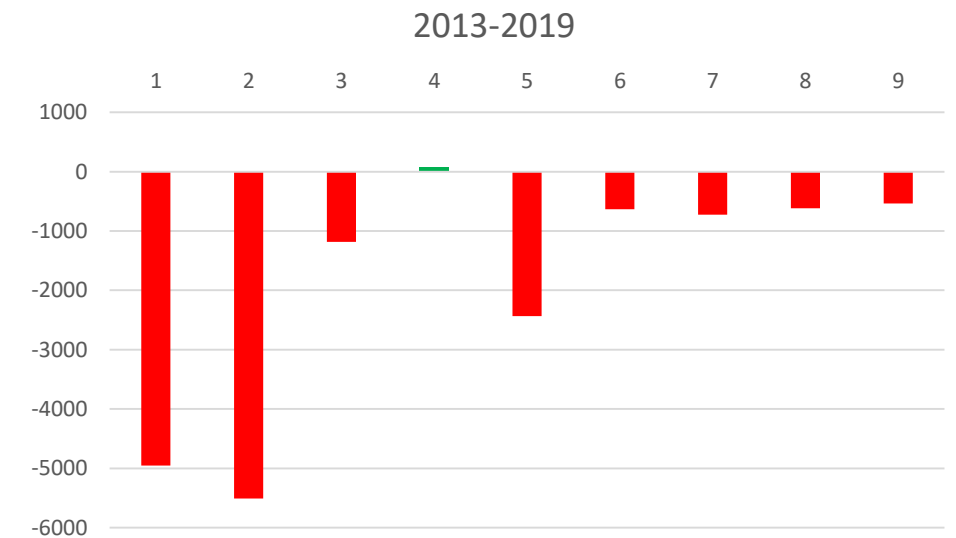
Total sediment budget – **-16542,6 m³**,

- Max erosion in 2013-2015 (I period) - -6472,1 m³ (2 years)
- Min erosion in 2015-2016 (II period) - -726,84 m³
- Significant erosion – western part of section – big landslide
- Low erosion – eastern part of section – resistant clay cliffs

✓ **-48,37 m³/m;**    **-8,06 m³/m/yr**

✓ **-1,00 m³/m²;**    **-0,17 m³/m²/yr**

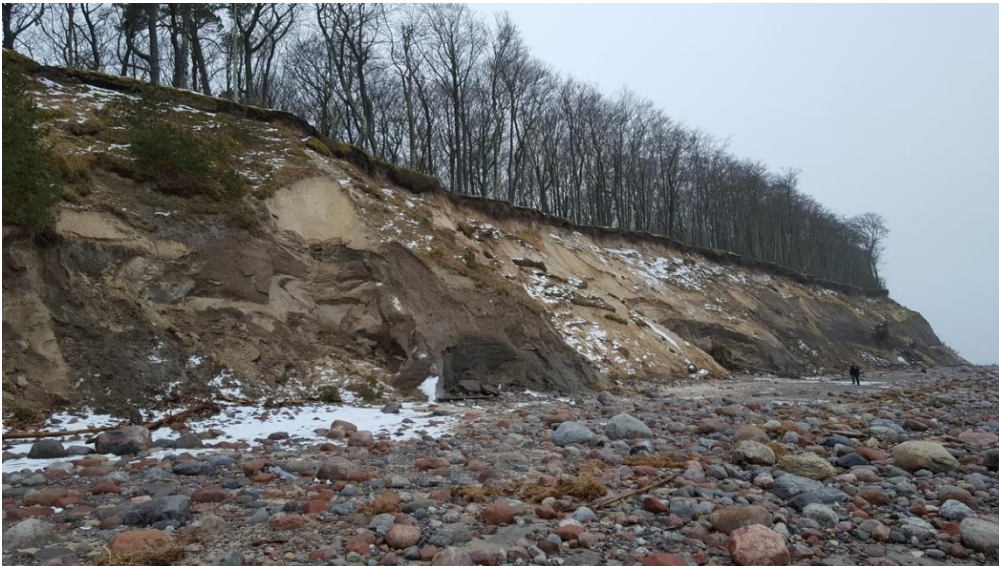
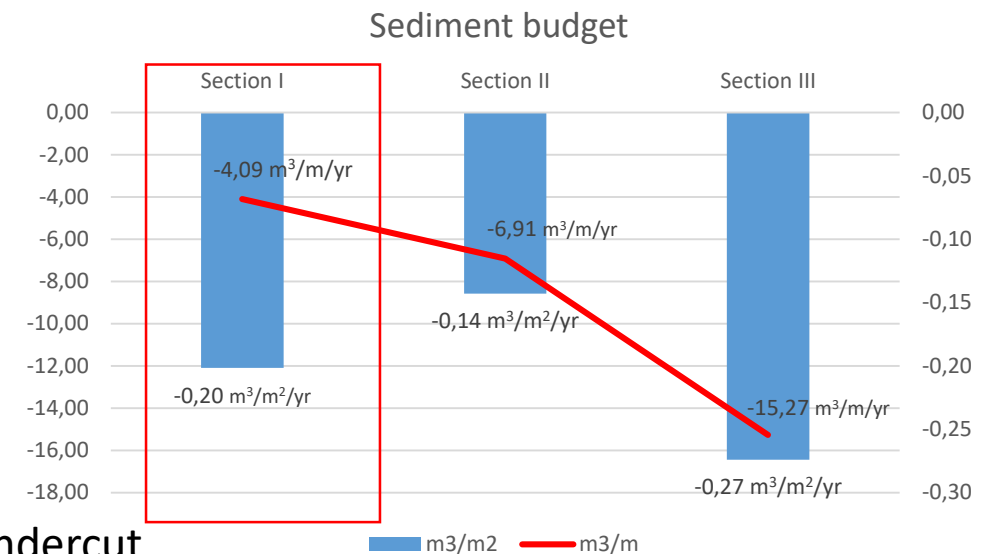
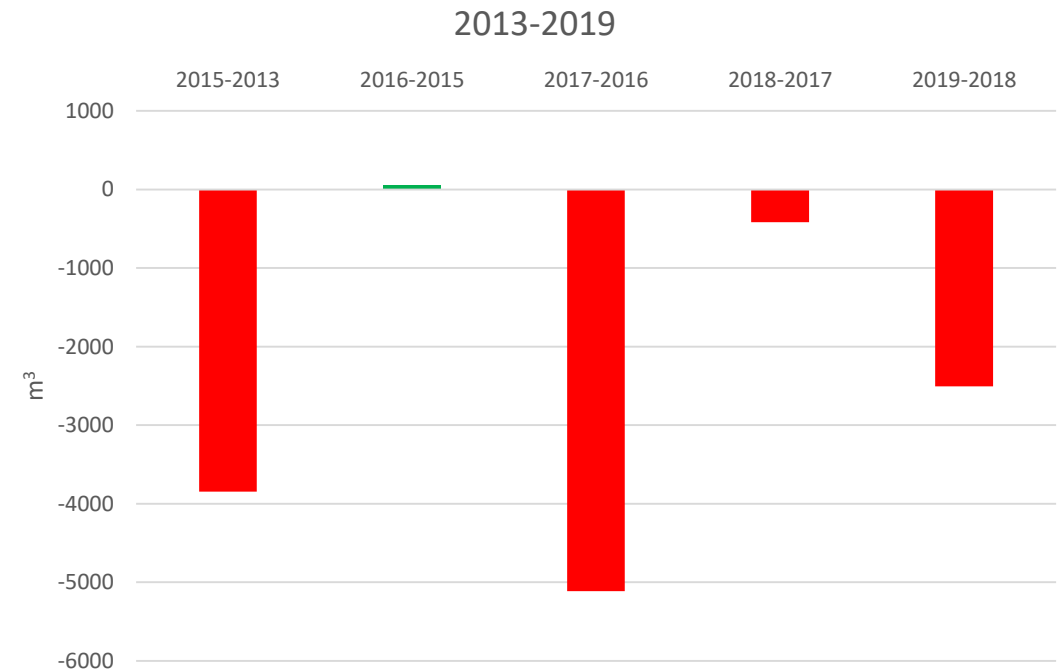
- Mostly clay cliff – relatively resistant sediments,
- Low height – 19-27 m,
- **Total erosion (2013-2019) – -11228.6 m<sup>3</sup>,**
- Lowest erosion - +27.9 m<sup>3</sup> (period II 2015-2016)
  - max sea level 586 cm, storm duration – only 2 h.
- Max erosion - -4892,83 m<sup>3</sup> (period III 2016-2017) – extensive abrasion undercut
  - max sea level – 640 cm, storm duration 75 h.
- **Cliff efficiency – - 4,90 m<sup>3</sup>/m/yr**
- **Cliff dynamics - -0,24 m<sup>3</sup>/m<sup>2</sup>/yr**

Section I – after heavy storm surge (Axel Storm), January 2017 (max erosion)

- Within 6 years, the most material to the submerged areas was delivered by section II ( $-16542,6 \text{ m}^3$ ).
- The high dynamics of section I was conditioned by the northern exposure of the shore and the largest exhibition towards the sea of all sections. Waves in the biggest storm (Axel Storm - January 2017) were flowing perpendicular to the shoreline. At that time, the greatest damage was recorded on the northern exposure shores.
