# **Spatial diversity and time variability of erosion and accumulation processes on the unconsolidated cliffs of the Wolin Island (Southern Baltic - Pomeranian Bay)**

**Marcin Winowski, Zbigniew Zwoliński, Andrzej Kostrzewski  
Institute of Geoecology and Geoinformation, Adam Mickiewicz University**

Quantification of the  
sediment budget of  
unconsolidated cliffs of the  
Wolin Island in the years  
2013-2019

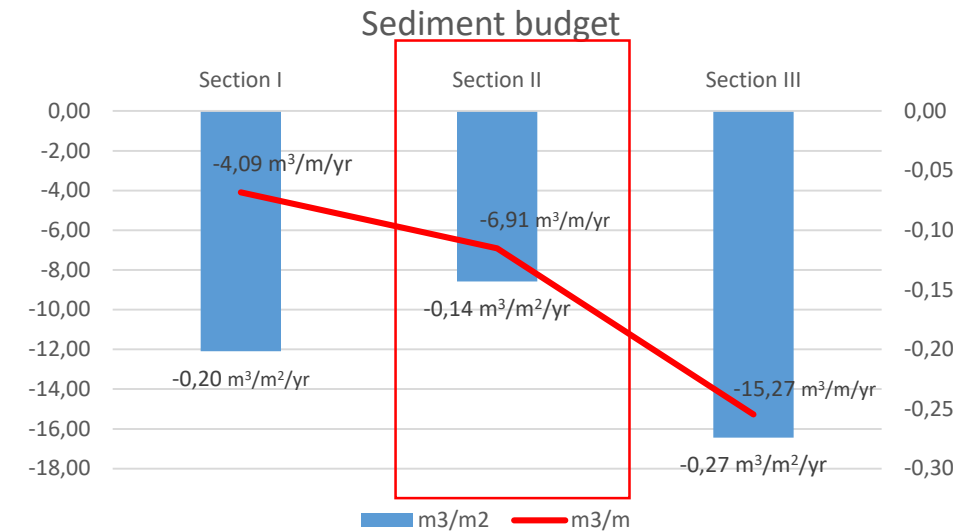
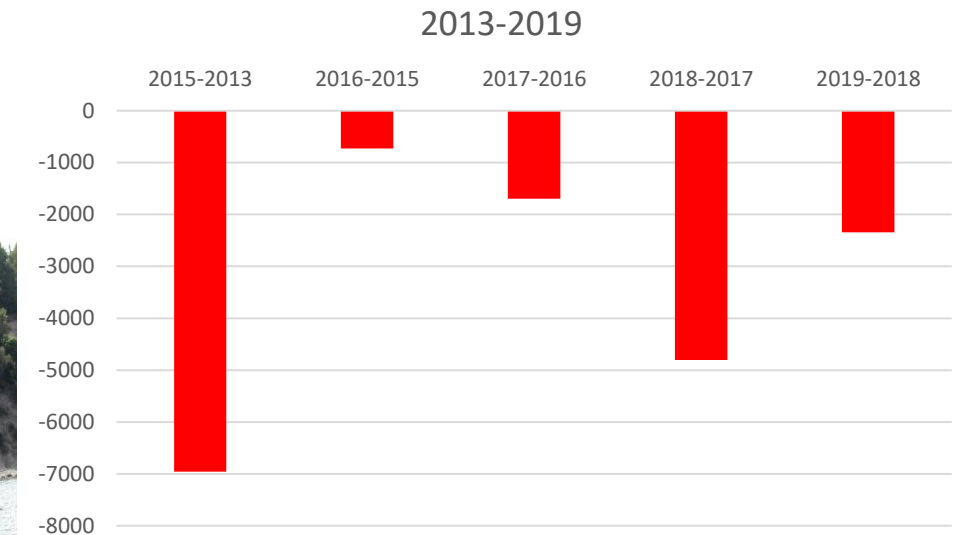
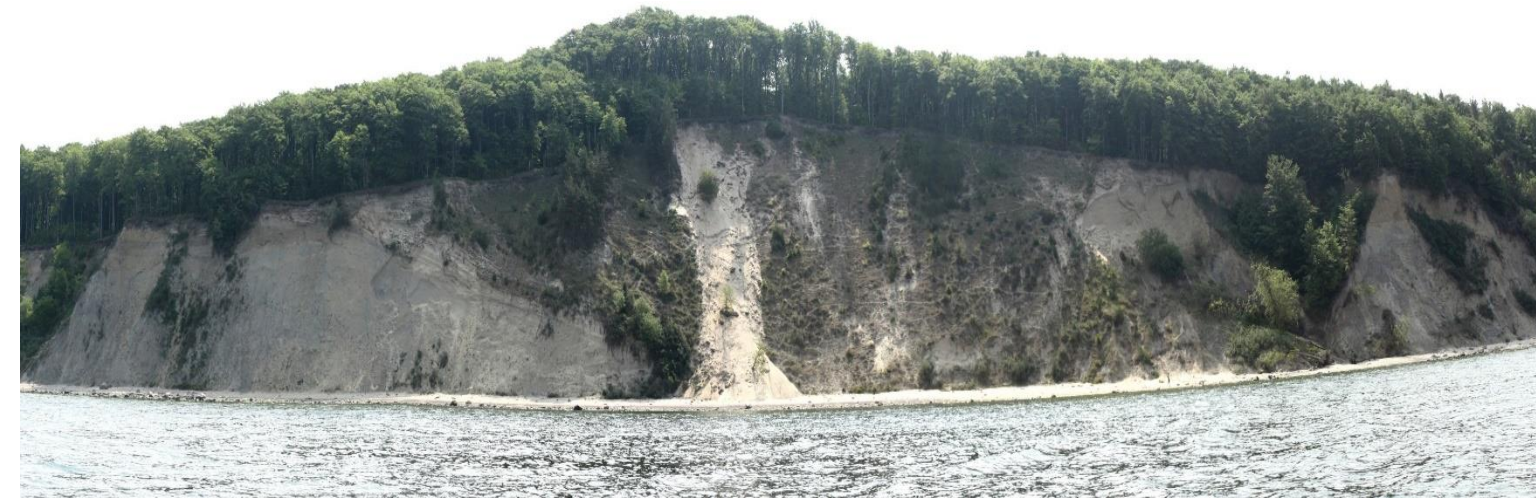
- Various geology structure (west and east – clay, middle – sand),
- Increased height – 35-60 m,
- **Total erosion (2013-2019) – -16542,6 m<sup>3</sup>,**
- Lowest erosion - -726,84 m<sup>3</sup> (period II 2015-2016)
  - max sea level 586 cm, storm duration – only 2 h.
- Max erosion - -6472,1 m<sup>3</sup> (period I 2013-2015) – extensive scatter niche
  - max sea level – 600 cm, storm duration 31 h.
- **Cliff efficiency – - 8,06 m<sup>3</sup>/m/yr**
- **Cliff dynamics - -0,17 m<sup>3</sup>/m<sup>2</sup>/yr**

Section II – extensive scatter niche in the middle part of section , June 2015

- The low efficiency and dynamics of section II depends mainly on clay bedrock. These deposits are very resistant to denudative processes. Mainly colluvial forms with reduced resistance are abraded. The highest dynamics in this section occurred in its western part. An extensive landslide was created there, which was then quickly abraded.
