CASE STUDY OF INTEGRATING ECOSYSTEM MANAGEMEMNT INTO SPATIAL PLANNING IN RURAL ENVIRONMENT Michaela Danáčová¹⁾, Roman Výleta¹⁾, Kamila Hlavčová¹⁾, Silvia Kohnová¹⁾, and Ján Szolgay¹⁾ 1) Department of Land and Water Resources Management, Faculty of Civil Engineering, Slovak University of Technology in Bratislava, Bratislava, Slovakia; kamila.hlavcova@stuba.sk

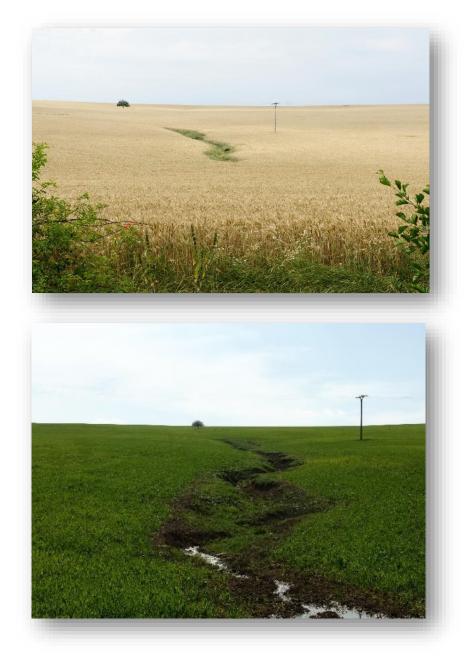
▲ Fig. 2: The signs of erosion in the watershed of Haluznikov creek.

The method was applied in the cadastral area of the village of Vrbovce lies in the district of Myjava in the western part of Slovakia (see Fig. 1). The **total area** of the locality investigated is **5147 ha** and it lies in a hilly country, with an altitude ranging between **350 m a.s.l and 650 m a.s.l**. The area belongs to a moderately warm-climate region, with a mean annual **air temperature** of 7.5°C and mean annual **precipitation** totals ranging between 700-800 mm. The cadastral area of the village of Vrbovce belongs to the basin of the **Teplica river**. The collectivization of the agricultural land, which took place after the end of World War II, resulted in the loss of this stable landscape, which was replaced by a number of large cooperative fields. This transformation led to an increased occurrence of flash floods and significantly intensified erosion processes (see Fig. 2).

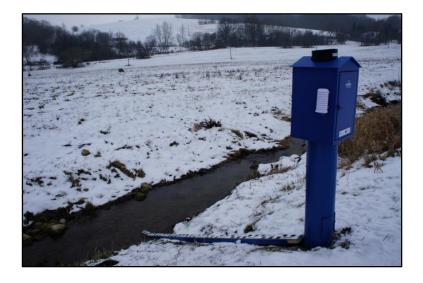
◄ Fig. 10: Location of operational stations in the study area.

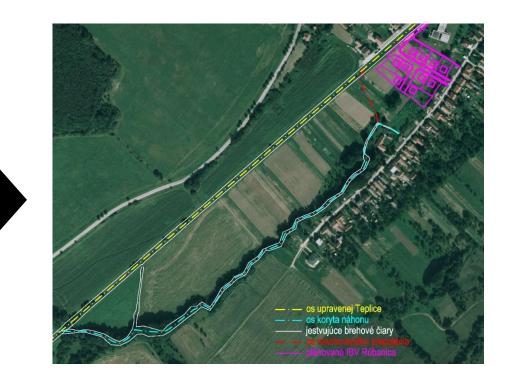
▲ Fig. 9: Proposal for an increase of space for inundation and housing.

Ichthyological and dendrological research was implemented in riverine areas and, using 2D hydrodynamical modelling, we submitted a proposal for the revitalization of the inundation zone of Teplica river and devised new areas suitable for housing (Fig. 8).

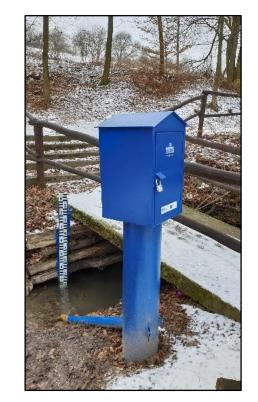
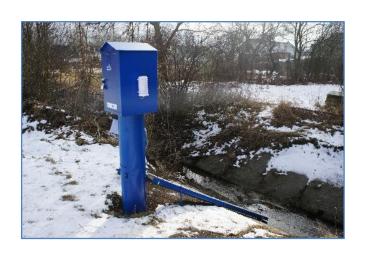
▲ Fig. 13-14: Water ulovský creek and Zapasecni
